ALMSBURY FARMHOUSE, WINCHCOMBE, GLOUCESTERSHIRE

Archaeological Ground Monitoring

07/01279/FUL

July 2012

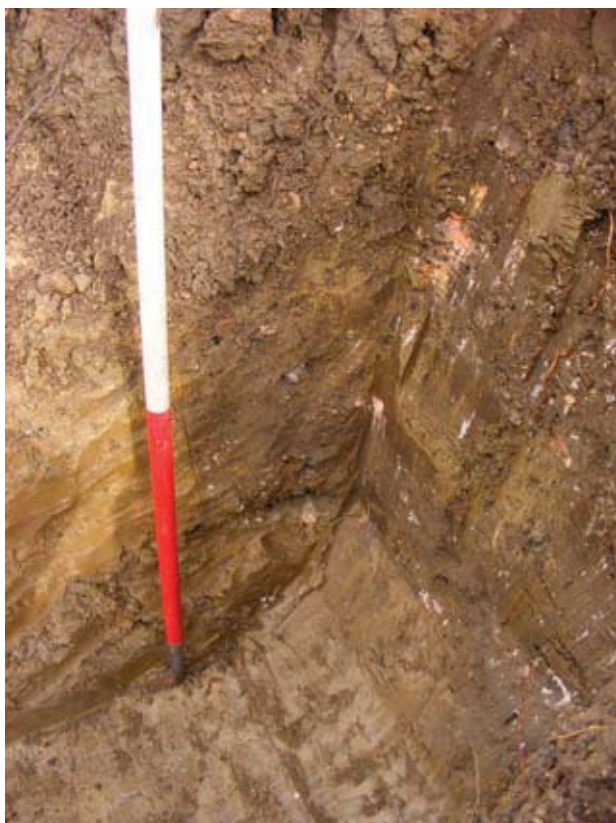
Illus 3

Possible wall cut [4005]

A very small part of a feature was exposed that may have been the cut of a possible wall trench [4005] aligned north-south. The fill consisted of mid brownish grey clay loam with rare charcoal flecks and small limestone fragments, stone that may have formed the base of a wall was present.

The feature was part exposed, just below the topsoil layer [4001] at the extreme east end of the dig for the new foundations at 7.5m south of the north garden boundary wall and 18.50m from the east elevation of the farmhouse. No further archaeological features were exposed by the cutting of the new foundation trenches for the proposed building.

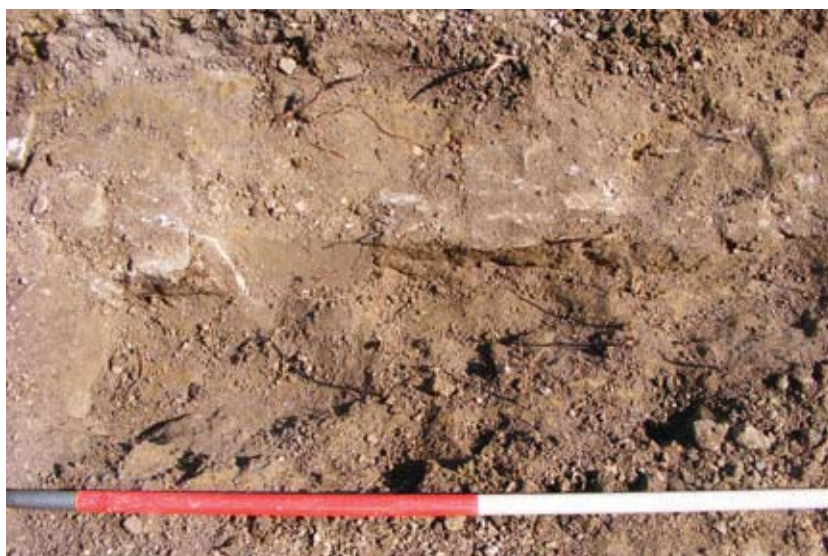
Illus 4

Possible culvert [1000]

The structure had been heavily truncated from above as well as at its north and south ends. It appeared un-bonded and measured 0.7m wide x 3.3m long x between 0.08m and 0.3m deep lying below the made ground [4002]. This feature was possibly the remains of a culvert.

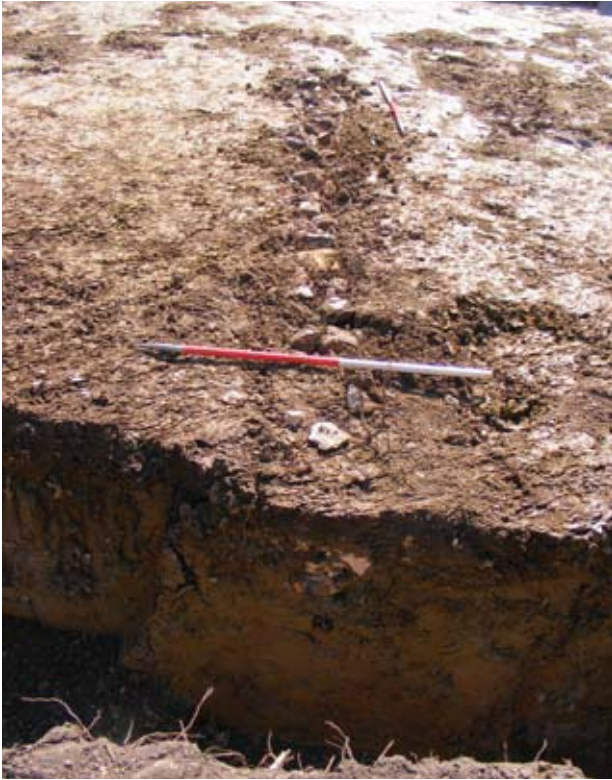
Illus 5

N-S aligned land drain [1002]

A second feature exposed by the strip was [1002], a stone filled land drain measuring 0.20m wide x more than 5m long located at nearly 11m from the east elevation of the farmhouse. The drain dropped downward towards the north garden boundary

following the slope of the hill and presumably, it drained into or at least towards the stream that bounds the northern extent of the site.

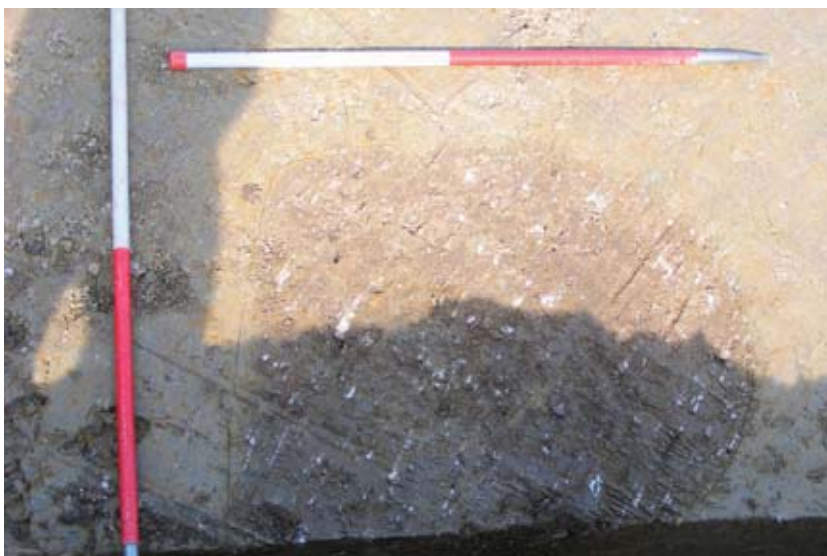
Illus 6

Pit feature [1003] pre-excavation

Feature [1003] was a pit, roughly circular in plan, with a rounded bowl shaped profile measuring 0.91m x 0.73m x 0.2m deep. The fill consisted of mixed greenish brown clay containing frequent small chips and flecks of oolitic limestone, occasional animal bones (large herbivore), and a single small piece of clay pipe stem. The feature was located at 8.3m east of the east elevation of the farmhouse and was located just on the northern edge of the line of a new excavation for a garden wall that divided the site into north and south halves. No further archaeological features were located in this area of the site.

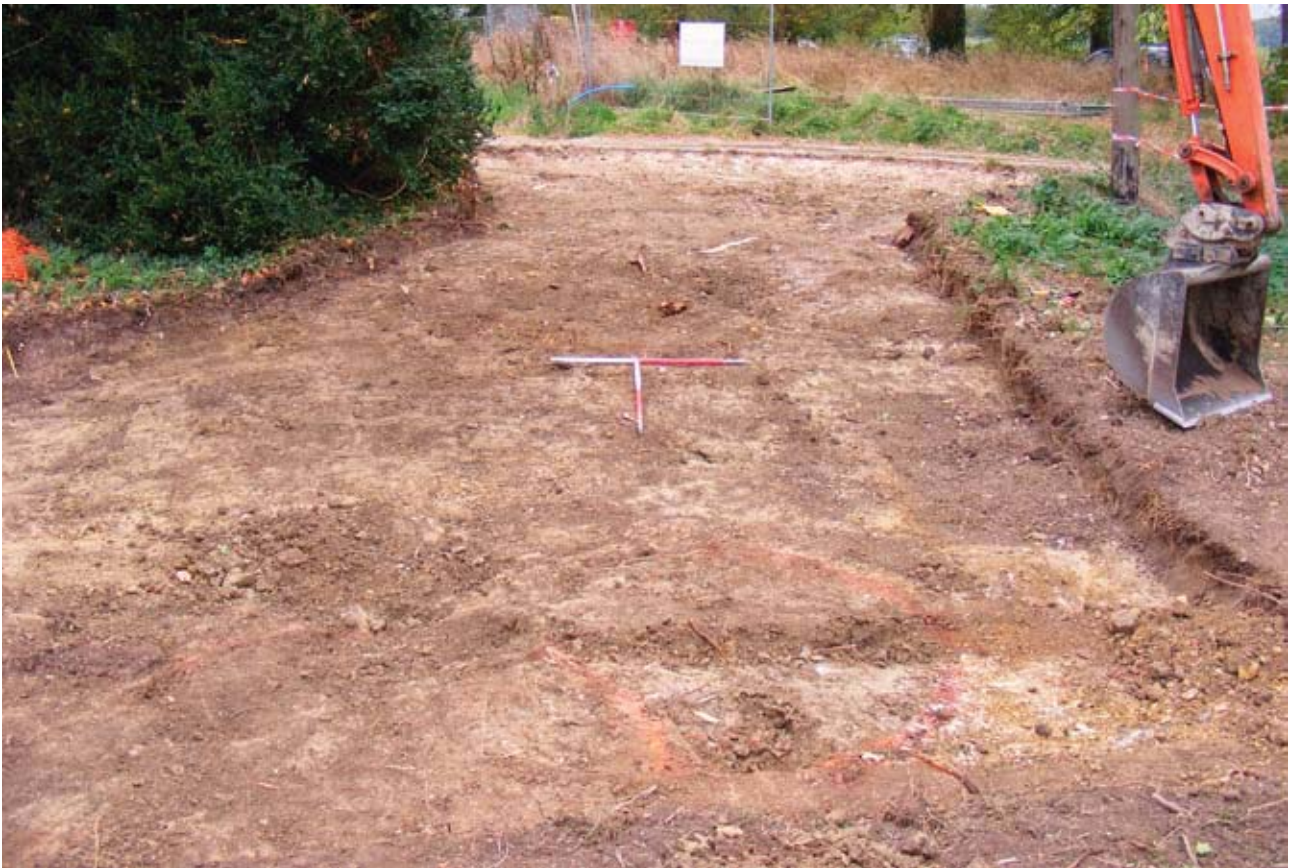
Illus 7

Features [6000/6002] pre-excavation

Topsoil was stripped from the west and south-west of the buildings to clear an area for a new driveway and parking bays. The excavation revealed two inter-cutting features ([6000] cut [6002]) in the location of the new parking bay at far west of the buildings (approximately 11m from the west end of the farmhouse). The later of these features [6000] was a roughly circular rubbish pit measuring 1.8m in diameter by 0.4m deep. The fill consisted of reddish/orange clay silt fill [6001] with finds dating to around the 18th century including bottle glass and a piece of local coarse ware with black glazed internal and external surfaces.

The earlier feature [6002] was roughly circular measuring 1.8m in plan with sloping sides and a convex base. The feature measured 0.52m deep.

The base of the feature had what appeared to be a red clay lining or compacted primary fill [6003] that contained animal bone, late post medieval pottery, and glass. A secondary fill of the feature [6004] measured around 0.1m deep and consisted of ash and charcoal. No further features were exposed by the strip.

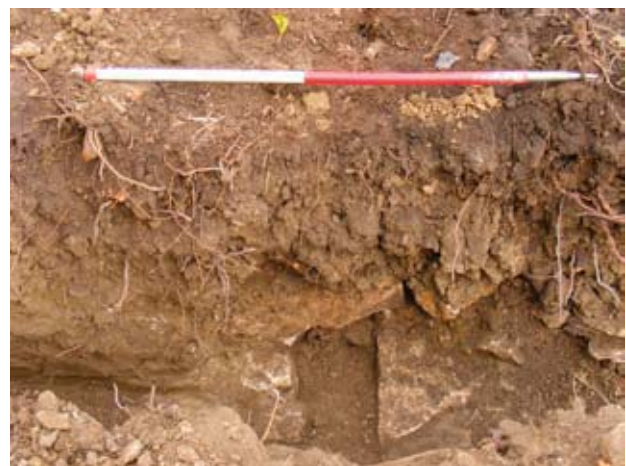
Illus 8

Features [6000/6002] partly excavated
