PROJECT SUNRISE

Archaeological Evaluation

for ECUS Limited

October 2011

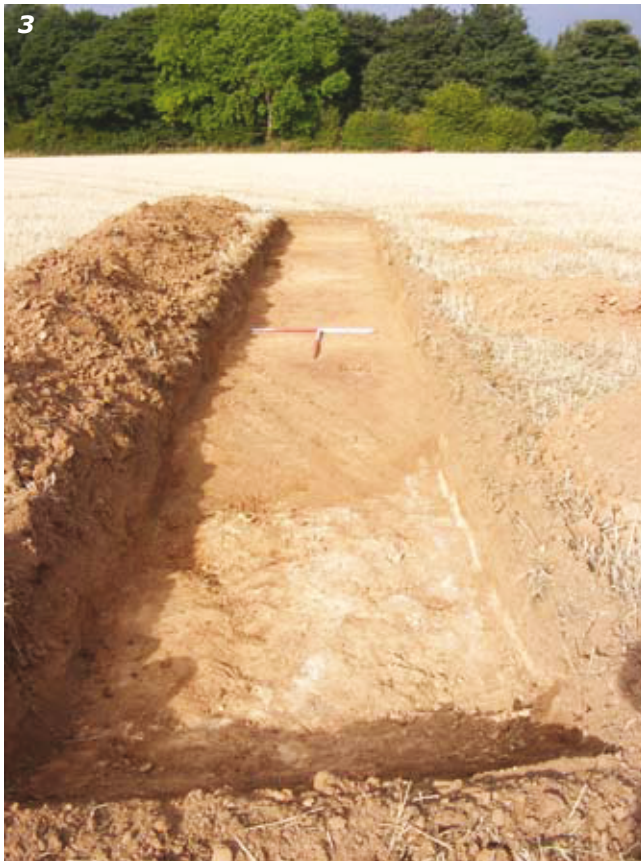
Illus 3

Trench 3 facing west, showing geology at east of site

Trench 3 was targeted over two parallel north-south linear anomalies running from the south-east corner of the turbine base. Beneath the topsoil, two possible north-south linear features roughly in position of the geophysical anomalies (4003 and 4004) were identified. [4003] was hand cleaned and slot – excavated, and was found to have a very irregular profile and a diffuse interface with deposit [4001]. [4004] was similarly investigated, and was found to be even more diffuse than [4003], with undefined edges and voids indicating possible animal burrowing. Both features were interpreted as natural due to their extremely irregular character and are possibly the result of depth variations in the geological deposits, as this part of the site was located at the bottom of a slope in the local topography.

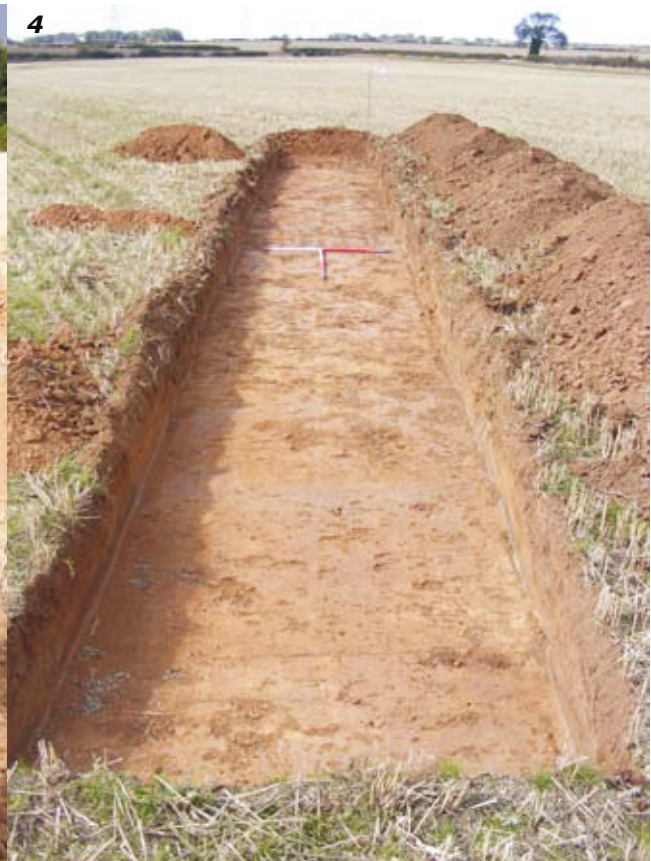
Illus 4

Trench 6 facing west, showing geology at west of site

A single trench, Trench 6, was excavated at Turbine 1, targeted near the intersection of two crossing linear anomalies. No features were identified in this trench. It is possible that the geophysical anomalies identified are the result of slight changes in the composition of the clay horizon, as this deposit is slightly variable across the site.
