FORT ROYAL PARK, WORCESTER

Topographical Survey

for Worcester City Council

October 2011

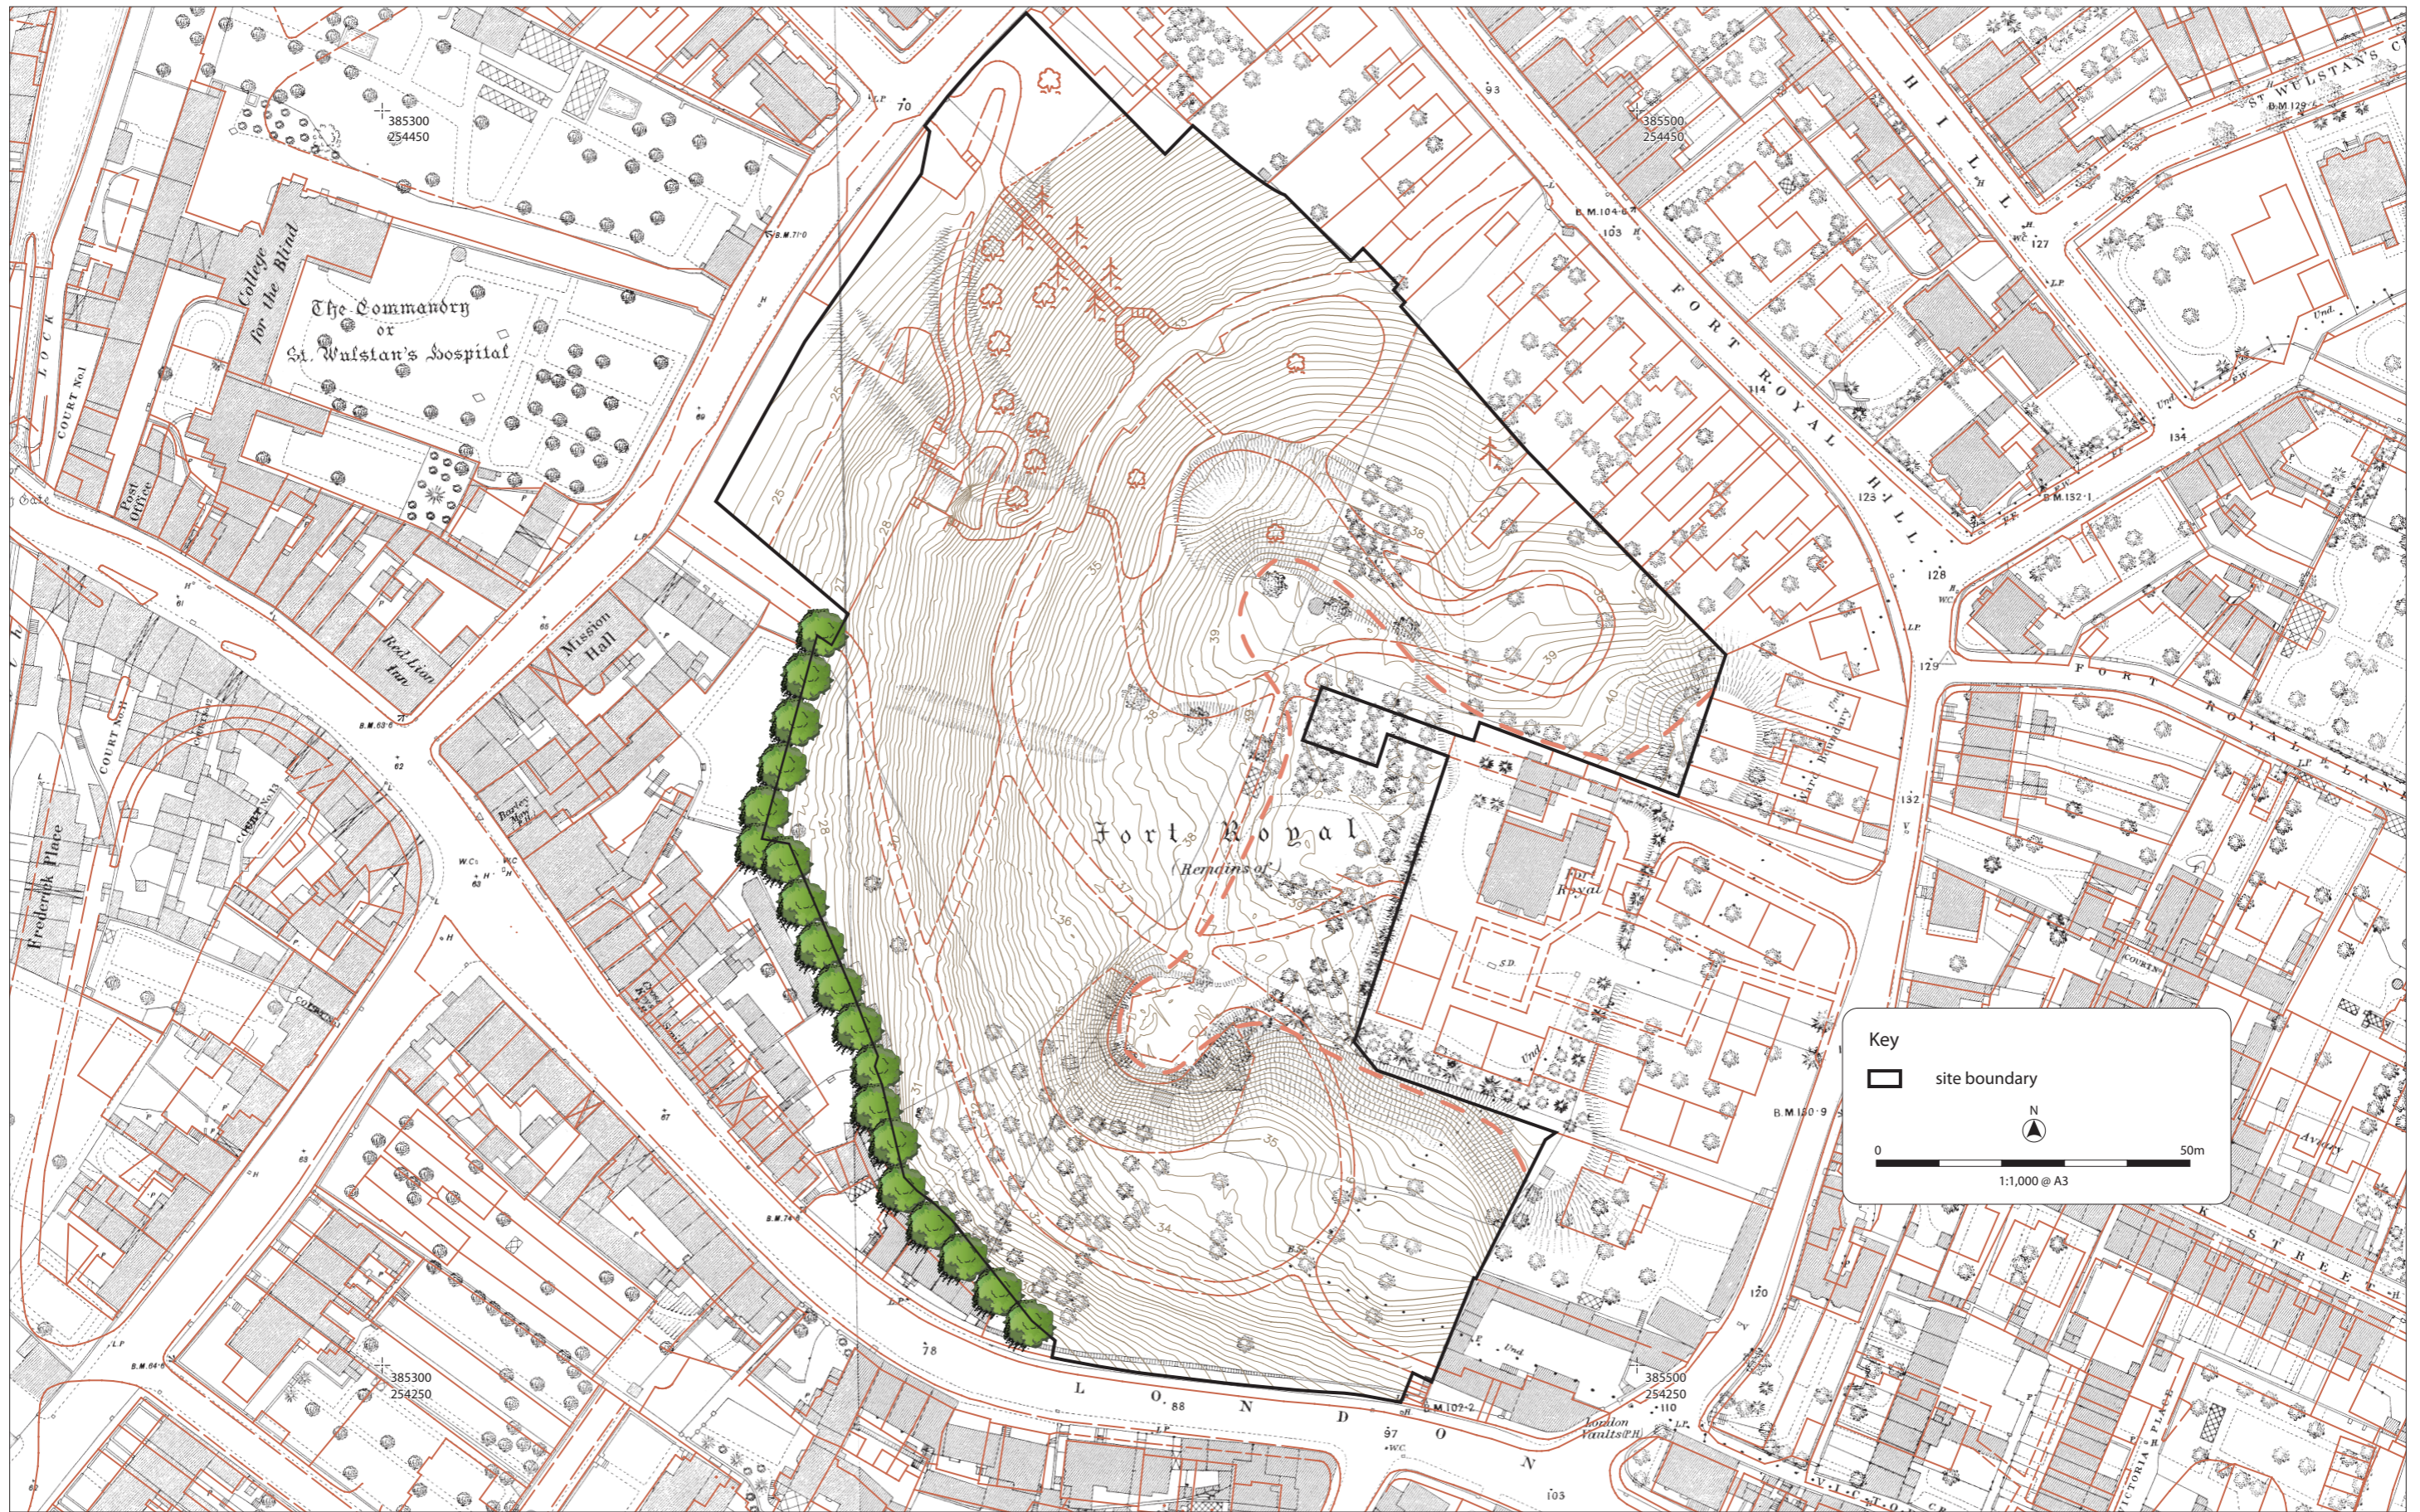
Illus 3
Contour plan overlaid onto an 1886 Ordnance Survey plan

way identified on the survey conducted by A M Fraser (1879) have now been incorporated into the present landscape and are no longer clearly visible upon the surface.

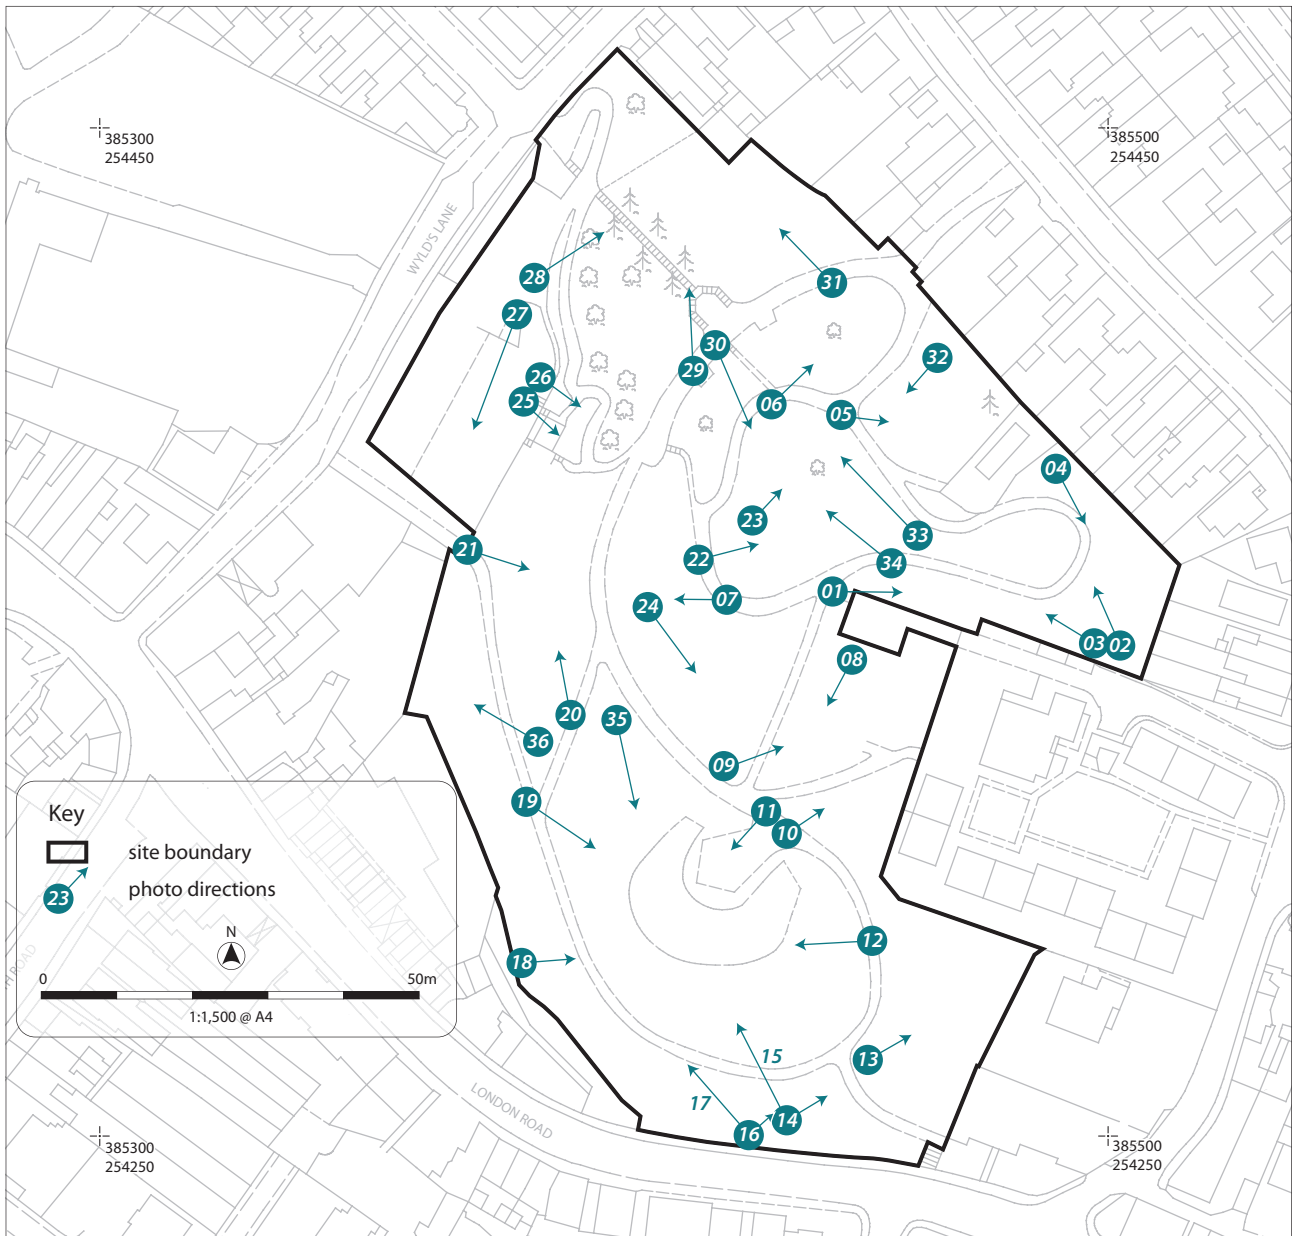
Illus 4
Photo reference plan

<i>Photo no.</i>	<i>Colour Slide</i>	<i>B&W</i>	<i>Digital</i>	<i>Direction Facing</i>	<i>Description</i>
1	602/1	583/1	FRPW11-01	E	Area near entrance, view towards E Bastion
2	602/2	583/2	FRPW11-02	NW	View from Bastion to NW
3	602/3	583/3	FRPW11-03	NW	View from Bastion toward Bastion at N
4	602/4	583/4	FRPW11-04	SE	View back from toilets, towards east Bastion
5	602/5	583/5	FRPW11-05	E	View towards toilet block as ground slopes
6	602/6	583/6	FRPW11-06	NE	View showing grounds sloping west
7	602/7	583/7	FRPW11-07	W	Grounds sloping west, possibly covered way/hollow way
8	602/8	583/8	FRPW11-08	SW	View from car park area showing flattened area
9	602/9	583/9	FRPW11-09	NE	View towards hollow near field in front of Fort Royal House
10	602/10	583/10	FRPW11-10	NE	View from west Bastion
11	602/11	583/11	FRPW11-11	SW	View showing slope of west Bastion
12	602/12	583/12	FRPW11-12	W	View looking at south Bastion slope

13	602/13	583/13	FRPW11-13	NE	View showing south Bastion slope
14	602/14	583/14	FRPW11-14	NE	View showing south Bastion slope
15	602/15	583/15	FRPW11-15	NW	View looking towards west Bastion
16	602/16	583/16	FRPW11-16	NE	View towards remnants of south Bastion
17	602/17	583/17	FRPW11-17	NW	View across sloping ground in front of west Bastion
18	602/18	583/18	FRPW11-18	E	View towards west Bastion
19	602/19	583/19	FRPW11-19	SE	View towards west Bastion slope
20	602/20	583/20	FRPW11-20	N	View showing sloping ground, possible remains of hollow way
21	602/21	583/21	FRPW11-21	E	View identifying features, possible remains of hollow way
22	602/22	583/22	FRPW11-22	NE	View towards north Bastion
23	602/23	583/23	FRPW11-23	NE	Flattened area within confines of northern Bastion
24	602/24	583/24	FRPW11-24	SE	Hollow area to south of north Bastion (tree bowl)
25	602/25	583/25	FRPW11-25	SE	Landscaped wall, possible reused stone.

26	602/26	583/26	FRPW11-26	SE	Landscaped wall
27	602/27	583/27	FRPW11-27	SW	Area towards east of playground
28	602/28	583/28	FRPW11-28	NE	View looking at slopes to NE of north Bastion
29	602/29	583/29	FRPW11-29	N	Sloping land, running NW away from north Bastion
30	602/30	583/30	FRPW11-30	SE	View looking towards north Bastion
31	602/31	583/31	FRPW11-31	NW	Sloping land nw of north Bastion
32	602/32	583/32	FRPW11-32	SW	Area towards NE of north Bastion
33	602/33	583/33	FRPW11-33	NW	View showing north Bastion
34	602/34	583/34	FRPW11-34	NW	View showing north Bastion
35	602/35	583/35	FRPW11-35	S	View towards west Bastion
36	602/36	583/36	FRPW11-36	W	General view showing land sloping west away from west Bastion

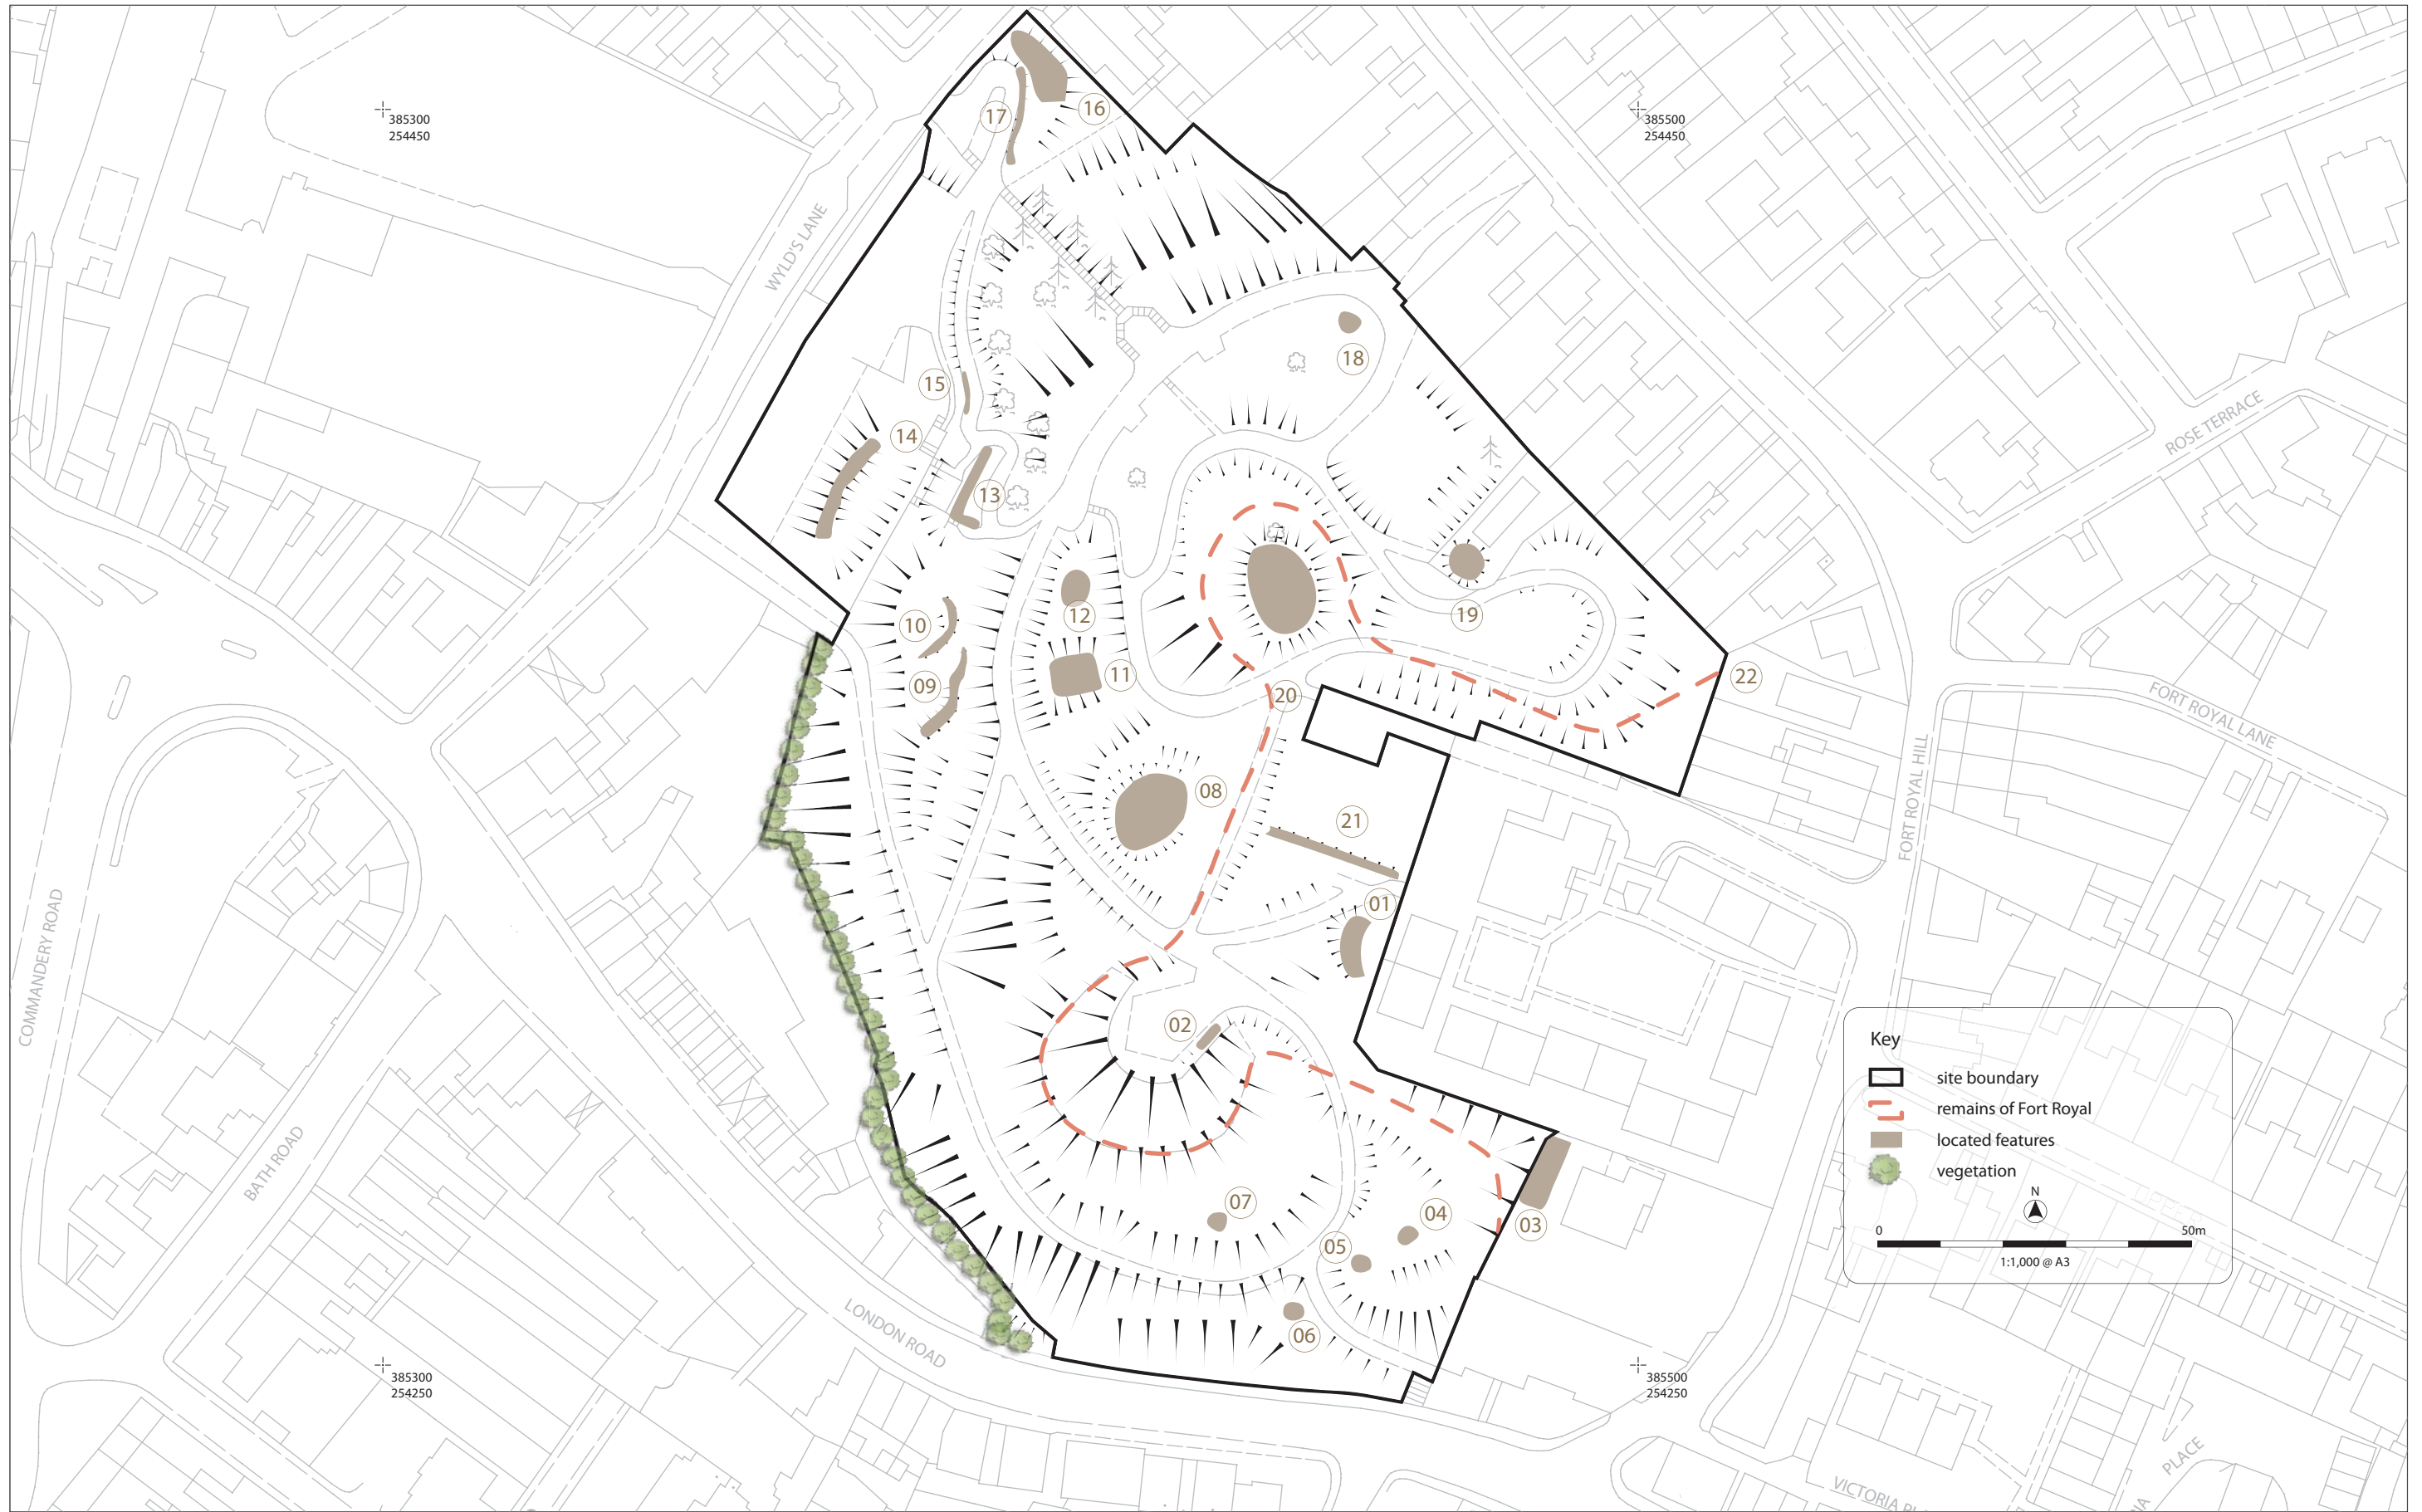
Illus 5
Hachure plan

Currently the area comprising the remains of the Civil War Fort is covered with mown grass, tarmac paths, and mature trees. The western bastion is defined by a path and ornate flower border and is consequently the

best preserved element of the Fort, whereas the profile of the northern bastion has been softened through various phases of landscaping.

The eastern and to a lesser extent the southern bastions are both clearly visible within the park and on the survey and it is interesting to note that within the property located outside the parkland containing the site of the former southern bastion, a large proportion of worked stone can be seen.

Changes in landscaping are reflected though a series of slight depressions spread over the site, which are probably evidence of tree bowls and bench locations. The ditches and covered
