COMMON FARM BARN, IVERLEY

*Historic Building Recording
& Documentary Research*

*WF/10/0586
WF/11/0442*

November 2011

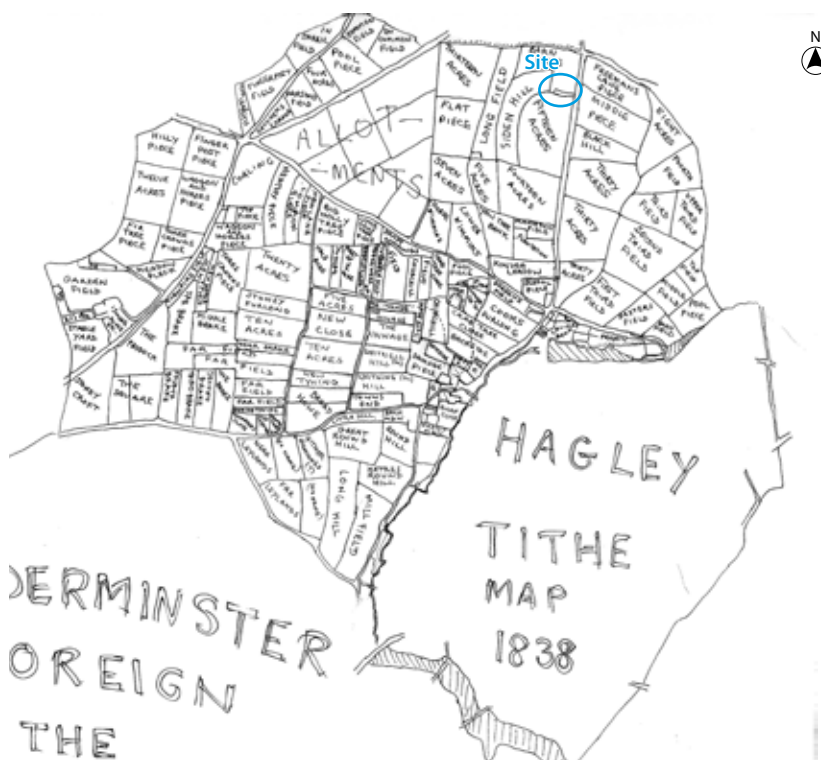
Illus 3
1838 tithe map

The Hagley tithe map of 1838 (Illus 3) reveals a division of land very similar to the present day. The large area of common land worked by Joseph Smith has been divided into nine separate fields. A narrow strip of land is marked corresponding to the Common Farm yard of the present day, the adjacent field is called Barn Piece. It seems likely that a barn existed on the site of Common Farm at this time.

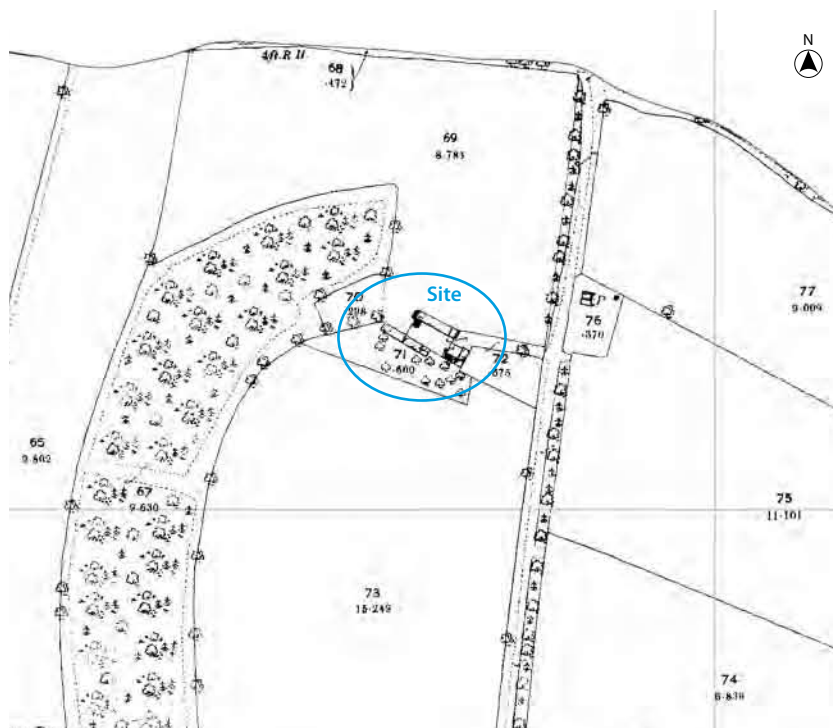
**Illus 4**

The 1883 Ordnance Survey map (Illus 4) shows the barn and stable block occupying the same footprint as the present day. A construction break can be identified on the barn dividing it into two buildings, the larger part to the west and a smaller build to the east. The 1902 and 1924 OS maps record no changes to the exterior arrangements of the buildings.

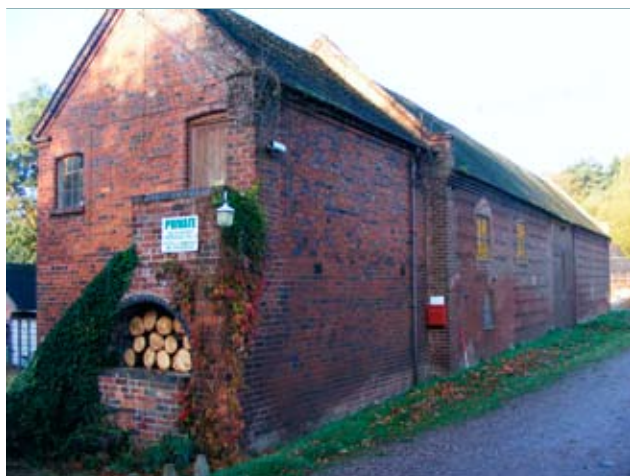
Area:	Barn
Structure:	Building
Element:	Front elevation (north-east facing)
Description:	19th century threshing barn. Full height double doors in centre. Nine courses of venting holes originally present over the whole elevation. Later insertion of windows has disrupted this arrangement. Step moulded brick coursing below roofline. Tile roof.
Fabric:	Mixed red brick forming a running bond, wooden sills, red brick arched lintels.
Repairs:	Some vents blocked off externally. Modern pointing visible on south-east corner. Recently inserted window at first floor level has removed arched lintel.
Related photos:	001, 003, 004, 005, 007, 008

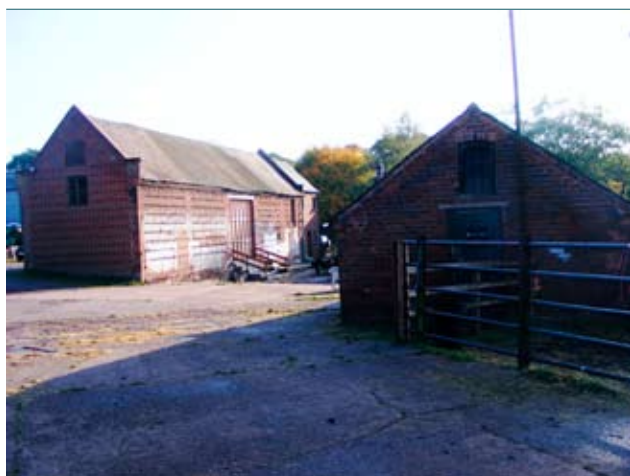
Area:	Barn
Structure:	Building
Element:	Rear elevation (south-west facing)
Description:	The rear elevation of the barn is similar in form to the front. A large aperture mirroring the full length barn doors on the opposite elevation is present. Concrete steps (showing signs of wear) lead down from the aperture into what was previously a steel framed lean-to barn (since demolished). A boarded up door and window aperture are present to the south-east of the large aperture. A bricked up doorway is visible to the north-west of the aperture, venting holes have been inserted into the brickwork to match the original.
Fabric:	Red brick, with white lime wash coating.
Repairs:	Modern lintel and concrete blocking is present over the central aperture suggesting recent work.
Related photos:	039, 040, 041, 042

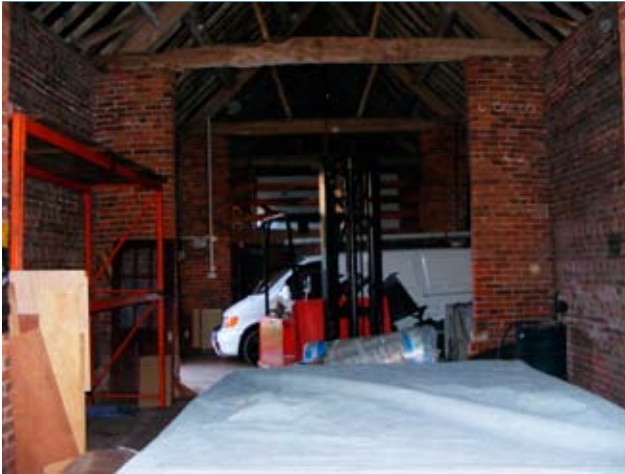
Area:	Barn
Structure:	Room
Element:	Internal area
Description:	Open plan internal barn space. Concrete floor. Brick pillars supporting roof trusses. Bottom chords of trusses retain bark. Ventilation holes visible on the exterior have been blocked internally.
Fabric:	Exposed brickwork
Repairs:	Upper metre of truss supporting pillars have been replaced with modern brickwork. Doorway in south-west of building has been filled with concrete block work.
Links:	
Related photos:	009, 010, 011, 012, 013, 014

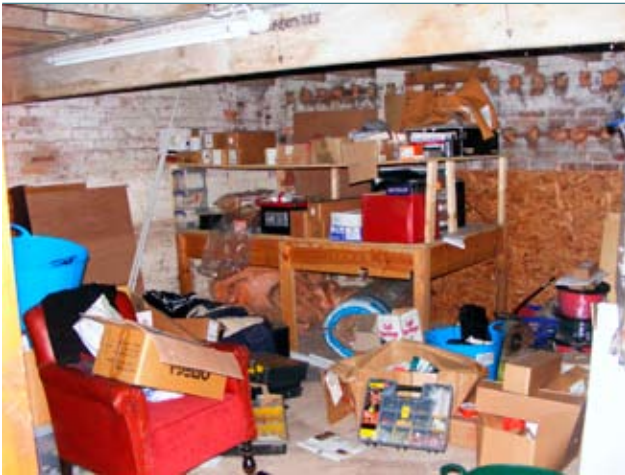
Area:	Barn
Structure:	Room
Element:	Internal area
Description:	Small workshop area located at south-east of main barn.
Fabric:	Whitewashed brick walls. Concrete floor. Exposed timber ceiling.
Repairs:	A modern brick pillar carrying a reinforced steel joist carries the first floor. First floor terminates at this point and opens out into full height barn space.
Related photos:	015, 016, 017

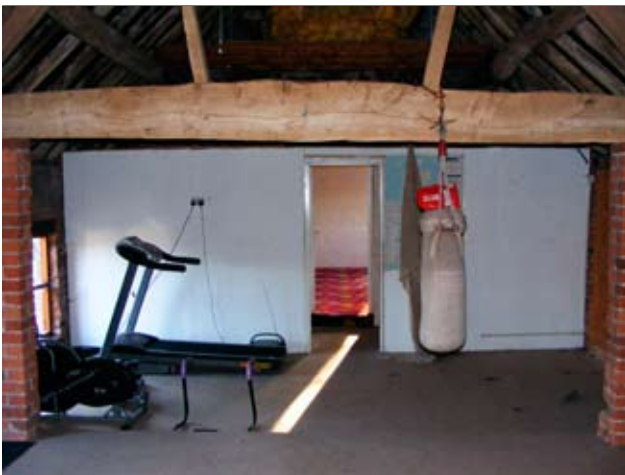
Area:	Barn
Structure:	Room
Element:	First floor
Description:	Area most recently used as a gym. Modern banister separates this area from full height barn space. Links to 'Barn extension' through doorway at south-east of room.
Fabric:	Exposed brickwork. Carpeted floor. The south-east part of this area has been boxed in with stud wall to create a toilet and storage area. The floor is split between two levels.
Detail:	Behind the water tank at the south-eastern extent of this room, the original vent holes are visible in the gable end. This confirms that the barn is an earlier structure to the adjoining 'barn extension' to the south-east.
Related photos:	018, 019, 020, 021, 022, 023, 029

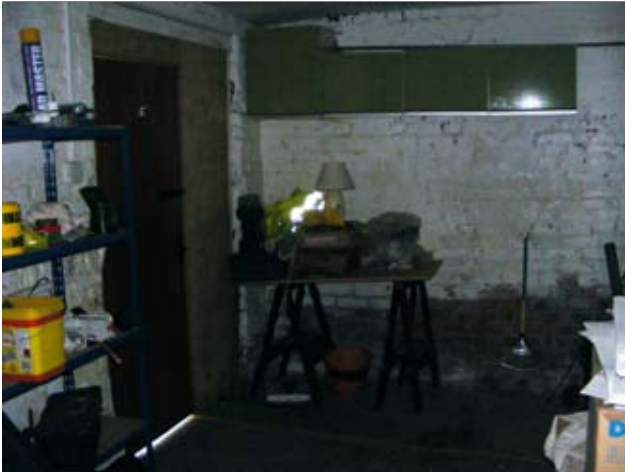
Area:	Barn
Structure:	Room
Element:	Storage room
Description:	Room belonging to barn structure but now accessed through later barn extension. Currently used for storage. A further room is present to the north-east but access was not possible.
Fabric:	Painted brick. Concrete floor.
Related photos:	034

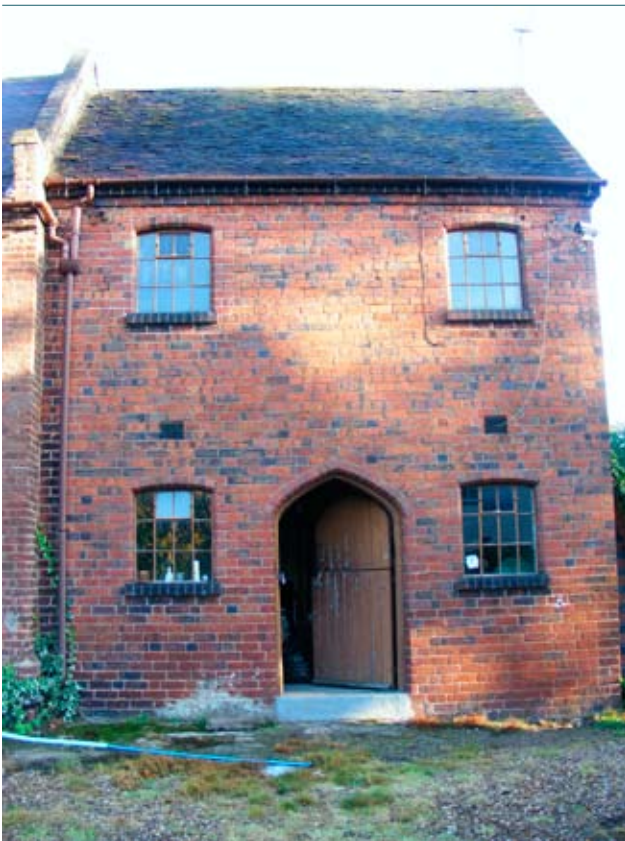
Area:	Barn extension
Structure:	Building
Element:	Front elevation (south-west facing)
Description:	19th century extension to existing barn. Door and internal fittings suggest that this was a stable. Two storey building consisting of one room on each floor. Pointed arch door surround.
Fabric:	Mixed red and blue brick in a common bond with Flemish headers. Metal framed windows with blue brick sills.
Detail:	Iron air vent grills at upper ground floor level.
Related photos:	030, 035, 036, 038, 039

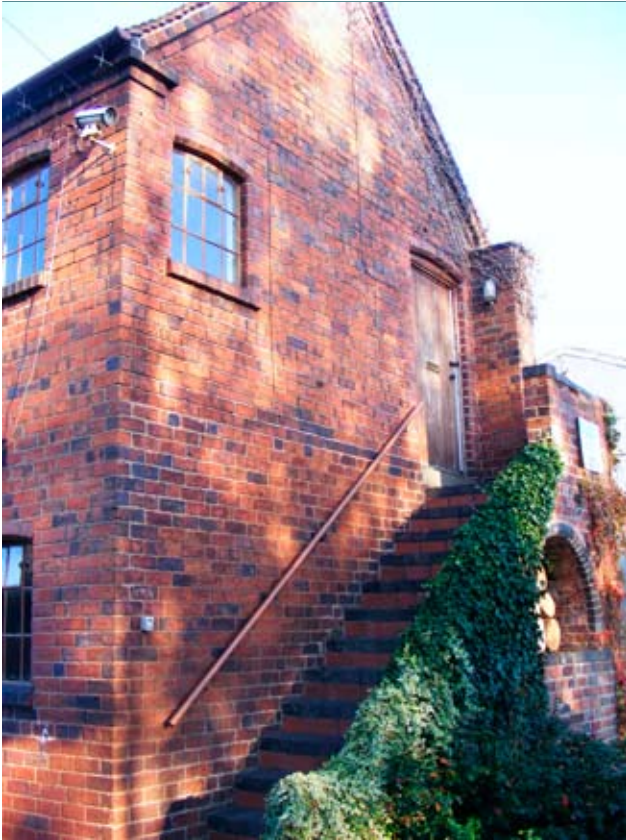
Area:	Barn extension
Structure:	Building
Element:	Side elevation (south-east facing)
Description:	External brick staircase leading to door at first floor level. Wood store and horse mounting step beneath staircase.
Fabric:	Red and blue brick and tile.
Related photos:	037, 071

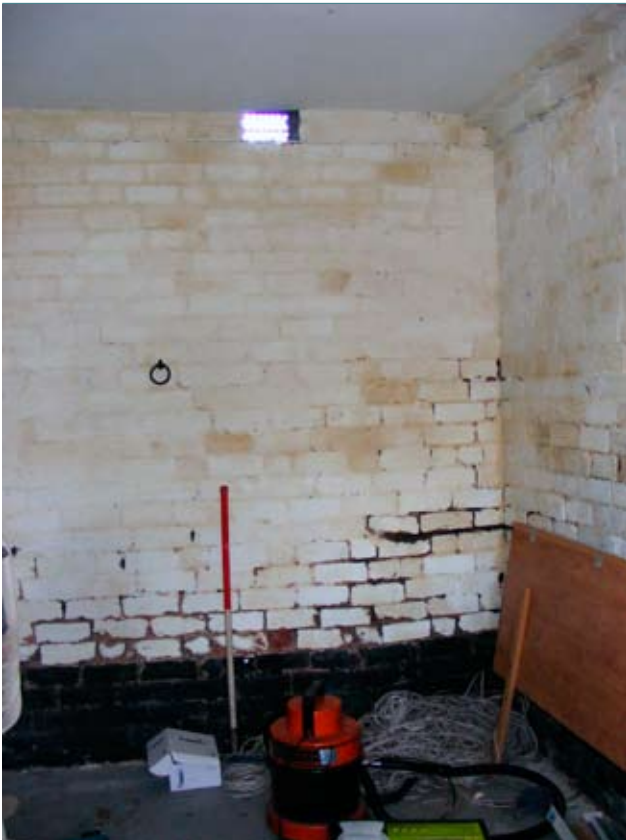
Area:	Barn extension
Structure:	Room
Element:	Ground floor
Description:	Room currently used for storage. Original use appears to be for stabling horses.
Fabric:	Painted brick walls. Concrete floor. Doorway through to ground floor rooms of barn.
Detail:	Iron tether ring on north-eastern wall. Double opening stable type door. Ventilation grills just below ceiling level on front and rear elevations.
Related photos:	031, 032, 033

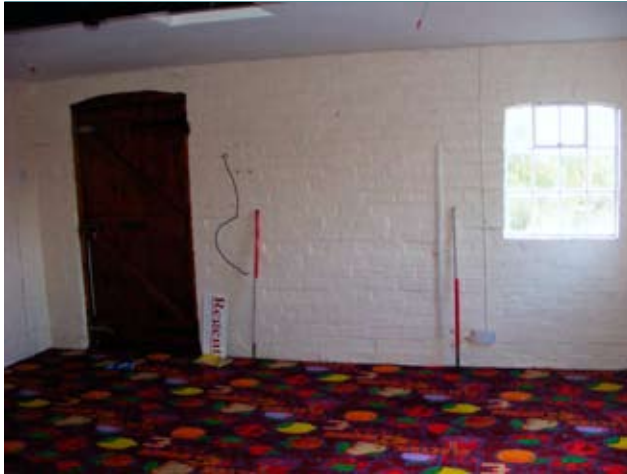
Area:	Barn extension
Structure:	Room
Element:	Upper floor
Description:	Upper floor of stable, potentially used as a tack room in its original form. Latterly used as a bedroom. Loft hatch to roof space in ceiling (not accessible at time of survey).
Fabric:	Painted brick finish and carpeted. Metal frame windows with wrought iron catches. Single exposed wooden beam in ceiling with iron fixing bolt and plate.
Related photos:	024, 025, 026, 027, 028

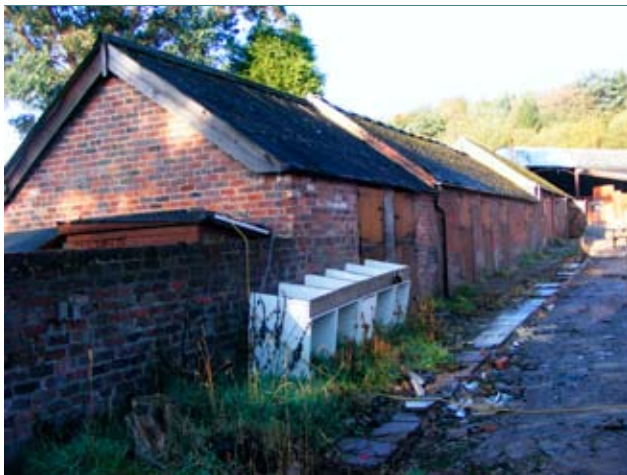
Area:	Stable Block
Structure:	Building
Element:	Front elevation (north-east facing)
Description:	Due to the slope of the land the building is stepped along its length giving three different roof levels. The lowest roof level relates to a later phase of construction. The building is comprised of ten separate stables – some with full height partition wall, others with half height partitions.
Fabric:	Mixed red brick construction with tile roof. Later phase of building has asbestos roofing.
Alterations:	Originally eight stables, a further two stables were added to the south-east at a later date. The front elevation of stables eight, nine and ten has been entirely rebuilt with modern bricks. The front elevation of stable 1 is built off a pre-existing boundary wall.
Related photos:	044, 045, 046, 049, 050, 057, 058, 063, 069, 070

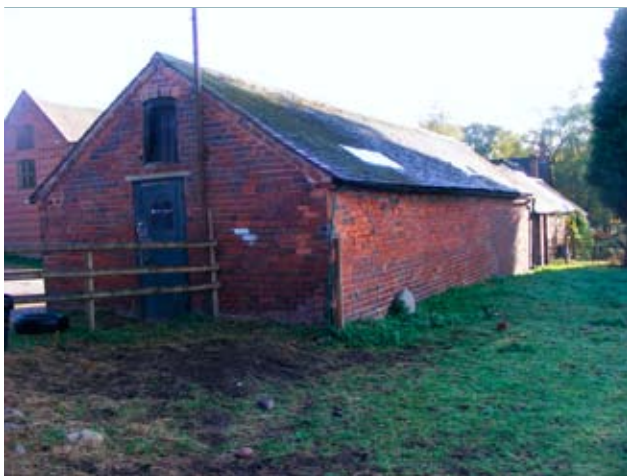
Area:	Stable Block
Structure:	Building
Element:	Rear elevation (south-west facing)
Description:	Red brick construction. Bricked up window corresponding to rear of room 7. Butresses either side of window to rear of room 6.
Related photos	064, 065, 066, 067

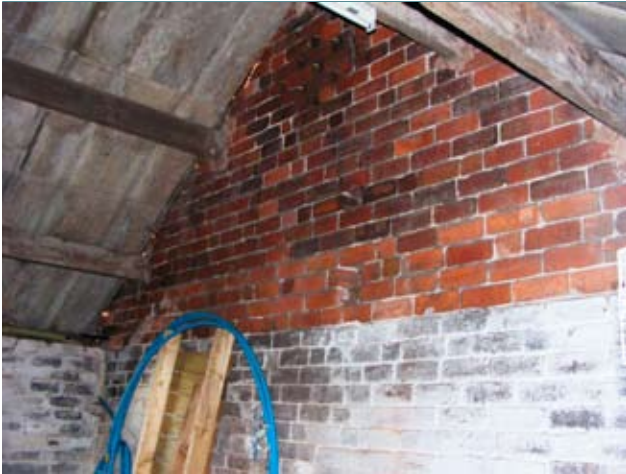
Area:	Stable Block
Structure:	Rooms 1 and 2
Element:	Internal area
Description:	Stables 1 and 2 appear to be the latest in the sequence. A concrete block wall separates the two rooms. The roof purlins are clearly inserted into the side elevation of stable three at a later date. The rooms are currently used for general storage.
Fabric:	Brick and concrete block construction with small window to the rear of each room.
Related photos:	047, 048

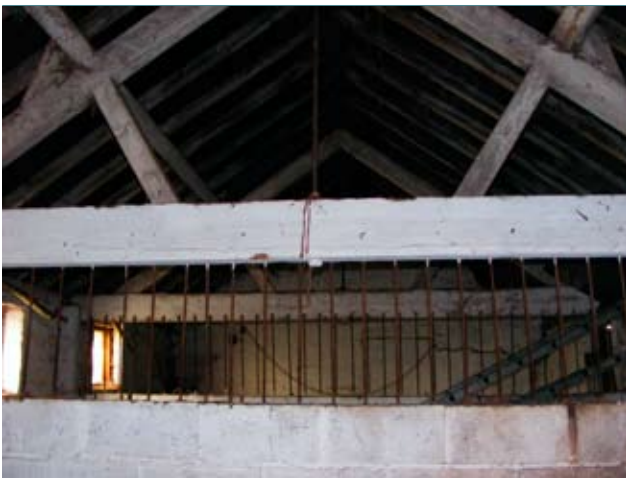
Area:	Stable Block
Structure:	Rooms 3, 4 and 5
Element:	Internal area
Description:	These rooms are separated by half height concrete block walls which are clearly a later insertion, potentially replacing wooden divisions. Original roof trusses are visible. Two blocked up doorways through to room 6.
Fabric:	Concrete floor. Small window to the rear of each stable.
Alterations:	Later concrete block dividing walls. Blocked up doorways.
Related photos:	051, 052, 053

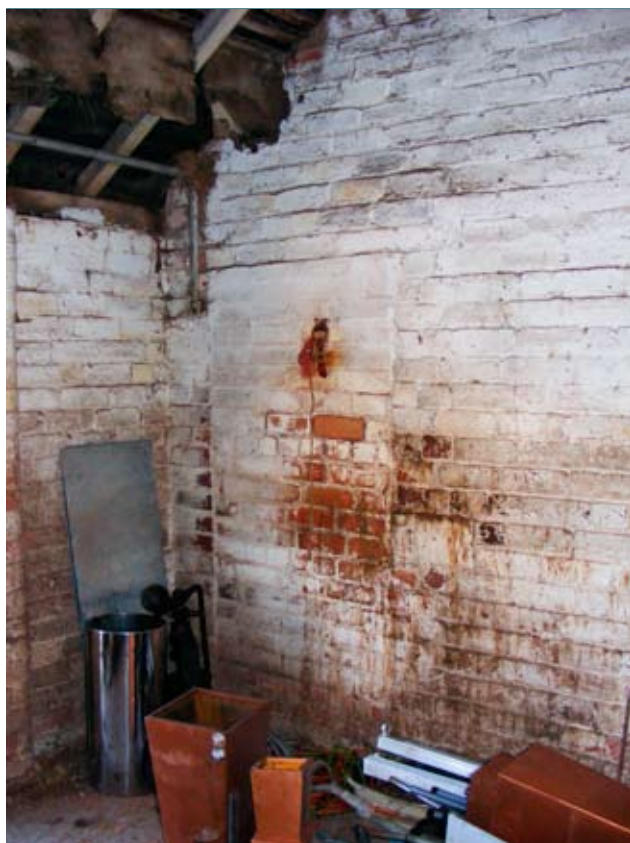
Area:	Stable Block
Structure:	Room 6
Element:	Internal area
Description:	Appears to occupy a different function to rooms 1 to 5. Full height external door and bricked up doorways through to stables 5 and 7 suggest that this was used as a storage or tack room.
Fabric:	Painted brick walls. Concrete floor.
Alterations:	Bricked up doorways.
Related photos:	054, 055, 056

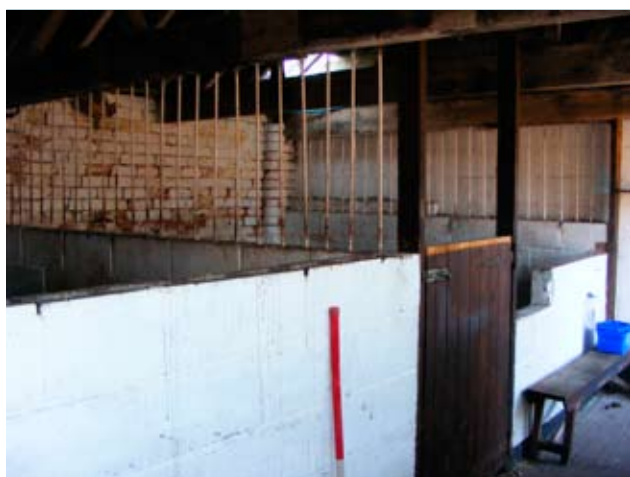
Area:	Stable Block
Structure:	Rooms 8, 9 and 10
Element:	Internal area
Description:	Room eight is separated from room 9 by a half height concrete block wall. The external doors for rooms 9 and 10 both lead into a corridor affording access to both stables. The internal arrangement is clearly later than the original construction. Vertical iron bars connect half height concrete walls to the bottom chord of the roof trusses.
Related photos:	059, 060, 061, 062
