MOSELEY SECONDARY SCHOOL, WEST MIDLANDS

Archaeological watching brief

for Lend Lease

January 2012

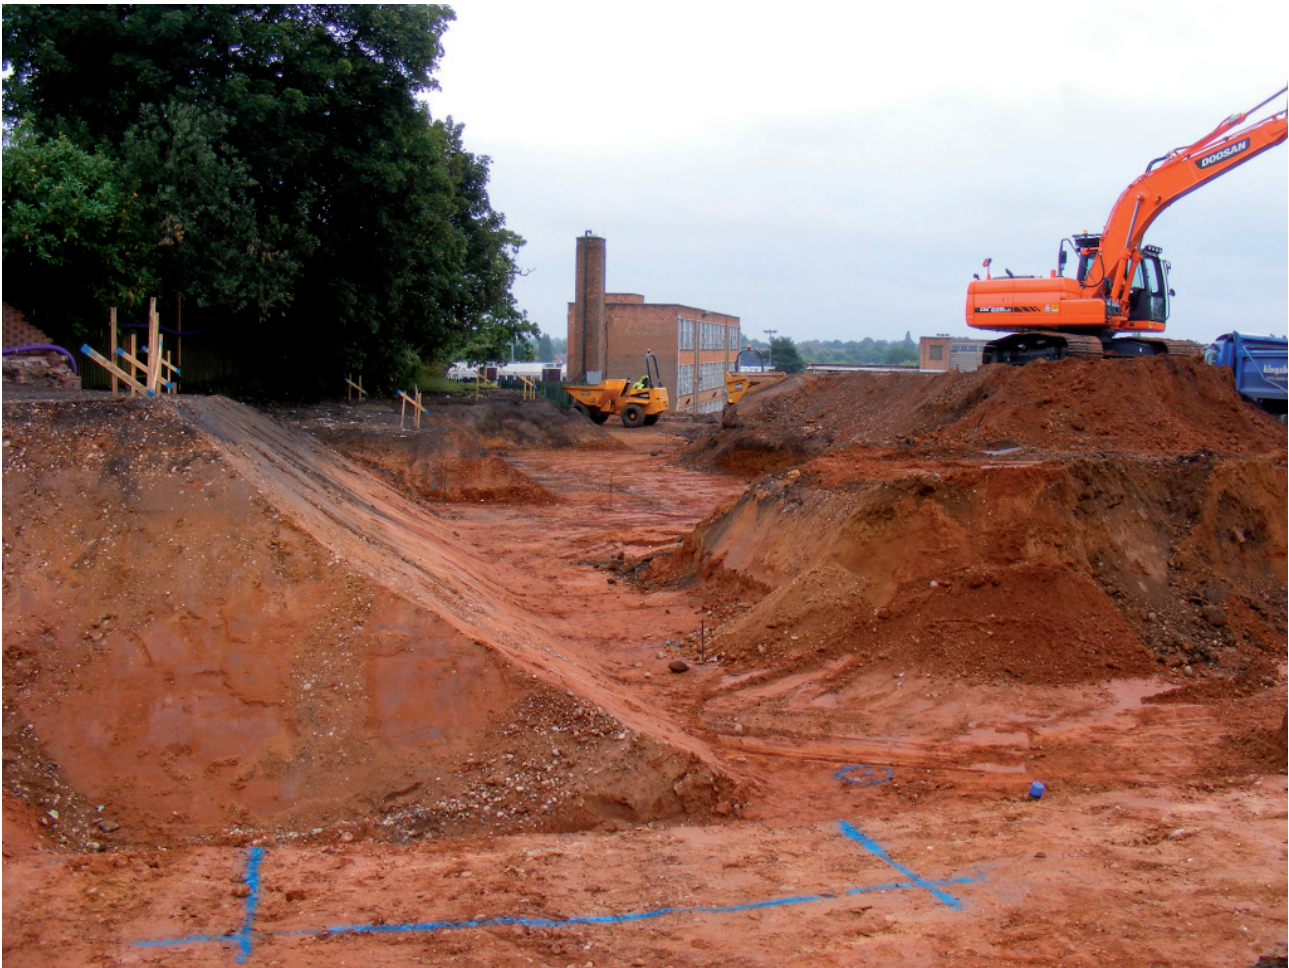
Illus 2

General view of excavations looking east from the upper site

The ground level was reduced to accommodate the building footprint (Illus 1) and a retaining wall on the north of the upper site. The profile revealed a geological deposit comprised of mottled reddish orange sandy clay which continued to the full depth on excavations (Illus 2). This was overlain by a made up dark deposit (106) up to 0.6m and in some places was topped with very shallow topsoil. On the west of the site there was a redeposited geological deposit (105) above (106). On the northeast of the upper site excavations revealed a series of 20th century red brick

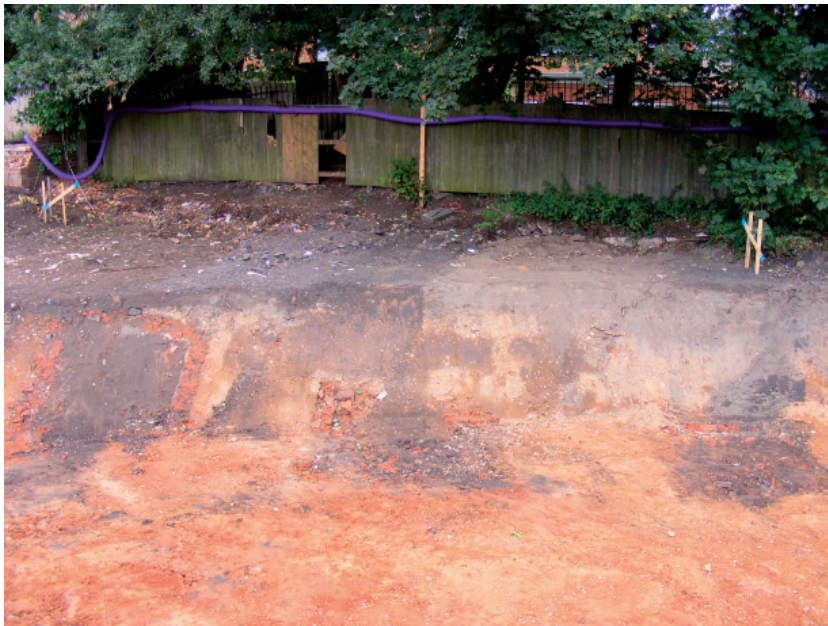
◀ Illus 3

20th century foundations that may represent the greenhouse visible on the 1903 OS 2nd edition

footings with 20th century fill approximately 0.2m below the ground surface (Illus 3). These footings indicated the presence of four structures running northwest–southeast for 1.75m.

footings for the greenhouses that are visible on the Ordnance Survey 2nd edition 1903.

The red brick structures identified at the northeast of the upper site are likely to have been the remnants of the

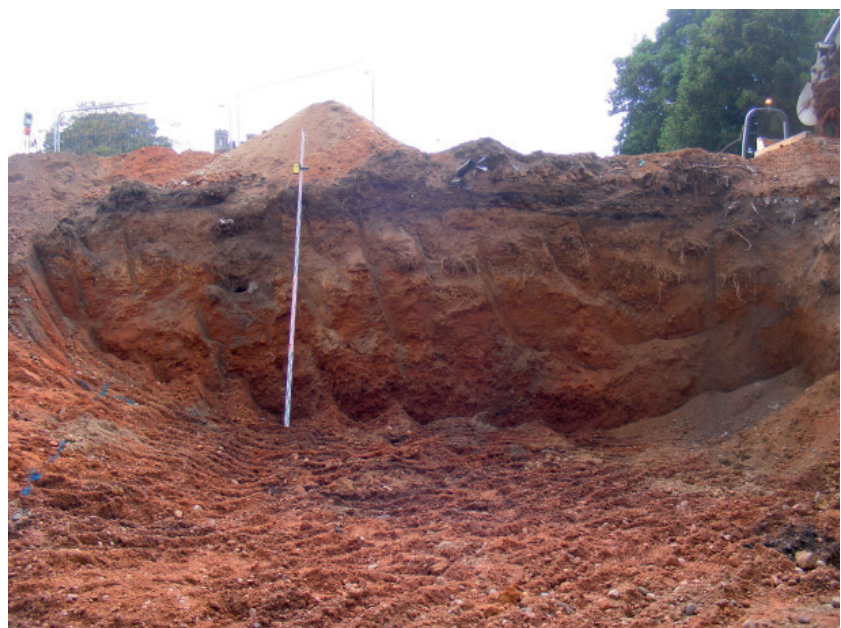
Illus 4 ▶

The lower site revealed the same sequence of deposits as the upper site (Illus 4). Some 19th–20th drainage and an inspection chamber were uncovered. There was an abundance of 20th glass and ceramics within the topsoil of this area. No archaeology was identified.

Ground reduction excavations in the terraced ground from the upper site to the lower site

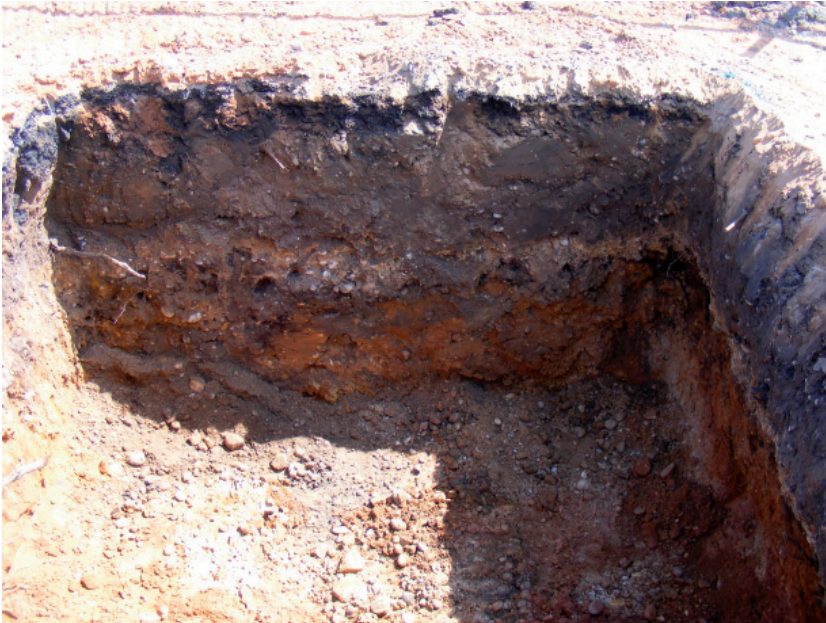
◀ Illus 5

Excavated footing showing soil profile

1.3m x 1.3m x 0.6m. They revealed the same sequence of deposits as seen around the site with shallow topsoil (103) and a modern layer (106 and 107) of varying depth up to 1.0m onto a sterile geological deposit (Illus 5). In some areas a redeposited geological deposit was above 106 and 107 at the west. No archaeology was identified.
