## THE SEARCH FOR EWYAS HAROLD PRIORY

*Season Two*

*for Ewyas Harold Archaeology  
and History Group*

*March 2012*

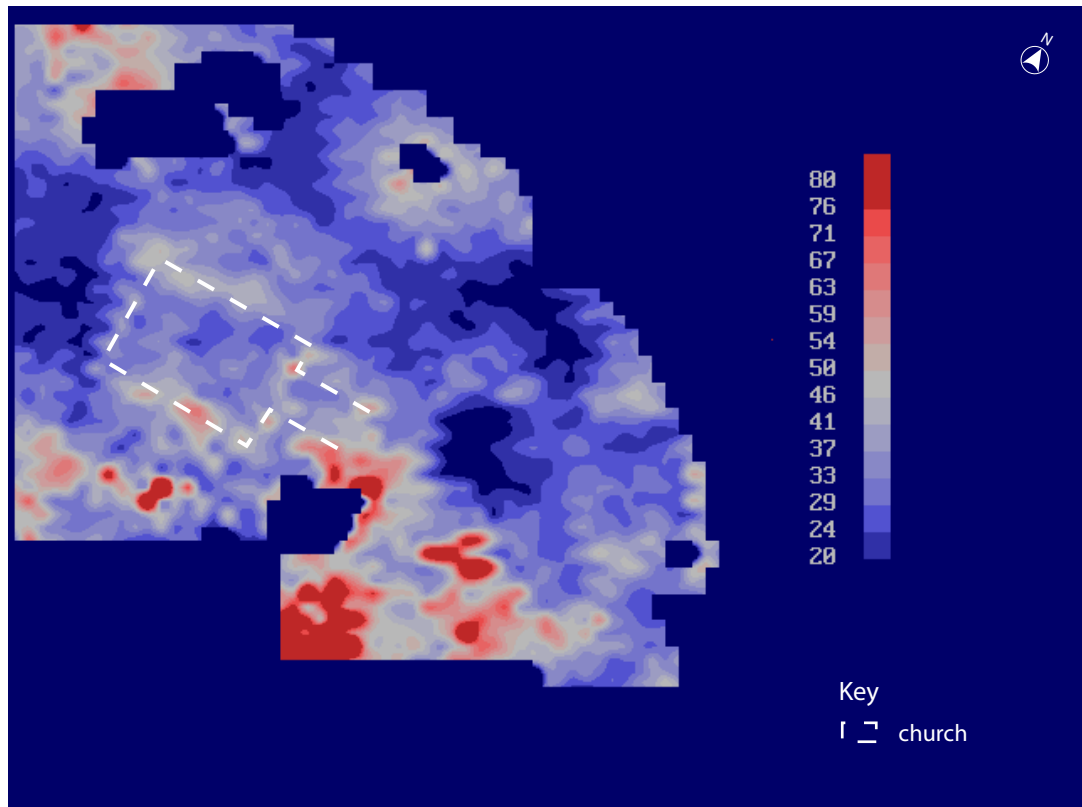
## Illus 2

The resistivity survey  
of Dulas Court

The data collected (*Illus 2*) does not demonstrate any marked background trends implying that there is little or no effect from variations in the any underlying geology or drainage. The horizontal nature of the area surveyed lends some credence to this hypothesis. It is also likely that underlying deposits are relatively homogeneous, given the site's location between two streams and its use as a burial ground. Therefore it should be possible to attribute any responses observed to features within the upper 1m of the ground surface.

Two sets of features visible on the surface are likely to have an effect on the readings. The first of these is the presence of trees and shrubs whose roots will locally dehumidify the soil creating substantially enhanced resistivity readings. The second is the presence of stone

grave monuments which can inhibit electrical contact with the ground and as a result can produce much enhanced high or low responses. In the results two areas of higher responses which are believed to result from the presence of trees or shrubs have been identified. A similar area of responses has also been identified across the south side of the site, although in this case some of the responses observed may also be due to the presence of grave monuments.

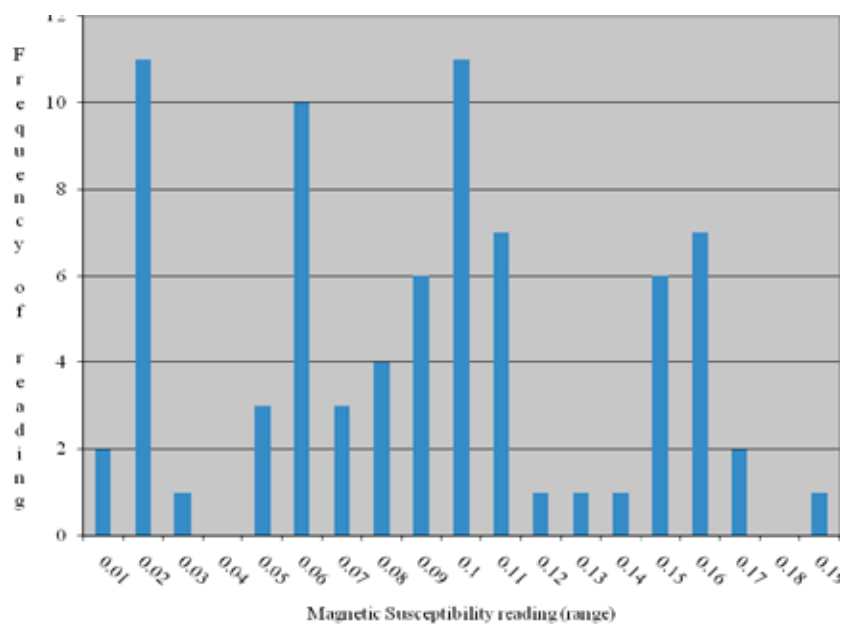
Graph 1

Frequency distribution of rock susceptibilities

- Stones with readings clustering in the  $0.01\text{--}0.02 \times 10^{-3}\text{SI}$  range;
- Stones with readings clustering in the  $0.05\text{--}0.06 \times 10^{-3}\text{SI}$  range;
- Stones with readings clustering in the  $0.09\text{--}0.10 \times 10^{-3}\text{SI}$  range;
- Stones with readings clustering in the  $0.15\text{--}0.16 \times 10^{-3}\text{SI}$  range;

All of the tufa (stone 5 from the archway, stones 19, 24, 25 & 26 from the church) fell within the first group of tightly clustered and low susceptibility readings. Exceptions are stone 22, which may have been misidentified, and one reading from stone 19 which may be an outlier. The sandstone rubble, used in the majority of the chancel

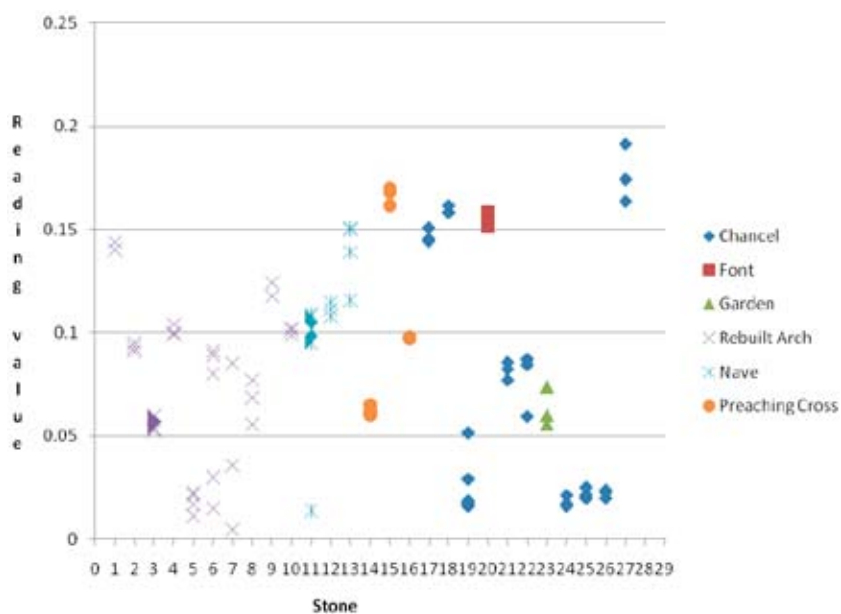
Graph 2

Stone magnetic susceptibility readings

The final group of stone readings seemed mainly confined to stones used with a decorative purpose – the carved capital in the reconstructed archway, the font base in the nave and the base of the preaching cross all fell within this group.

The data collected shows that the instrument is capable of distinguishing between different types of building material. The apsidal end of the chancel was rebuilt at least twice, which may

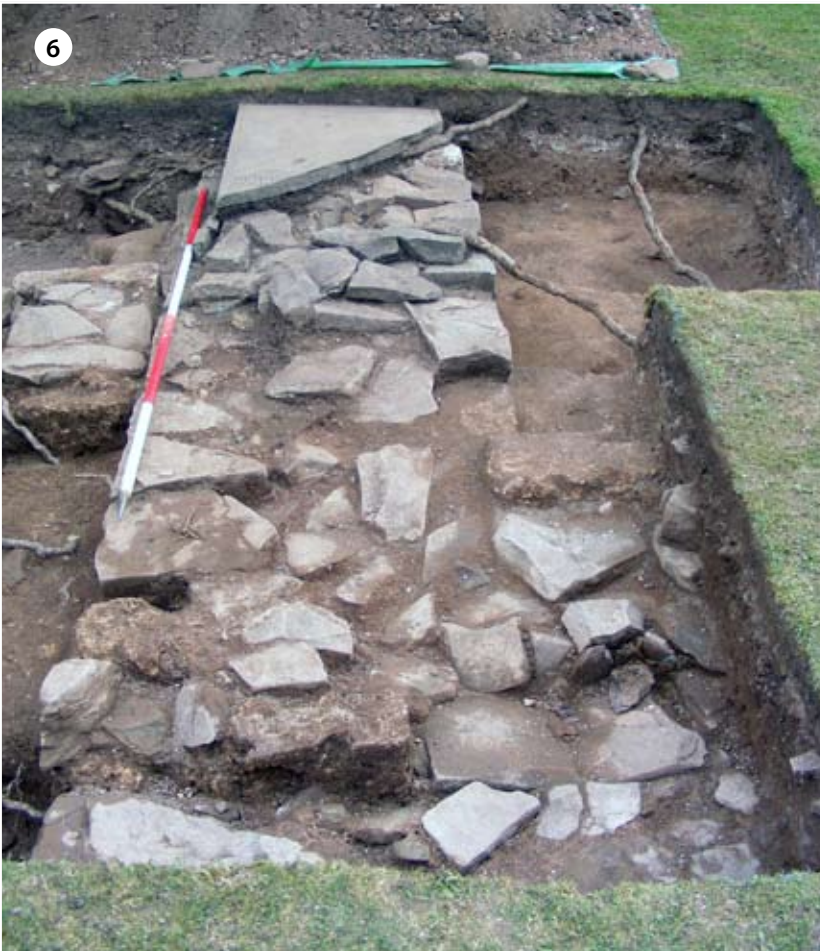
**Illus 6***Eastern wall of nave, context 215***Illus 7***Possible ancillary building or buttress, wall 244***8.2 The Chancel**

A portion of the east wall [215] of the nave and its return to the west was revealed in Trench 2 (*Illus 7*). It measured 3.25m north-south and 1.35 east-west (*Illus 5, Illus 11*). It was approximately 1.05m wide and the excavated depth was 0.50m. It was constructed of sandstone and was rendered on the eastern and western faces. On the eastern side foundations, projected approximately 100mm from the face. Tufa was used in the quoins and a break in the construction at the southern end terminated with a tufa block. It may be either an arch base or a doorway which was constructed in order to access the chancel. Mortar floor surfaces (222, 223) cut by later burials on the eastern side of the wall may have related to the medieval use of the nave.

A stone structure [244] butted to the northern wall of the nave [215] (*Illus 8*). It was not fully revealed in the extension to Trench 2 and ran

into the section to both the north and west. It measured 1.40m x 0.55m and was revealed only in plan (DRW 8). It is likely to have been a buttress shown on a 19th century illustration of the church.

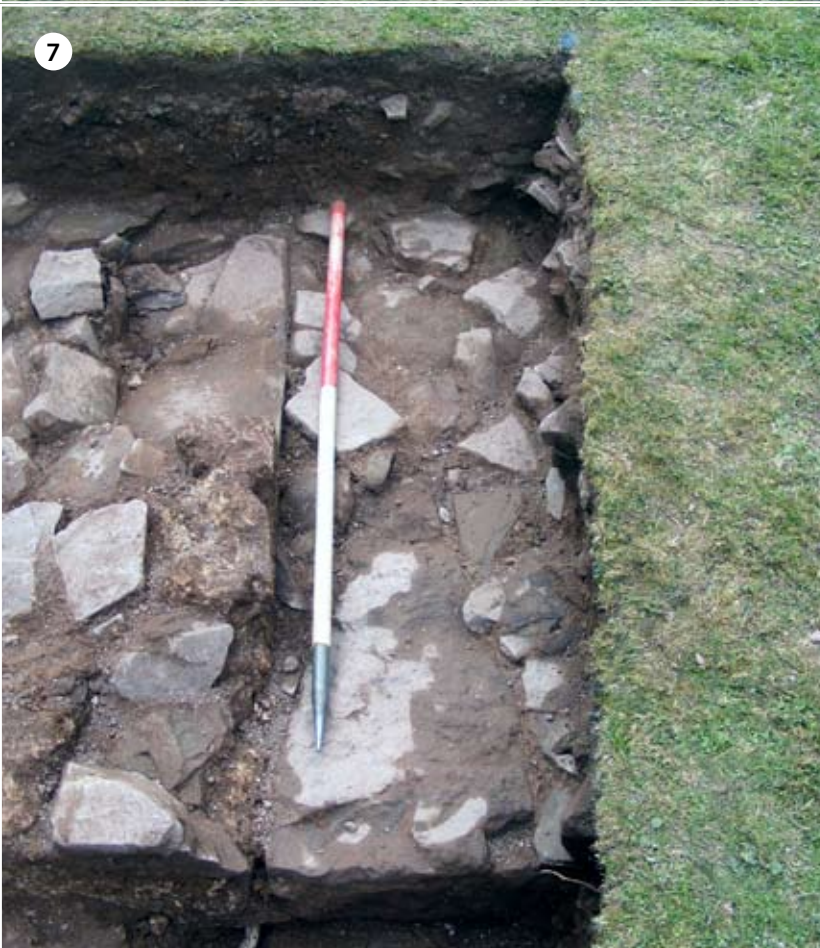
**Illus 8**

*North wall of chancel (212) and eastern wall of nave (215)*

In this phase it is certain that the chancel and the nave formed a structure of contemporaneous build. The earlier apsidal end (wall 256) appears to have been replaced by a second apse (wall 209). The northern wall [212] of the chancel butted against the eastern face of the nave (*Illus 9*) and was constructed of sandstone with a width of 0.80m and depth of 0.20m. As in the nave, the wall contained tufa quoins where it abutted other structures and at corners, and these may have been placed to show off architectural features. The foundations projected about 100mm from the wall base. The adjoining apse end (wall 209) was also constructed of sandstone with tufa blocks apparently deliberately placed. It was three courses deep and approximately 0.25m wide. The position of this apse appears to have created a broader entrance to the sanctuary than seems to have been present in the earlier phase. Within the interior of the apse in this phase was a compact silty deposit (220) containing no finds or charnel, but which appears to have been a floor surface.

The relationship between wall 212 and 209 was difficult to determine due to disturbance caused by the later squaring-off of the chancel and the presence of a post-medieval grave slab. It is assumed that they form part of the same build.

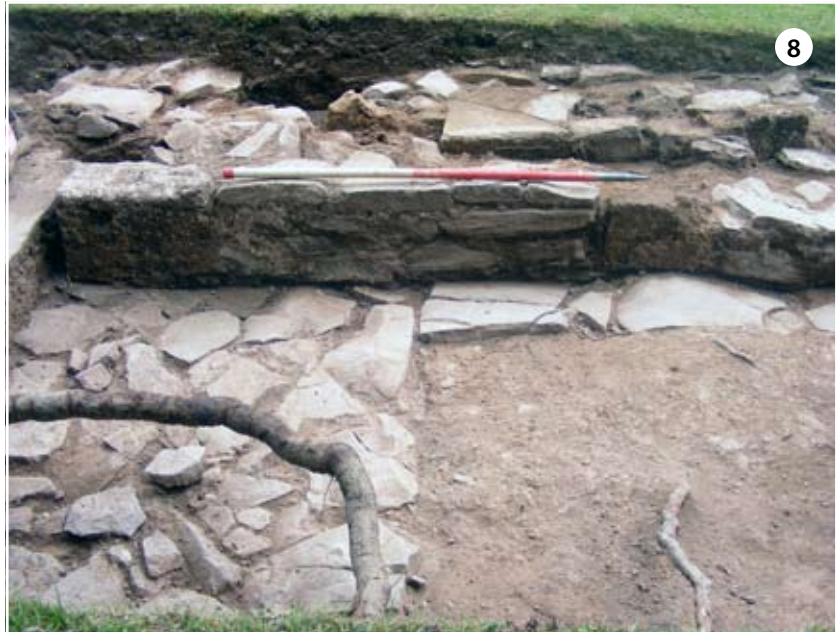
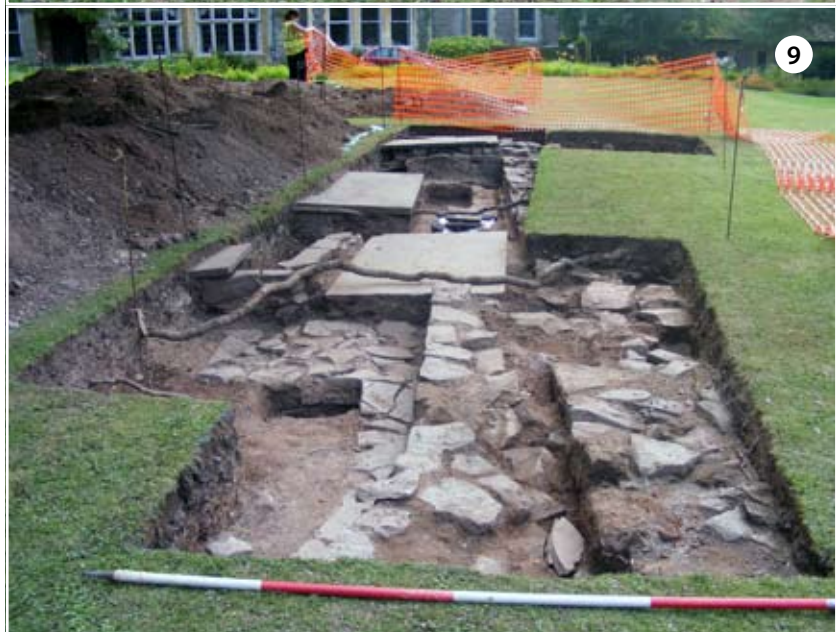
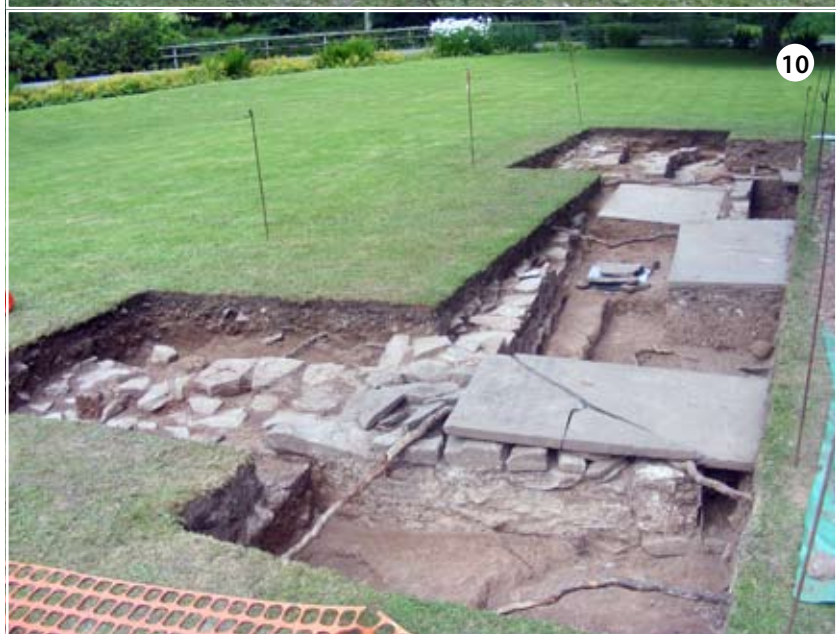
**Illus 11**

The chancel was a more complex structure, particularly at its eastern end (*Illus 10, Illus 11*). The only direct relationship with the nave that was observed during the excavation was a butting join with the east wall of the nave. This appears to date at least one phase of the chancel to contemporary with or later than the nave. However, due to constraints on dismantling the structure and the fixed position of the trenches, it is not known whether this relationship includes the earliest phases of the chancel seen in the excavation.

Wall 251 was exposed running along the northern edge of Trench 2. It was revealed only in plan and appeared to be of a rough construction. Although it contained occasional tufa blocks, these did not appear to be deliberately placed as in the previous phase and the build of the nave. It may have been built from re-used stone. Rubble filled the space between wall 251 and apse wall 209, and the outer face of wall 209 appeared to have been destroyed by the construction of wall 251 (*Illus 10*). Wall 251 appeared to butt against the east end of wall 212, but some

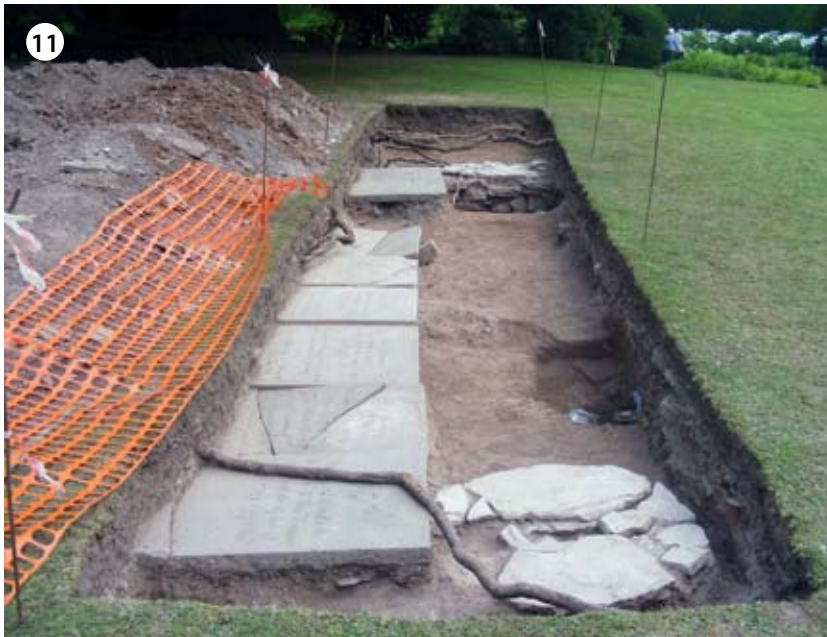
*Grave slabs in Trench 1*

The grave slabs in Trench 1 (*Illus 12*) commemorated members of the Lewis family. As with those for the Jones family found in Trench 2, surviving members of the family may have wished them to remain on the site.

The memorial stones were probably moved when the church was demolished and the gardens landscaped. In Trench 1 the stones lay within a layer of demolition debris (104) rich in plaster and mortar. They were laid edge to edge and in a family group. They were not laid upon a solid surface, neither was there evidence for grave cuts and fills or shafts beneath them. It was noticeable that the majority of the memorials were in better condition than that to Thomas and Sybill Jones in Trench 2 even though they were generally of similar date. It seems likely that they were laid flat and buried shortly after around the time of the church's demolition in the 1860s, only 100 years or so after they were first set in place.

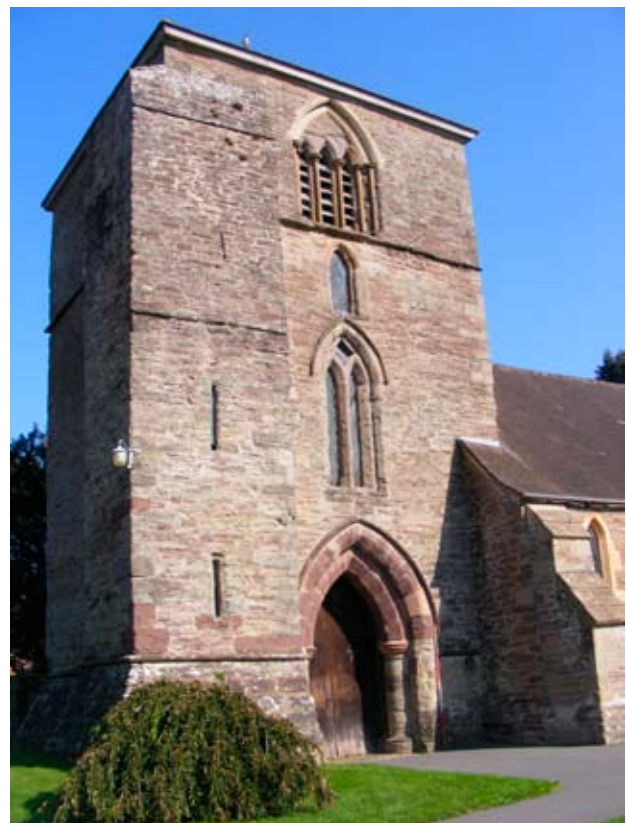
**Illus A4.2**

*The West Tower showing windows on south elevation*

The west tower was originally detached from the rest of the building. Detached towers are a feature of several churches in Herefordshire, though the reasons for this appear to be related to individual circumstances rather than to any broad strategy or purpose. There is, for example, no clear indication that this tower was ever designed for defence – considering the large size of its southern doorway.

The tower has a tall plinth topped by a string course and there is a second string course much higher up beneath the bell openings. The broad south doorway is original and has a double chamfered two-

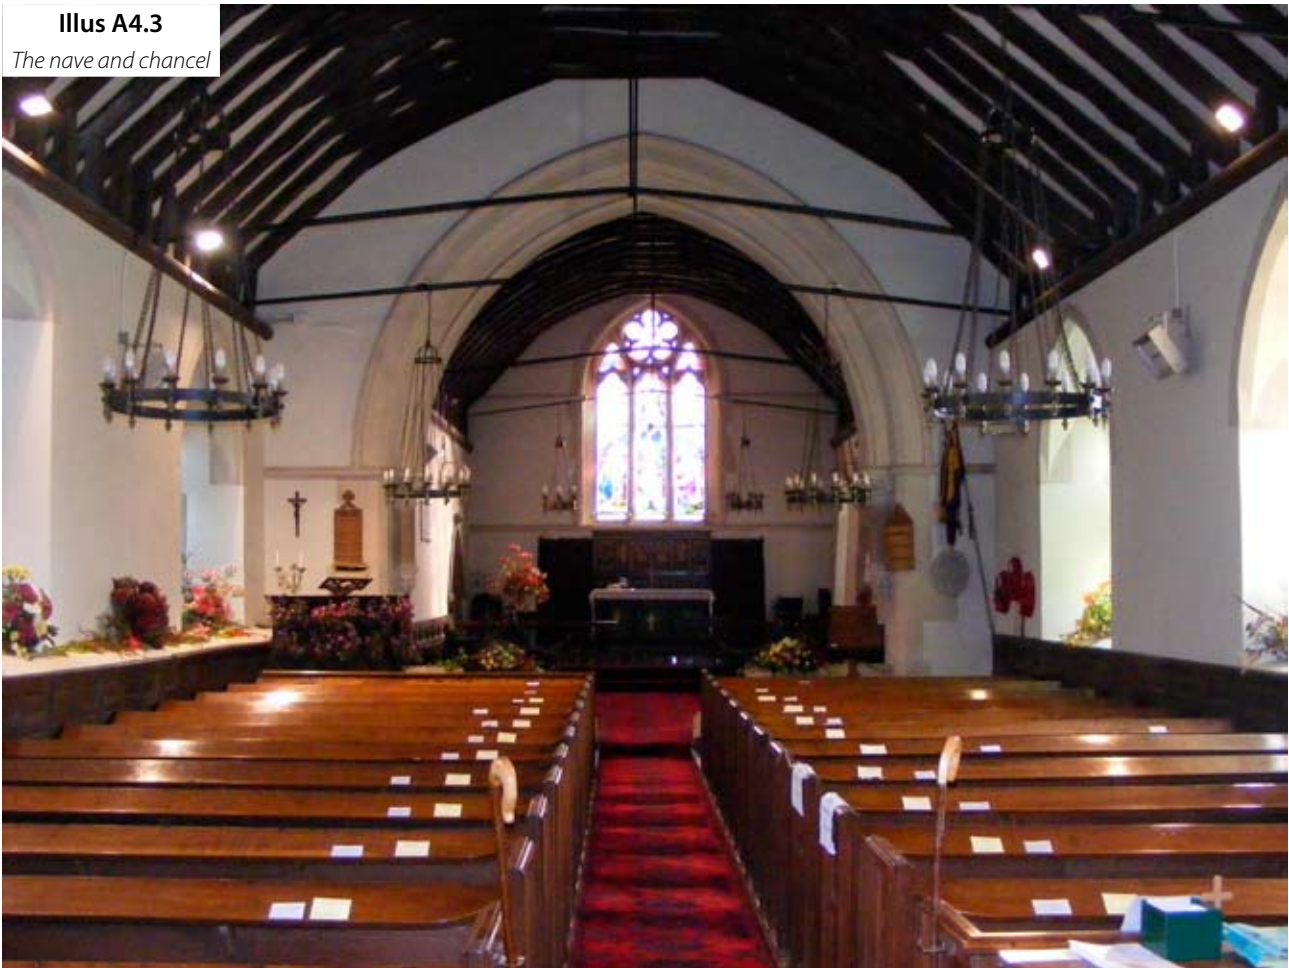
**Illus A4.3**

*The nave and chancel*

Although the chancel appears to be medieval, it has clearly been much altered and there are now no windows on the north side, which has been heavily rebuilt. On the south side there are three windows. The 1840 plan shows only two windows, suggesting that the medieval western cusped lancet is original, whereas the eastern lancet was probably moved from elsewhere in the building. The two-light central opening is a later insertion. The three-light Geometrical east window presumably dates from the 1868 restoration and has clearly replaced an earlier arrangement, possibly of stepped lancets.

The original design of the rest of the church is less easy to determine, but it may simply have consisted of nave and chancel. The nave was presumably rebuilt or, at least extended westwards to the tower, at a later date. In the 1840s the church was partly restored and the box pews and gallery in the nave were replaced by bench pews according to the ICBS file. The nave was then rebuilt in 1868 when the rest of the church was also restored at the same time.

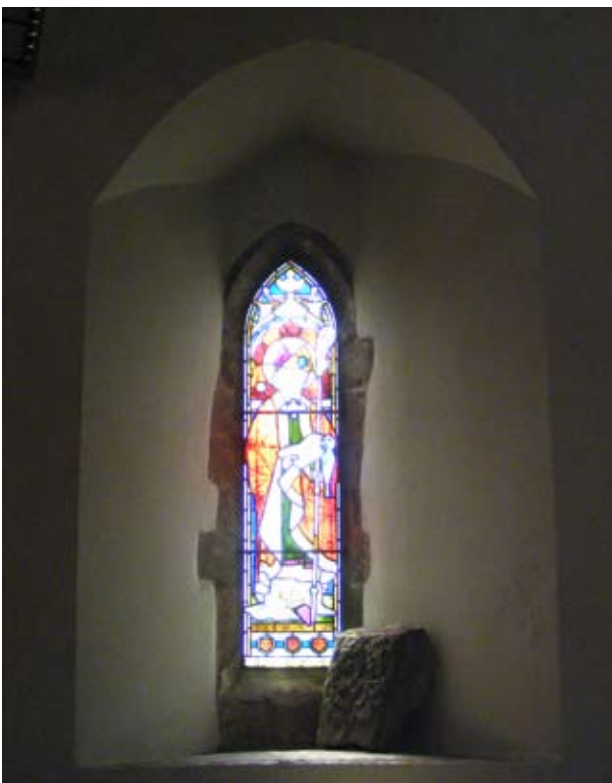
**Illus A4.4**

*Cusped lancet window, possibly original, with fragment of C13th grave slab*

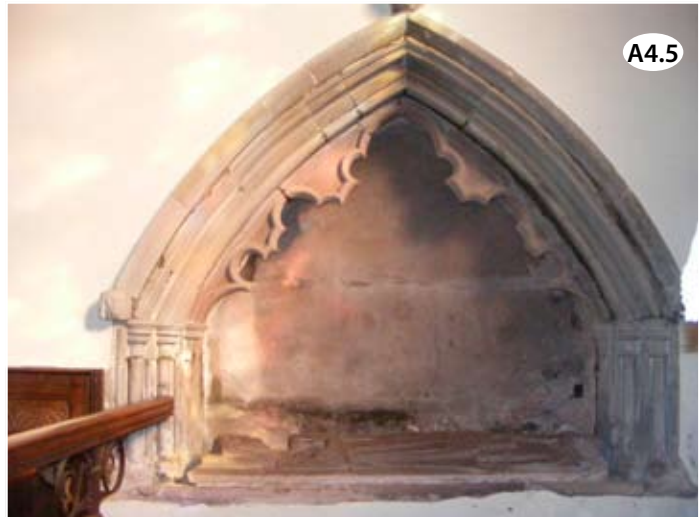
A4.5

*The 'Heart Tomb' of Clarissa, daughter of John Tregoz*

In the north wall of the chancel is an effigy reputed to be that of Clarissa, daughter of John Tregoz, Lord of Ewyas Harold (d. c1300). The effigy contains a small cavity beneath its clasped hands, in which a vessel containing the heart of Clarissa is believed to have been deposited.

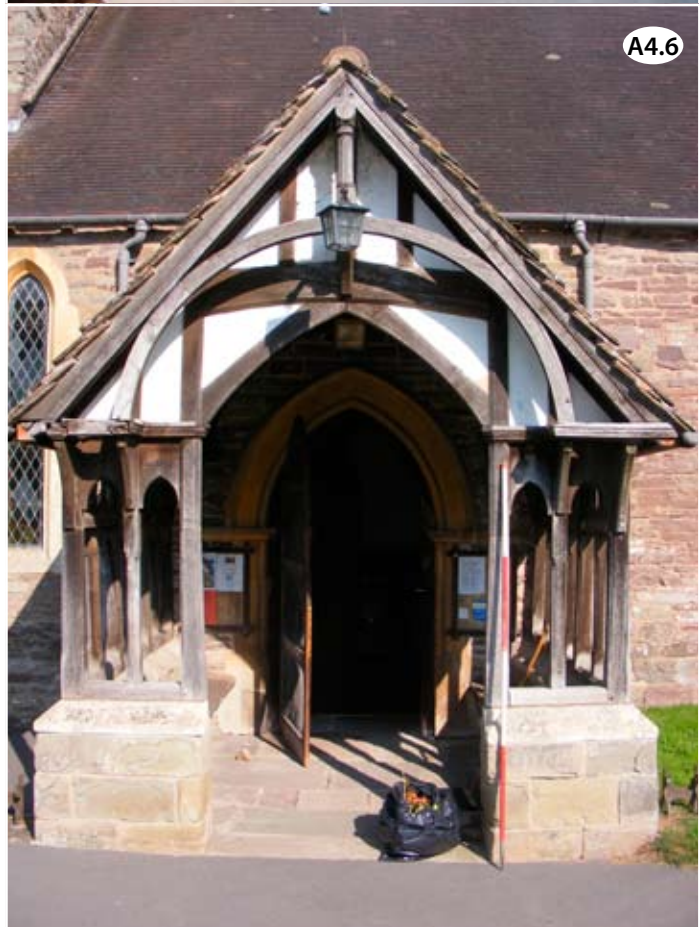
<b>Illus A4.5</b>	23
<i>The 'Heart Tomb' of Clarissa, daughter of John Tregoz</i>	
<b>Illus A4.6</b>	23
<i>The south porch</i>	
<b>Illus A4.7</b>	23
<i>The medieval nave roof</i>
