STONEBOW UNIT EXTENSION HEREFORD

Trial Trenching

for Herefordshire Primary Care Trust

March 2012

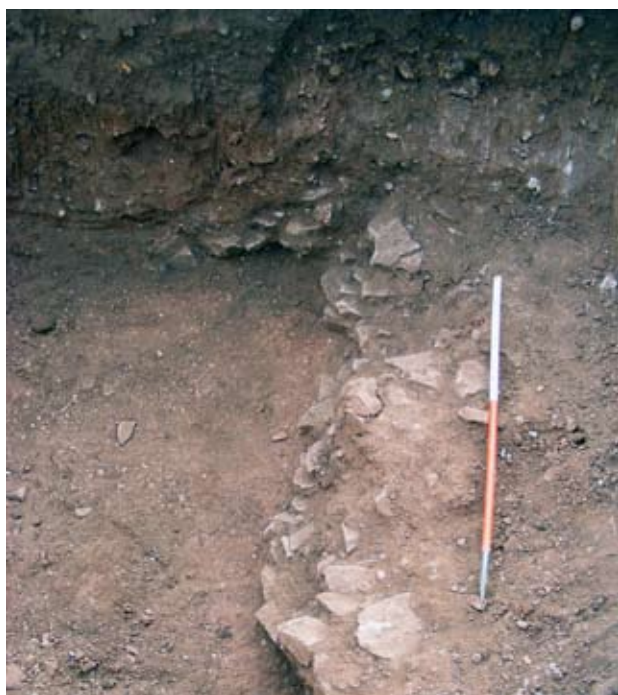
Illus 2
Wall or rubble [301]

The only feature of potential archaeological significance observed during the watching brief was a dump or rubble wall foundation on the northern side of the soakaway.

The natural gravel was present at a depth of 1.7m beneath the existing surface. Above it was a layer of fairly clean pink stony clay, possibly a redeposited natural deposit [304]. A line of rubble, either a foundation, or alternatively a dump of building material [301] ran across the northern side of the hole. Only one of the stones may have been worked, this was roughly shaped rather than sawn or carved. There was no bonding material present suggesting that if this was, indeed, part of a wall it would have been a footing rather than a standing structure. The single very small sherd of pottery recovered from it implied a date in the 16th or 17th centuries. The feature lay on the limit of the excavation at a depth of some 1.3m beneath the existing surface. It lay upon, or was cut into the natural red brown gravel and had been cut on its southern side by a very large modern or post-medieval pit [302] with a vertical edge curving to a flat base. It was filled by a mixed brown clay silt [303] containing stone rubble and mortar flecks. Fill [303] was sealed by a 0.9m deep layer of topsoil.

One feature of possible archaeological significance was encountered during the work; thought to be either the foundations of a wall or a dump of masonry potentially associated with the position of St Guthlac's priory. After discussion on site it was agreed that the position of the soakaway would be moved slightly to the south leaving this feature in situ.

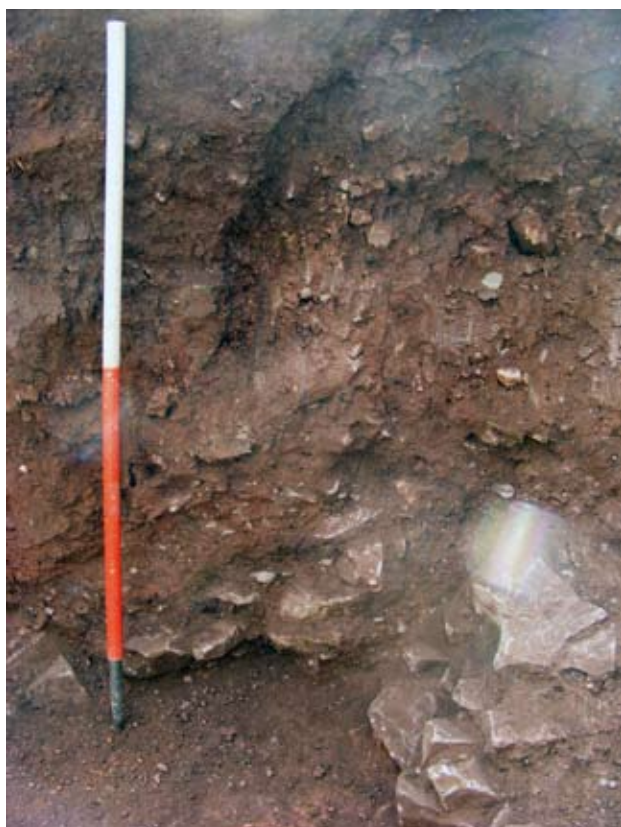
Illus 3
Wall [301] in section, showing cut [302]

301	3	Rubble footing or dump of stone. Much animal bone between stones. No bonding material.	L: 1.9+ W: 0.6 D: 0.5
302	3	Large cut with vertical sides sloping to flat base.	L: 2.1 W: 2.+ D: 0.9
303	3	Mixed brown clay silt with stone rubble, charcoal and mortar. Fill of [302].	L: 2.1 W: 2.+ D: 0.9
304	3	Pink brown clay with very frequent stone and gravel, possibly a redeposited natural.	L: 2+ W: 0.7+ D: 0.4
