ROTHERWAS FUTURES CONNECT PHASE 2

Archaeological Field Evaluation and Test Pit Monitoring

for Amey Consulting (on behalf of Herefordshire Council)

July 2011

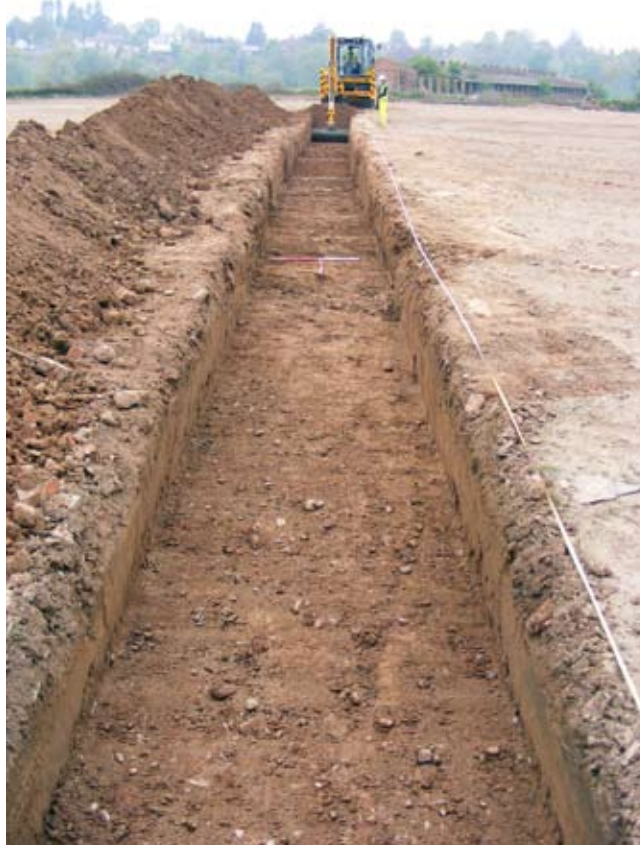
Illus 2
Excavation of Trench 1

Trench 1 was located towards the north-west edge of the flood alleviation pond and measured approximately 75m in length. The trench was excavated to an average depth of 0.40m below present ground level, at which point a natural gravel horizon was observed. The gravel horizon gently sloped towards the north end of the trench. Above the gravel horizon, the makeup of the site consisted of a red-brown silty subsoil beneath the current topsoil. The topsoil within the limits of the evaluation consisted of building debris, associated with the current phase of site and vegetation clearance. No archaeological remains were observed.

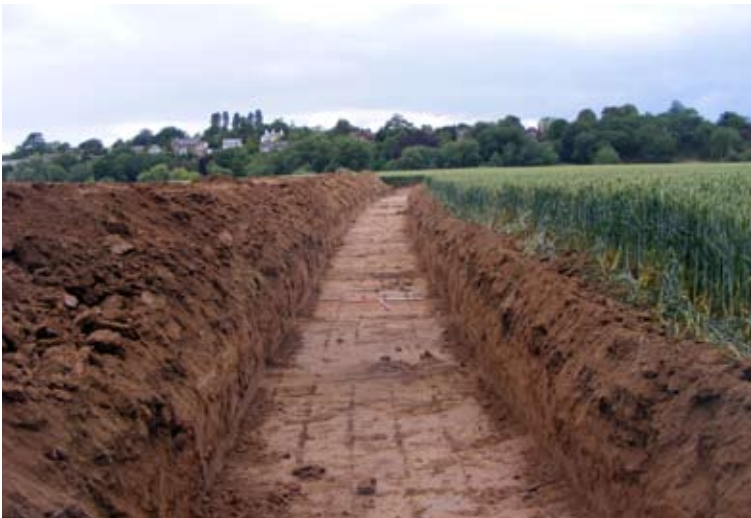
Illus 3
Evaluation of Trench 2

Trench 2 was located away from the area of the alleviation pond towards the north east of the site. The area was under crop at the time of the evaluation and care was taken to minimise the damage by repositioning the trench to the southern edge of the field.

The trench was excavated to a maximum depth of 0.65m, whereupon sterile geological deposits were encountered at an average of 0.45m below the current ground surface. No archaeological remains were observed.

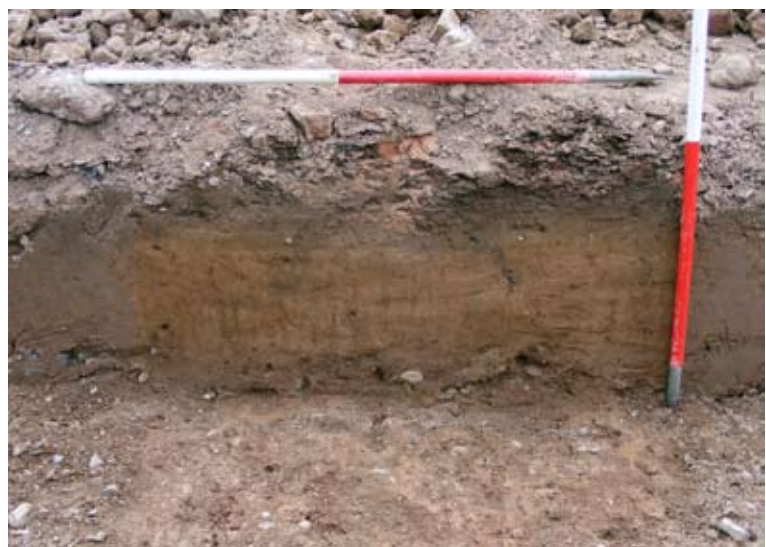
Illus 4
West facing section of Trench 3

Trench 3 was located towards the north east of the flood alleviation pond, this area had

been levelled and cleared of vegetation before the evaluation trenches were excavated. The trench was excavated to an approximate depth of 0.4m below present ground level and in all respects mirrored that of Trench 1, apart from the modern intrusion of services associated with the former military structures. No archaeological remains were observed.
