THE MERTON WORKS

Archaeological Watching Brief

DMS/112052/F

September 2012

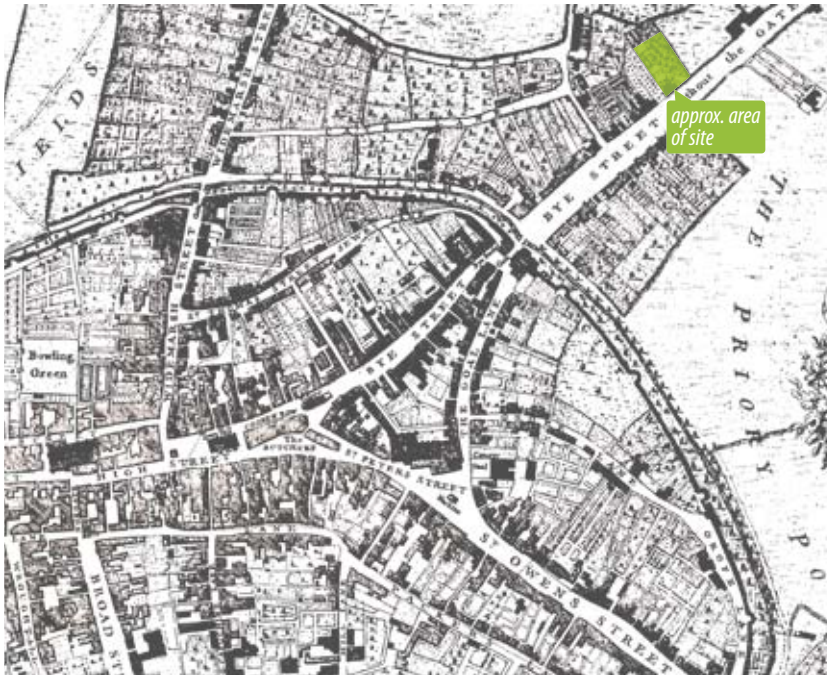
Illus 2

Examination of the historic mapping shows that the area of development has in general been open land and may once formed the back plot of buildings that fronted Commercial road. Taylor's map of 1757 shows the site was an open area behind a building fronting Bye Street bounded by an orchard to the northeast and some small buildings to the north-west (*Illus 2*).

Detail of Isaac Taylor's map of Hereford (1757) showing the approximate area of the site

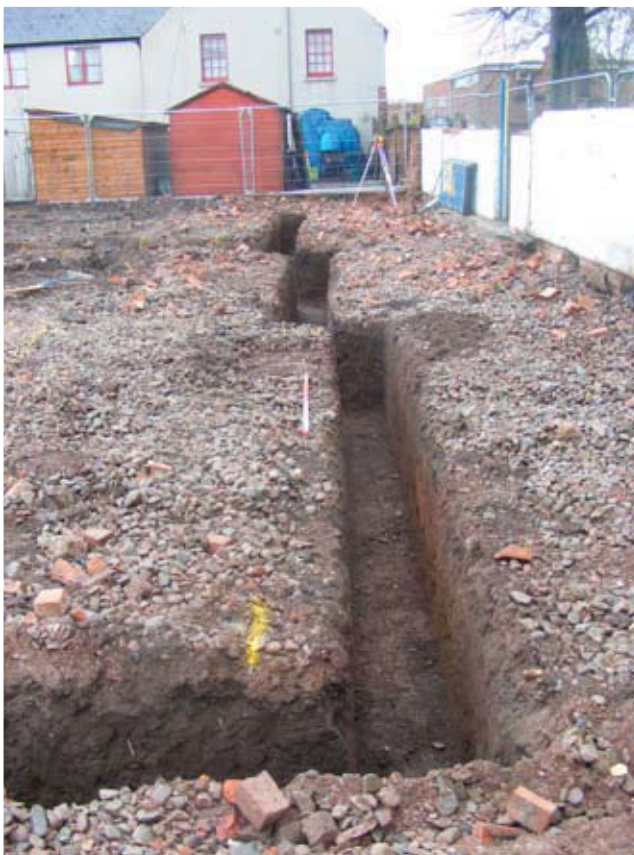
Illus 3

General view of the site showing the footings for Unit 3, 4 and 5

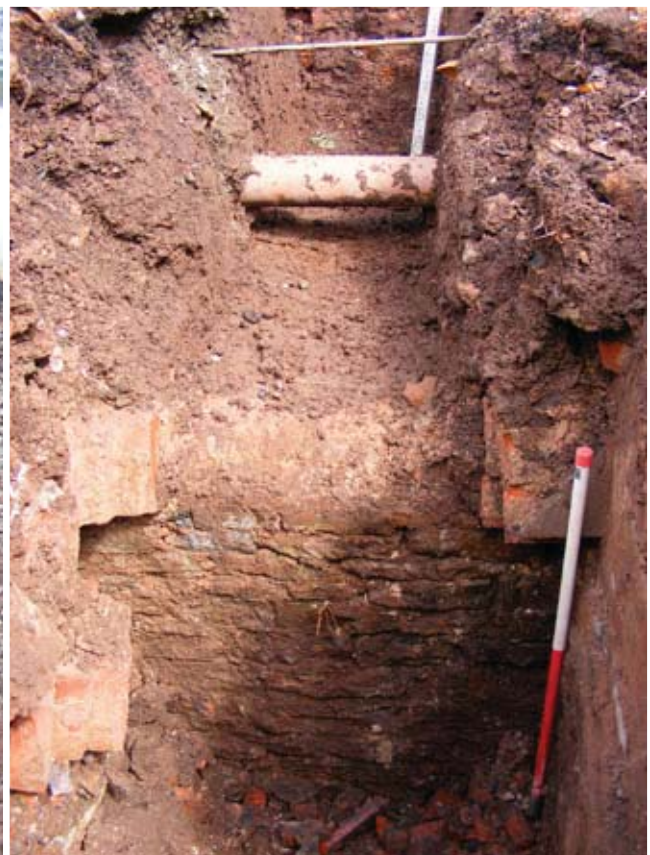
Illus 4

Detailed view of the in-filled cellar

The general stratigraphic make up the of the site consisted of the demolition remains of the previous structures overlaying a dark grey subsoil deposit containing small rounded pebbles, beneath which a sterile deposit of red gravels was observed (approximately 600mm below present day level) (Illus 4). Excavation of the footings was ceased at this level, as this was regarded by the Building Inspector to be satisfactory for construction.

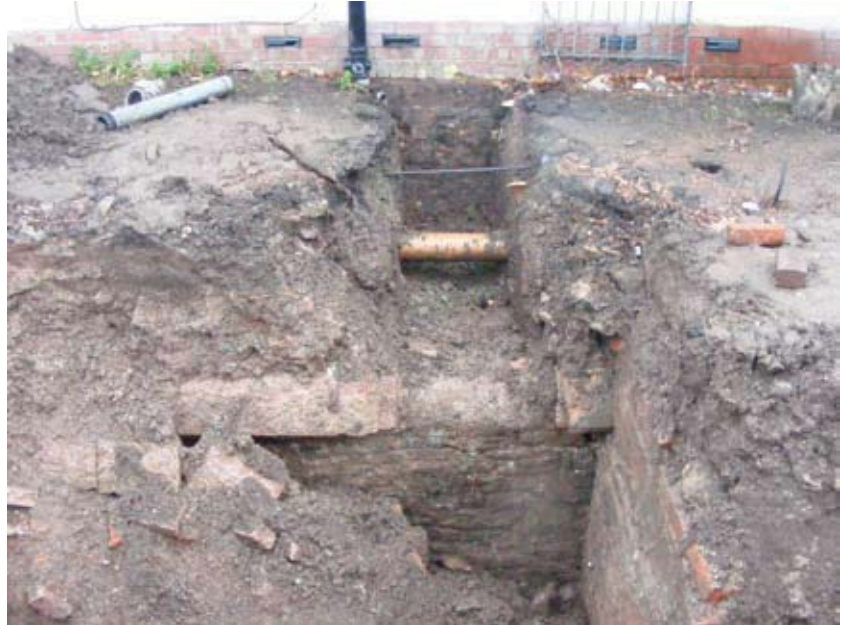
Illus 5

General view of the cellar

During excavation of the footings associated with the development of the existing building, evidence was found for a relatively recent backfilled cellar (Illus 5). Material from the cellar contained general demolition debris including galvanised buckets and window glass. The cellar was constructed from red brick with small sandstone blocks forming on wall. The cellar once had a brick constructed barrel vaulted ceiling. Due to the fragile nature and depth of the cellar, entry was considered unsafe and the cellar was recorded during excavation, by a series of photographs.
