## CASTLE TOOT, CLEOBURY MORTIMER

*Archaeological Watching Brief*

*for Mr S Thorogood*

*May 2012*

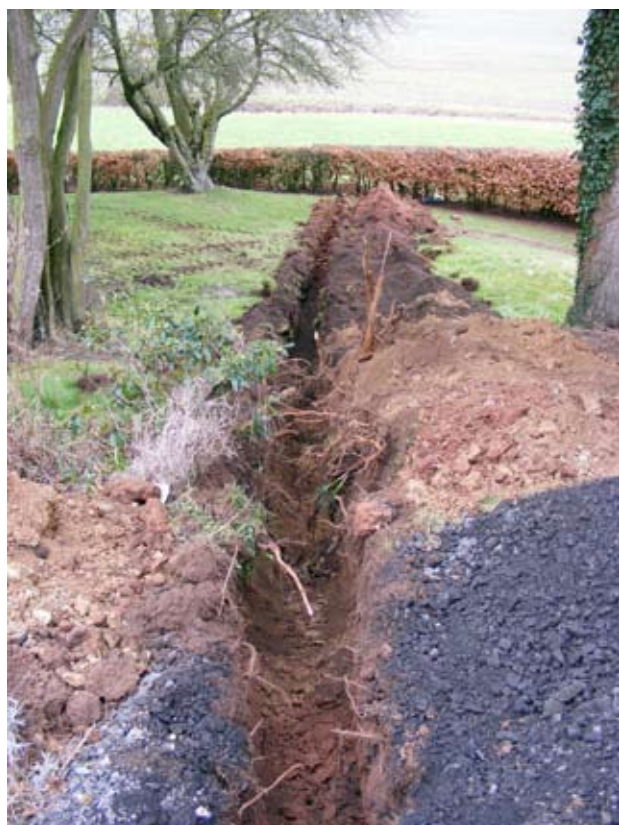
Illus 2

In the northeastern run of the pipe trench, there was, however, a significant deposit of dark topsoil measuring 7m in width and 0.6m in depth within the excavated trench.

The location of the deposit indicated that the dry moat surrounding the castle site had at this point been filled in and levelled. Examination of the spoil showed no finds to be present within the loam.

Dark topsoil indicating potential continuation of moat to N
