Marsh Mill, Leominster, HEREFORDSHIRE

Archaeological building recording and watching brief

Marsh Mill, Bridge Street, Leominster, Herefordshire:
Archaeological building recording and watching brief, 2009

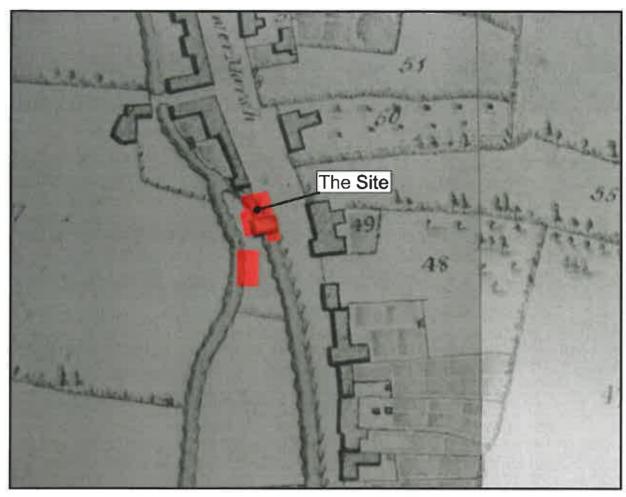
Marsh Mill on an extract from William Galliers 1825 "Plan of Leominster", Figure 2.

William Galliers Plan of Leominster (1825) shows a building on the site of Marsh Mill. It's position and dimensions suggest that it relates to Building 3 (Figures 8-11). The Sites and Monuments Record (entry 8909) indicates that this was the location of a post medieval mill and probably the site of a medieval mill. The 1967 Ordnance Survey map labels the building as a 'disused mill'.

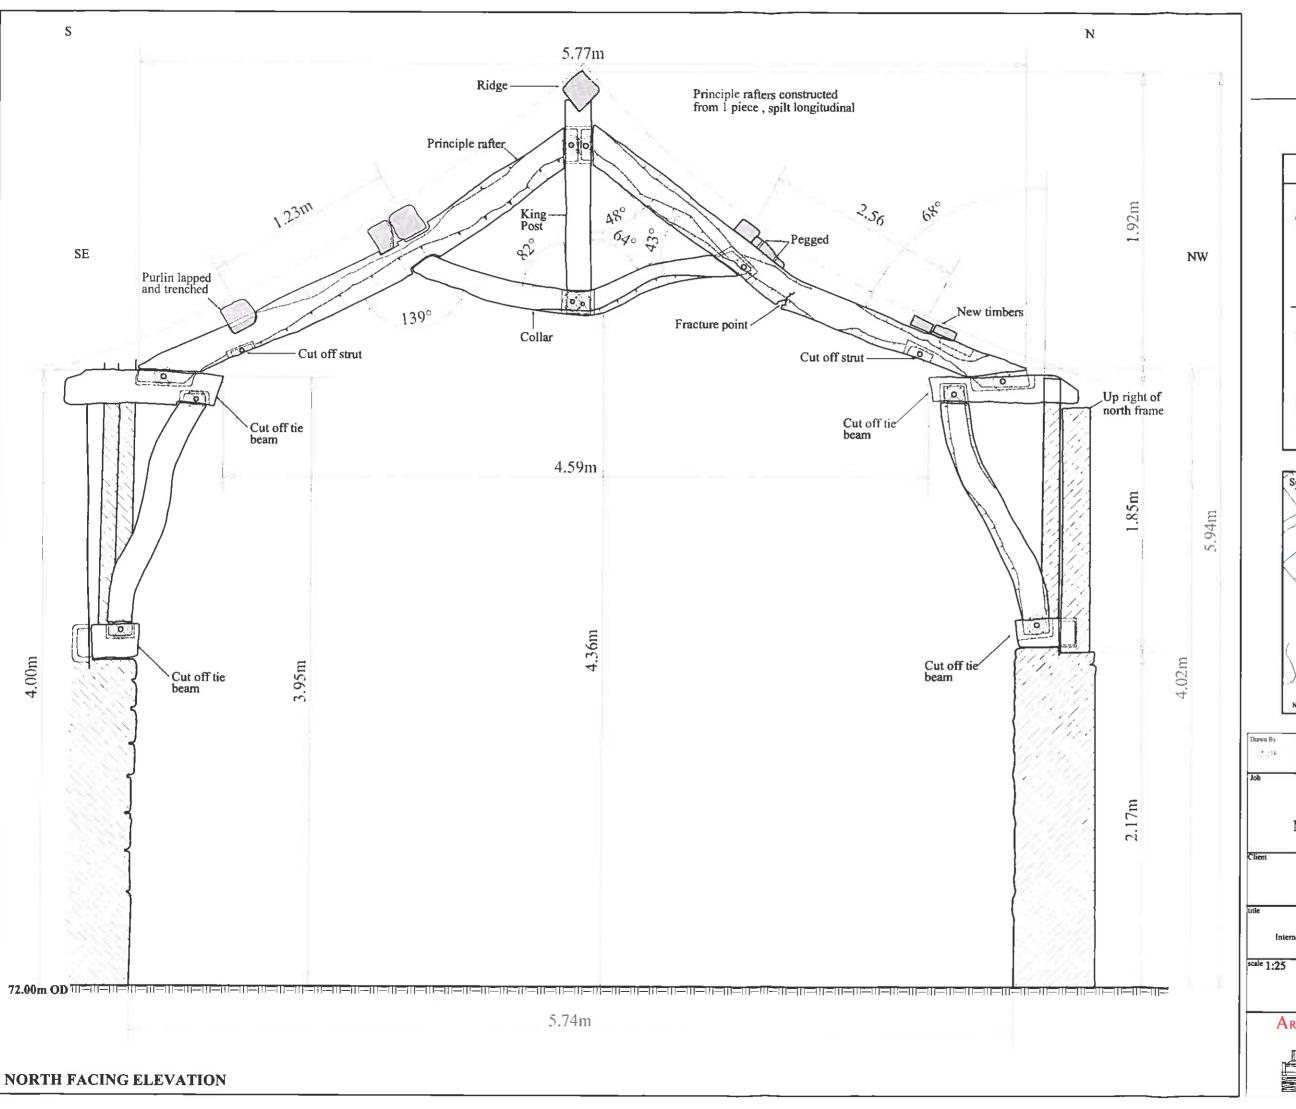
MARSH MILL LEOMINSTER TRUSS 1

The principal rafters of Truss 1 were from a single trunk, split length-ways into two matching halves. The rafters each had a redundant mortice on the under side, close to the bottom ends, and adjacent to the tie beam. The mortices had cut off tongues still pegged in place. The west rafter of Truss 1 was broken near the middle, and the truss was re-enforced by a modern truss on its south side.

The collar of Truss 1 had an exaggerated curve that was almost half round. All the old trusses in Building 3 had a more modern truss re-enforcing them on their south side, except for Truss 4 which had a new truss on its north side.

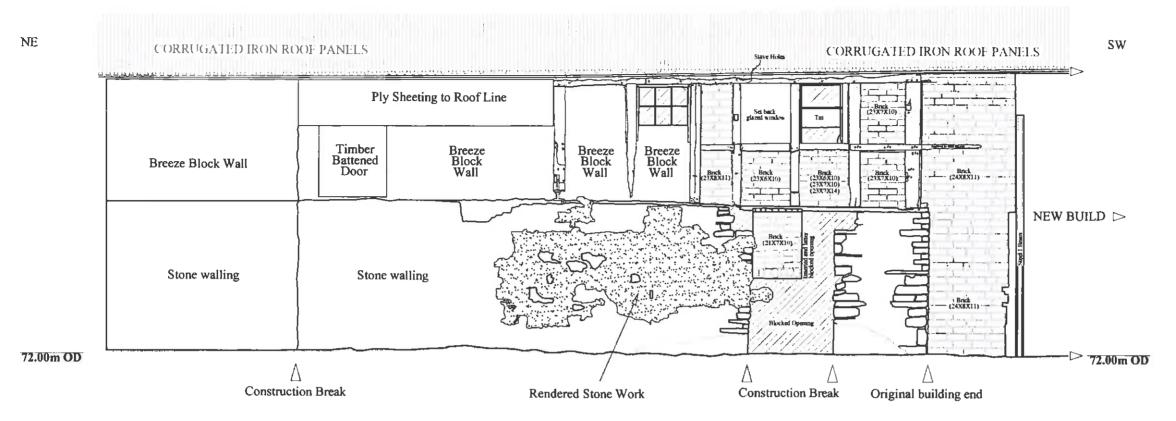
North west facing frame elevation. FRAME 1

The northwest frame was the most complete. It comprised vertical set members with a wall plate above and a sill beam below. These appear to have been set approximately 800mm apart (centre to centre), with a horizontal beam jointed at mid-height creating square panels. The first four uprights from the southwest end appear to be in their original position. The next two were probably reset when the six light window was inserted here, the last surviving one to the northeast probably still being in its original position. The panels have subsequently been in-filled with brick noggin, glazing, and breezeblock.

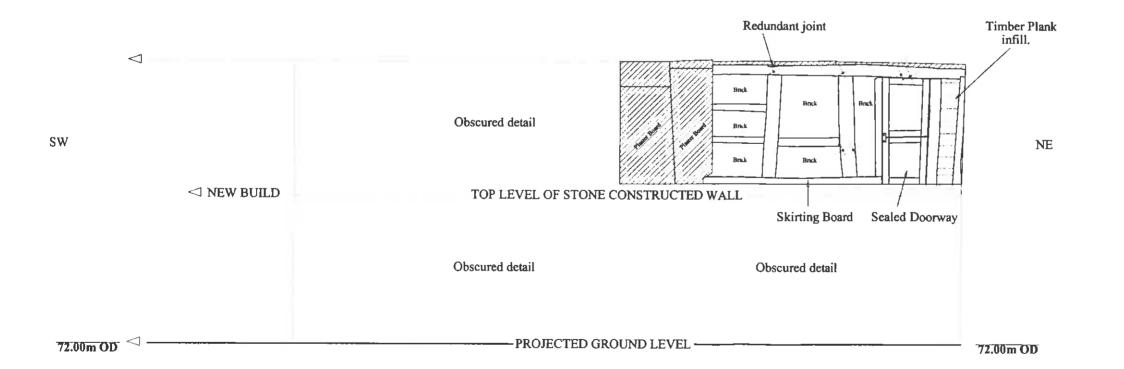
FRAME 2

At first floor level on the southeast side, the northern end of the original timber framed wall panelling survived in good condition but exhibited a few later alterations. On the northwest wall at first floor level, there was a similar but more complete, badly decayed, original timber wall frame. The timber frame walls had been removed from the northeast and southwest gable ends of the mill building, leaving just the trusses and tie beams intact. The north gable had been bricked in around the truss; the south end was left open and had been altered through a modern extension to the building.

South east facing frame elevation.
