SHOBDON CHURCH, HEREFORDSHIRE

Archaeological Watching Brief

for I J Preece & Son Ltd

July 2012

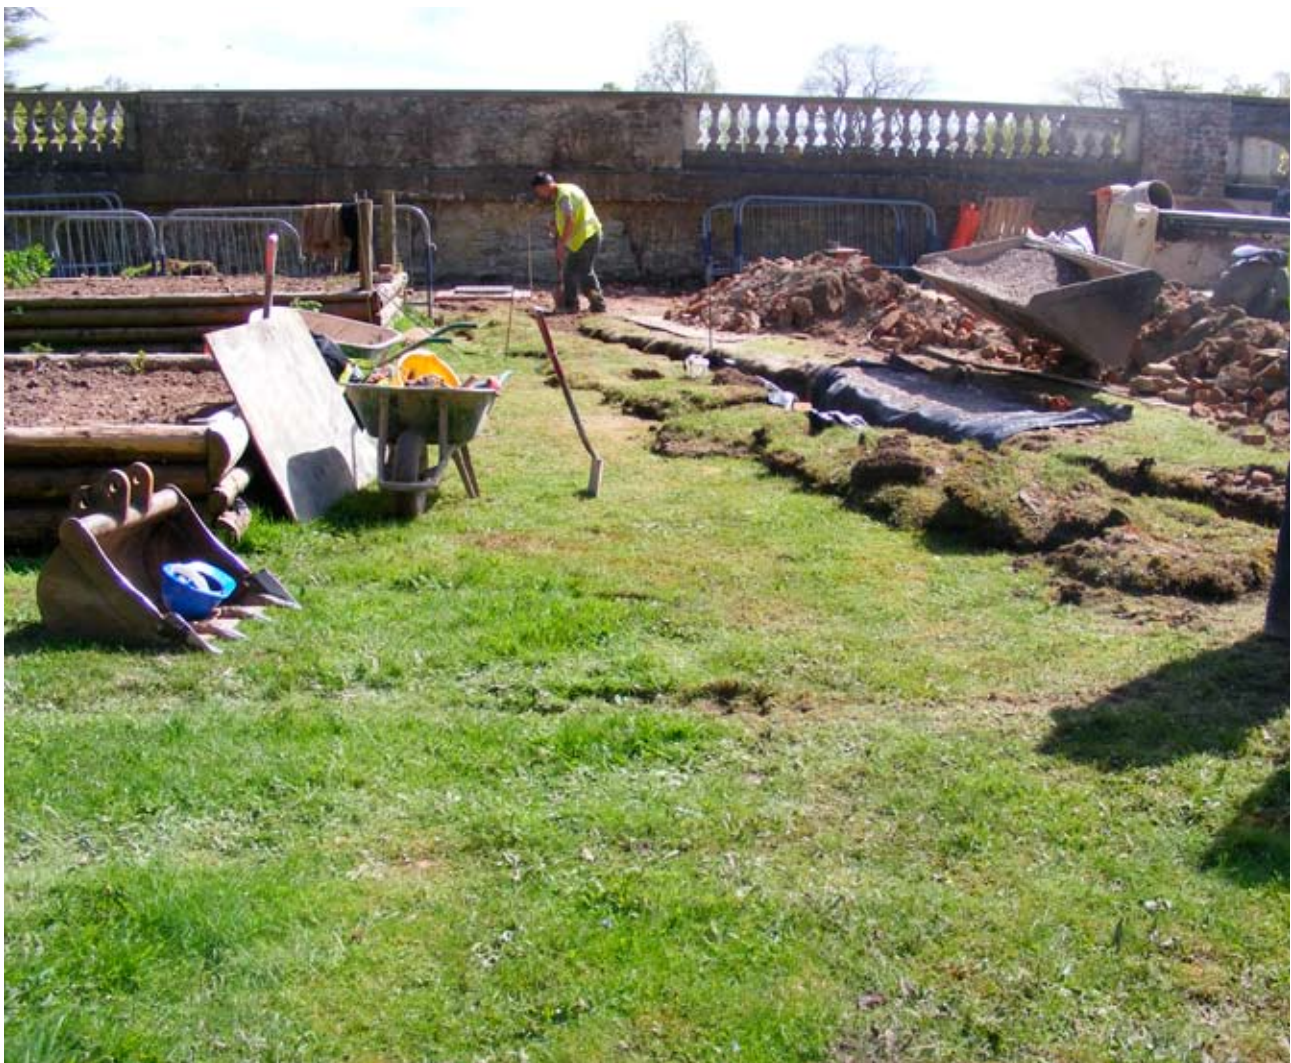
Illus 3

An excavation to establish the position of an existing soakaway at the south-eastern end of the trench was dug to a depth of 3m, after which the trench was dug to a depth of c1.3m. All parts of the trench were dug into a thick layer of brick rubble with architectural fragments and mortar. The deposits comprised rubble from the demolition of the Court used to fill the basements before excess was removed from the site, which had then been levelled. A number of walls with plaster facing were assumed to have been part of the basement area of the house.

Some 15.3m from the new inspection chamber was a stone wall on a north-west/south-east alignment. The northern wall of Shobdon court was encountered some 2m beyond the hedge on the northern side of the garden.

Drainage run leading from the south side of Shobdon Court manor

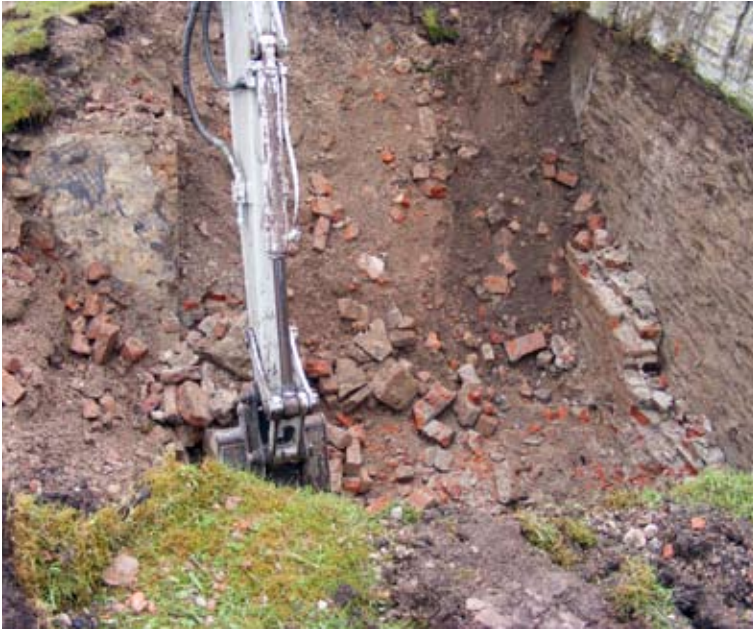
Illus 4

Backfilled cellars of Shobdon Court manor excavated in search of drainage connection

demolition of this structure in the 1930s, substantial structural remains survive beneath the surface. These are most likely to be cellars that were filled with rubble at the time the building was demolished.

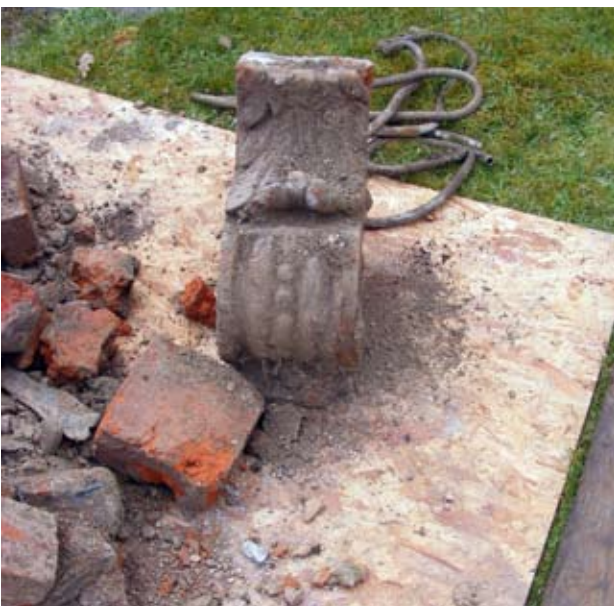
Illus 5

Architectural fragment from manor house

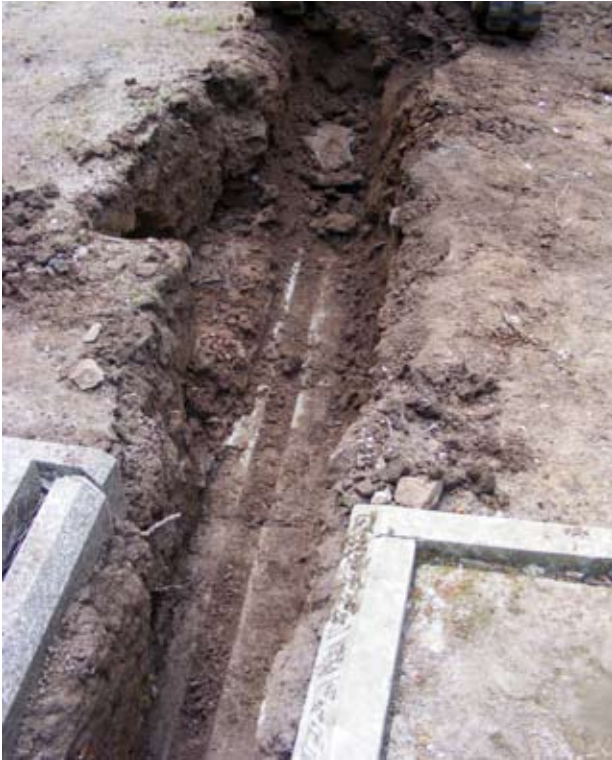
Illus 7

No archaeological features were present at the northeastern corner of the church; as the entire area had been disturbed by previous drain runs. The drain ran between the graves of the Bateman Hanbury family. At this point a stone culvert [105] with a carved base, was seen. It ran to the west along the full length of the north transept of the church. On its southern side a number of large slate slabs - possibly reused grave stones - appeared to run beneath the foundations of the church, although it was not possible to confirm that this was the case. It is thought that the slabs may have provided a damp course for this part of the church.

Stone drain [105]
