HEREFORD SATELLITE RADIOTHERAPY UNIT

Archaeological Evaluation

for Herefordshire Primary Care Trust

DMS/112924/F

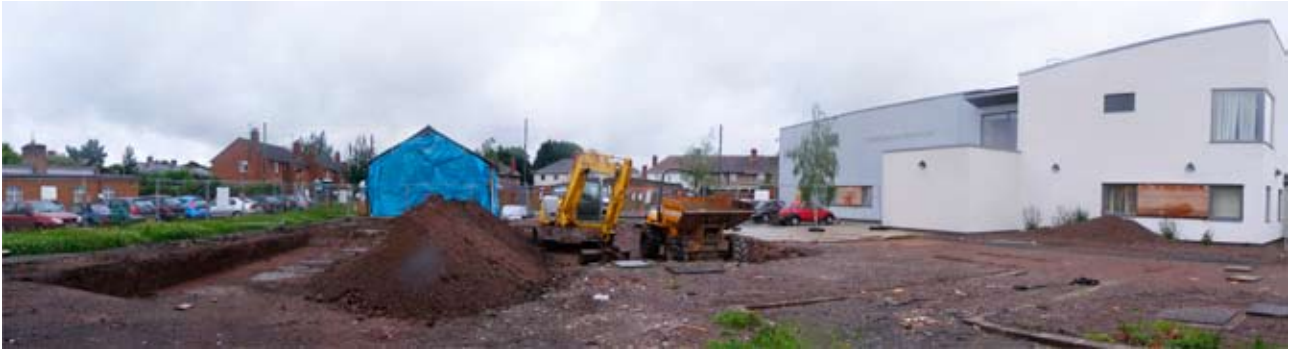
Illus 2

General view of the site during excavation

The evaluation comprised the excavation of two trenches, one 15m in length, and one 7m in length. Both lay within the principal area of the development. The evaluation trenches were located to avoid any known services, the need to do this being agreed in advance with the local planning authority's archaeological advisor. (Illus 2)

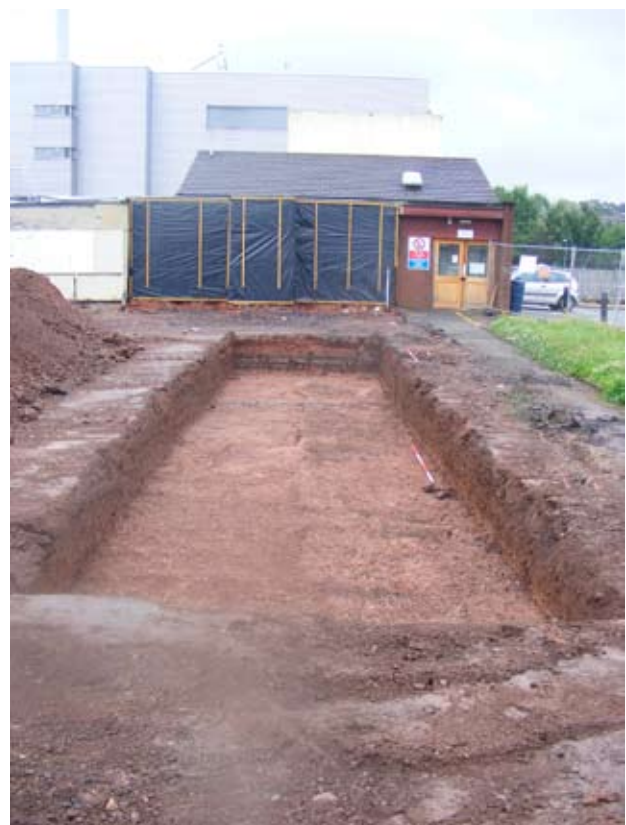
Illus 3

Within Trench 1 (Illus 3), a feature aligned east west cutting the subsoil was identified. It is most likely this represents a redundant service run, investigation of the feature indicated that the sides were straight cut and the width of the feature was also suggestive of a modern machine cut pipe run.

Trench 1 facing north-east

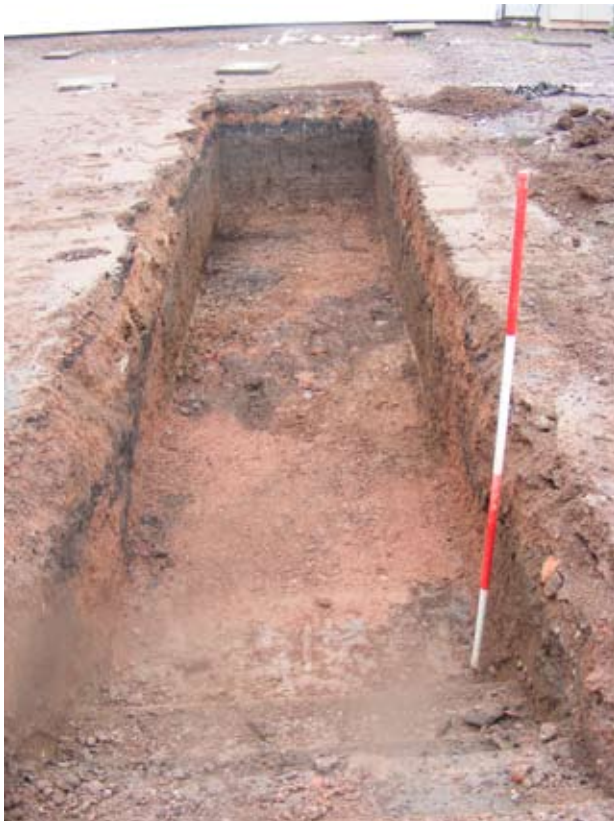
The excavation of Trench 2 (Illus 4) revealed an identical stratigraphic makeup as described above for Trench 1, with the exception of a large red pea grit filled cut aligned approximately southeast-northwest, cutting the subsoil. Partial excavation of

**Illus 4***Trench 2 facing north-east*

this feature indicated that it was possibly an unrecorded modern service run as it contained modern tarmac fragments within its makeup.

The large red gravel filled service run also cut a previously recorded, and now redundant, service run, in this case aligned northeast-southwest.

Within Trench 2 were two other features both with indeterminate edges. They were excavated to expose a section through them and were subsequently revealed to be very shallow and to contain modern ceramic finds. The original nature of these features is difficult to determine.
