4 KYRLE STREET, HEREFORD

Archaeological Evaluation

for Mr Robert Blackburn

September 2012

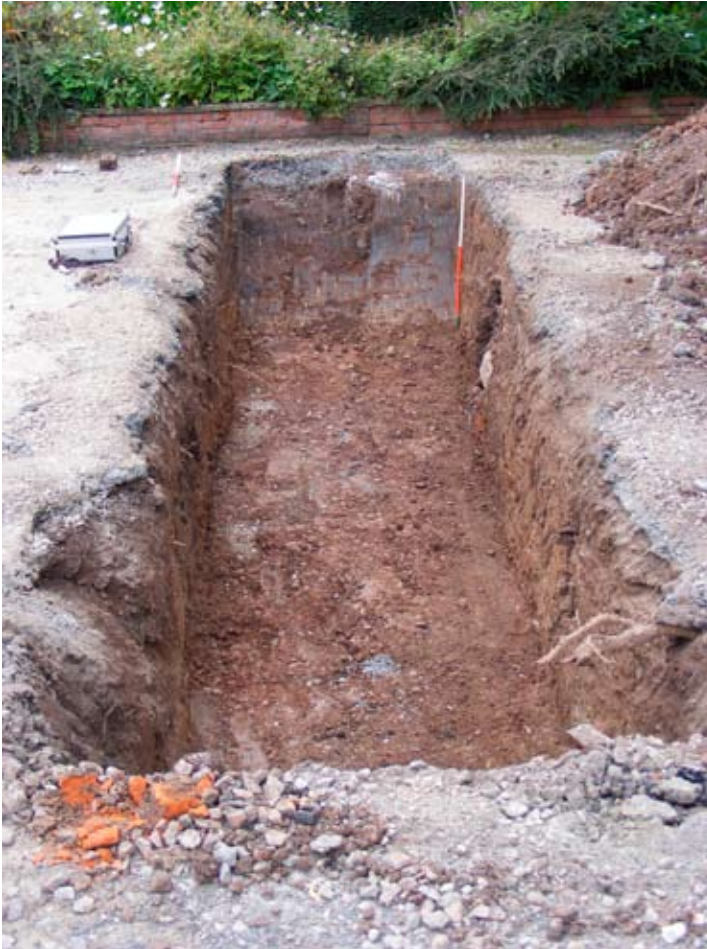
◀ Illus 2

General view of Trench 1

Trench 1 was located in the carpark to the south west of the property. It measured 1.7 x 8.5m and was excavated to a depth of 1.22m. The trench was originally intended to extend 10m but was shortened to avoid damage to the current drainage system. The excavation exposed a soil profile beneath the existing carpark surface (1002, 1005, 1006) overlaying an archaeological sterile layer of red gravels (1007). Within Trench 1, a modern machine cut trench (1003) aligned south west and north east cutting 1002 was identified. The base of feature 1003 was not reached as the excavated of the trench ceased when the archaeological sterile layer of natural red gravels was encountered (1007)

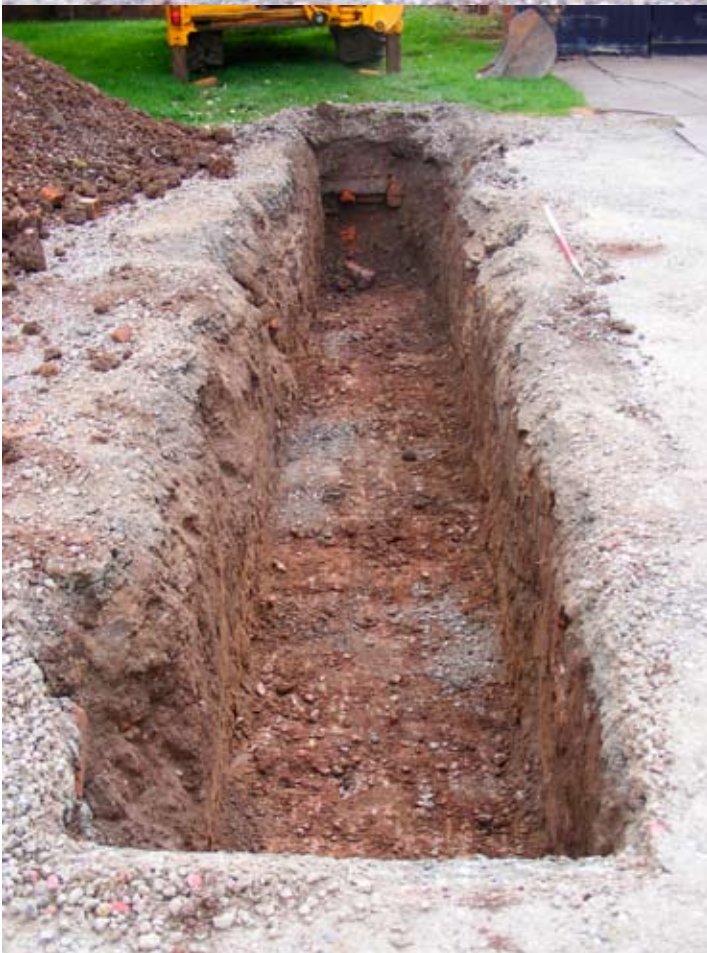
◀ Illus 3

Trench 2 was located to the rear of the main property and measured 1.7 x 8.2m and was excavated to a depth of 1.00m, where natural red/yellow clay layer (2004) was encountered. The sequence above was composed of light greyish brown subsoil (2003) which contained some fragments of modern ceramic material, overlain by dark brown modern topsoil (2002).

The topsoil was cut by three red brick walls aligned at 90 degrees to the trench (2005, 2007, 2008). The three walls were all constructed from machine made red bricks and shared similar dimensions. Associated with the wall structure (2005) and located at the southern end of the trench was the remains of a single course of red bricks, perhaps laid to form a surface. These modern structures probably related to a previously demolished building to the rear of the existing Kyrle House.

General view of Trench 2
