NEW INN CAR PARK, MARKET SQUARE, PEMBRIDGE

Watching Brief

for GRW Property Ltd

N121953/F

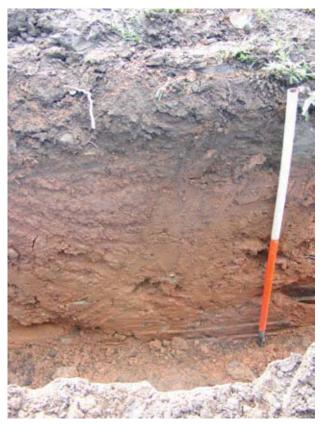
Illus 2 *North facing section at South edge of site*

The development site seemed largely undisturbed prior to excavation. Natural geological deposits were encountered at c 0.55m depth and comprised dark brown silt [003]. A subsoil deposit [002] was encountered at a depth of c 0.3m, and consisted of light brown clay which had no archaeological evidence within. The most recent deposit [001] was dark brown silt topsoil up to 0.30m in depth (*Illus* 2).
