## CHURCH COTTAGE, LITTLE DEWCHURCH

*Historic Building Recording &  
Geotechnical Test Pit Monitoring*

S121243/F

*January 2013*

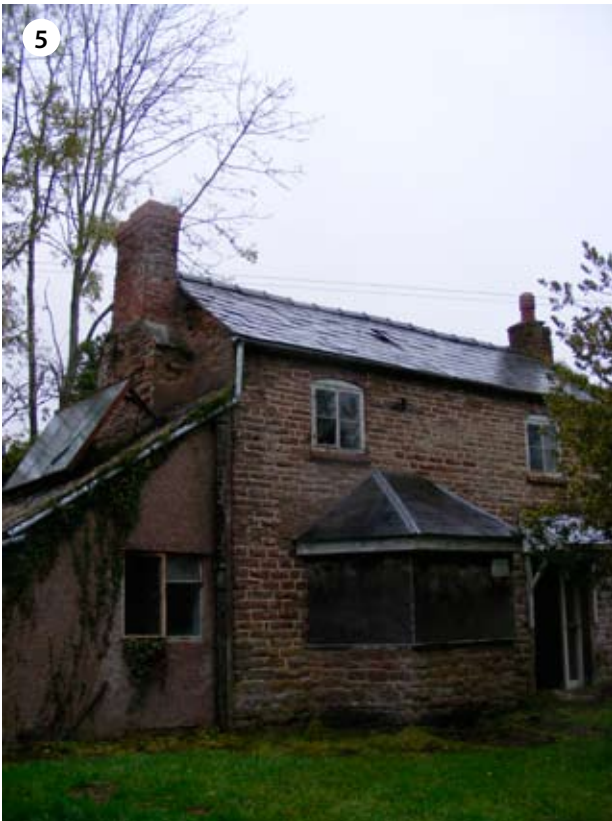
**Illus 5**

*General view showing the main elevation of Church Cottage*

The building's main elevation consists of two symmetrical second floor windows with side opening frames and supporting brick arches, above an offset entrance, with an additional and later metal framed and roofed bay window at ground level (Phase 5). The bay window although a later feature, attempts to mirror the construction of the main building though its use of coursed stone possibly reused when the original window was opened up to form the bay window, the use of a metal framed window within the bay would suggest that this was a late phase of works

The two modern extensions that flank the main façade are less sympathetic in their construction, and pre-date the bay window. Both extensions are constructed in hand made red brick; however, the eastern extension has undergone modern alterations in cinderblock (Phase 4). Although not exactly recent they possibly represent a period of expansion and modernisation to the faculties originally offered at Church Cottage, as the southwest lean-to extension was used as the house bathroom and toilet. The discomfort of accessing the external bathroom was somewhat eased through the addition of an open sided lean-to roof over the southwest entrance (Phase 5). The northeast extension survives in a very dilapidated condition; access to the extension appears originally only to be from the front of the dwelling, however, nothing-obvious remains to suggest a primary function.

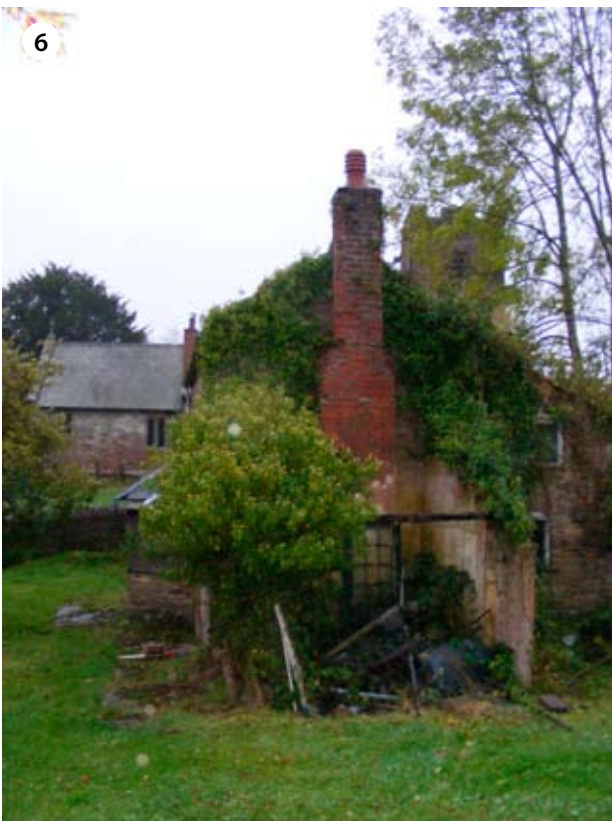
**Illus 6**

*General view of Church Cottage taken from the NE showing latter chimney and offset roof line*

The general appearance of the property when viewed from the east elevation shows a slight offset to the main roofline, with the rear eaves being lower than the front. This has led to the suggestion that the rear of the property is a later extension; however, investigation within the ground floor rooms confirms that the dwelling has not been extended, as there are no supporting walls present within the building, the internal walls being formed of timber, laths, and plaster.

The original design of Church Cottage incorporated an offset fireplace on the southwest elevation this provided heat, only to the main ground floor room, however a relatively modern, brick built chimney (Phase 3) was constructed on the northeast elevation, both stacks appear to have only provided heat to the ground floor rooms.

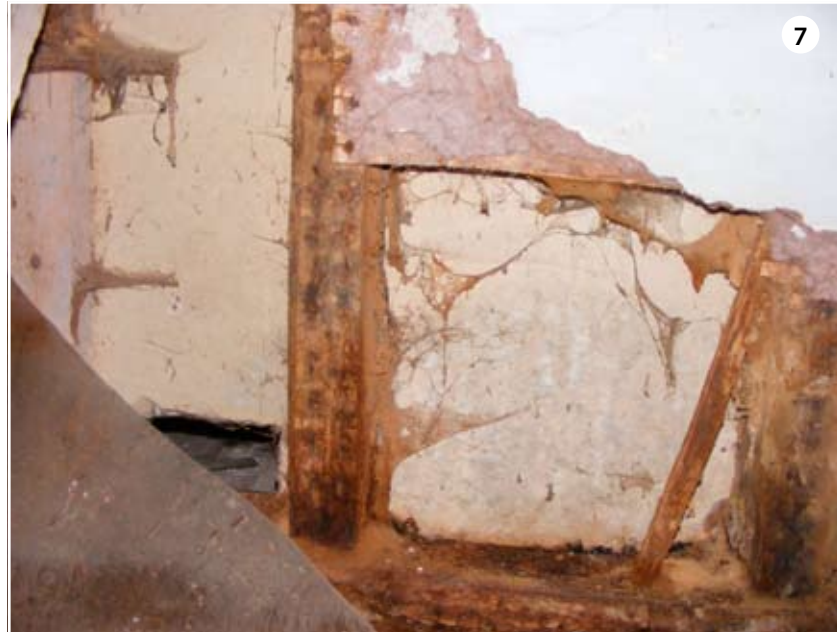
**Illus 7**

*Detail showing construction of internal walls*

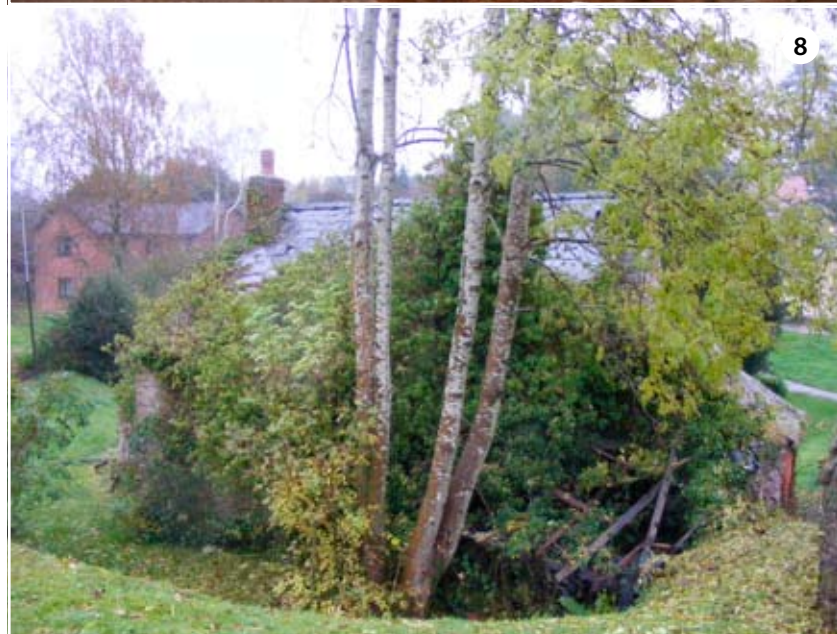
**Illus 8**

*General view showing extension located to the rear of the property*

Towards the rear of the property a stone-built single story structure, which on first inspection appears to pre-date the ground plan of Church Cottage is located. The building although, constructed in stone does not share the general characteristics of the main building. The stone is irregularly coursed, as well as showing a greater variation in general dimensions; the structure also exhibits a more weathered appearance.

As to the stone built structure to the rear of the property, the unusual ground plan and incorporation into the footprint of Church Cottage, would imply that the structure predates the foundation of Church Cottage. However, Church Cottage is building of two faces, the main facade being constructed from regular undressed ashlar blocks; whereas, the rear of the property contains weathered and irregular sized stones. This pattern of construction is repeated in the

fabric of the rear extension, possibly indicating that the building is relatively contemporary with the construction of Church Cottage. Examination of the available historical information also confirms that the structure is later than Church Cottage as the 1839 parish map shows only one building present on the site. The exact date of the rear structure may never be known but the 1905 OS map indicates the extension had been built by this date.
