## POST BOX COTTAGE, LONGTOWN, HEREFORDSHIRE

*Archaeological Watching Brief*

*DMS/110514/F*

*November 2012*

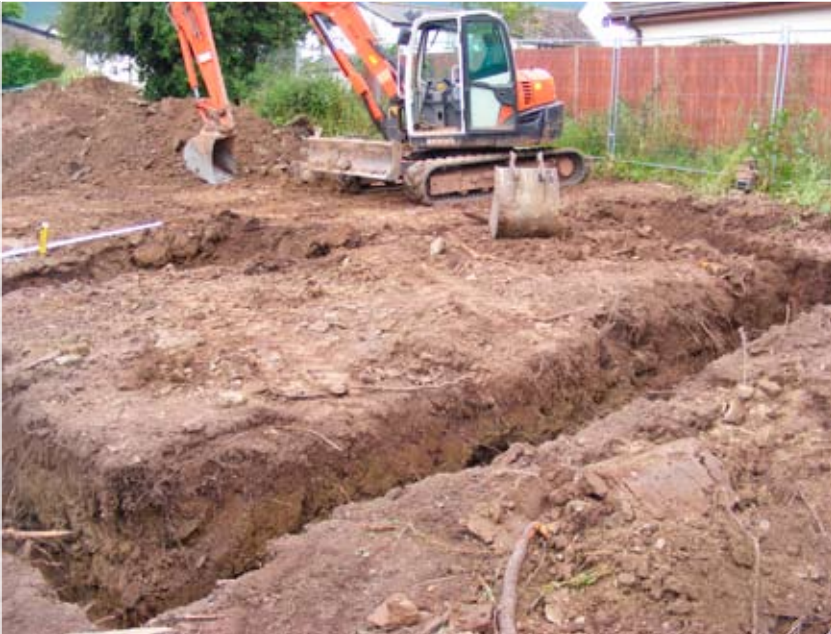
**Illus 3** ▶

*Excavated footings at the south of the site*

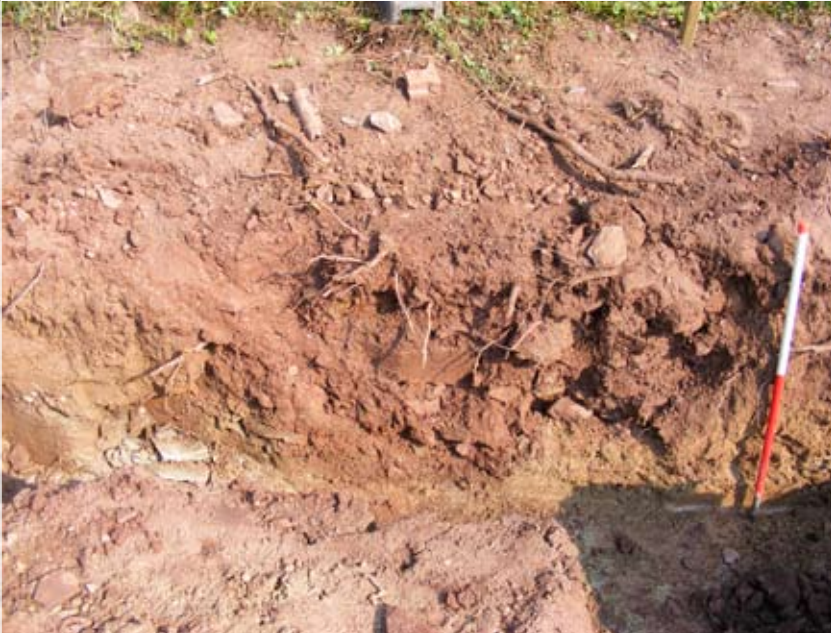
**Illus 4** ▶

At the northern edge of the site a series of bowl-like depressions [009, 011, 013] were observed in the section of an E-W aligned footing; cutting [002] and [003]. These features were filled by [004, 010, 012] respectively, which all consisted of a grey-brown silty clay with frequent large stones and sandstone rubble. They each had a depth of 0.7m and width of 1.0m and probably indicate disturbance caused by the removal of trees previously growing on the site.

*[009] tree-throw pit visible in section*
