EGGHILL PHASE 2

Archaeological Evaluation

for Kier Partnership Homes Ltd

December 2012

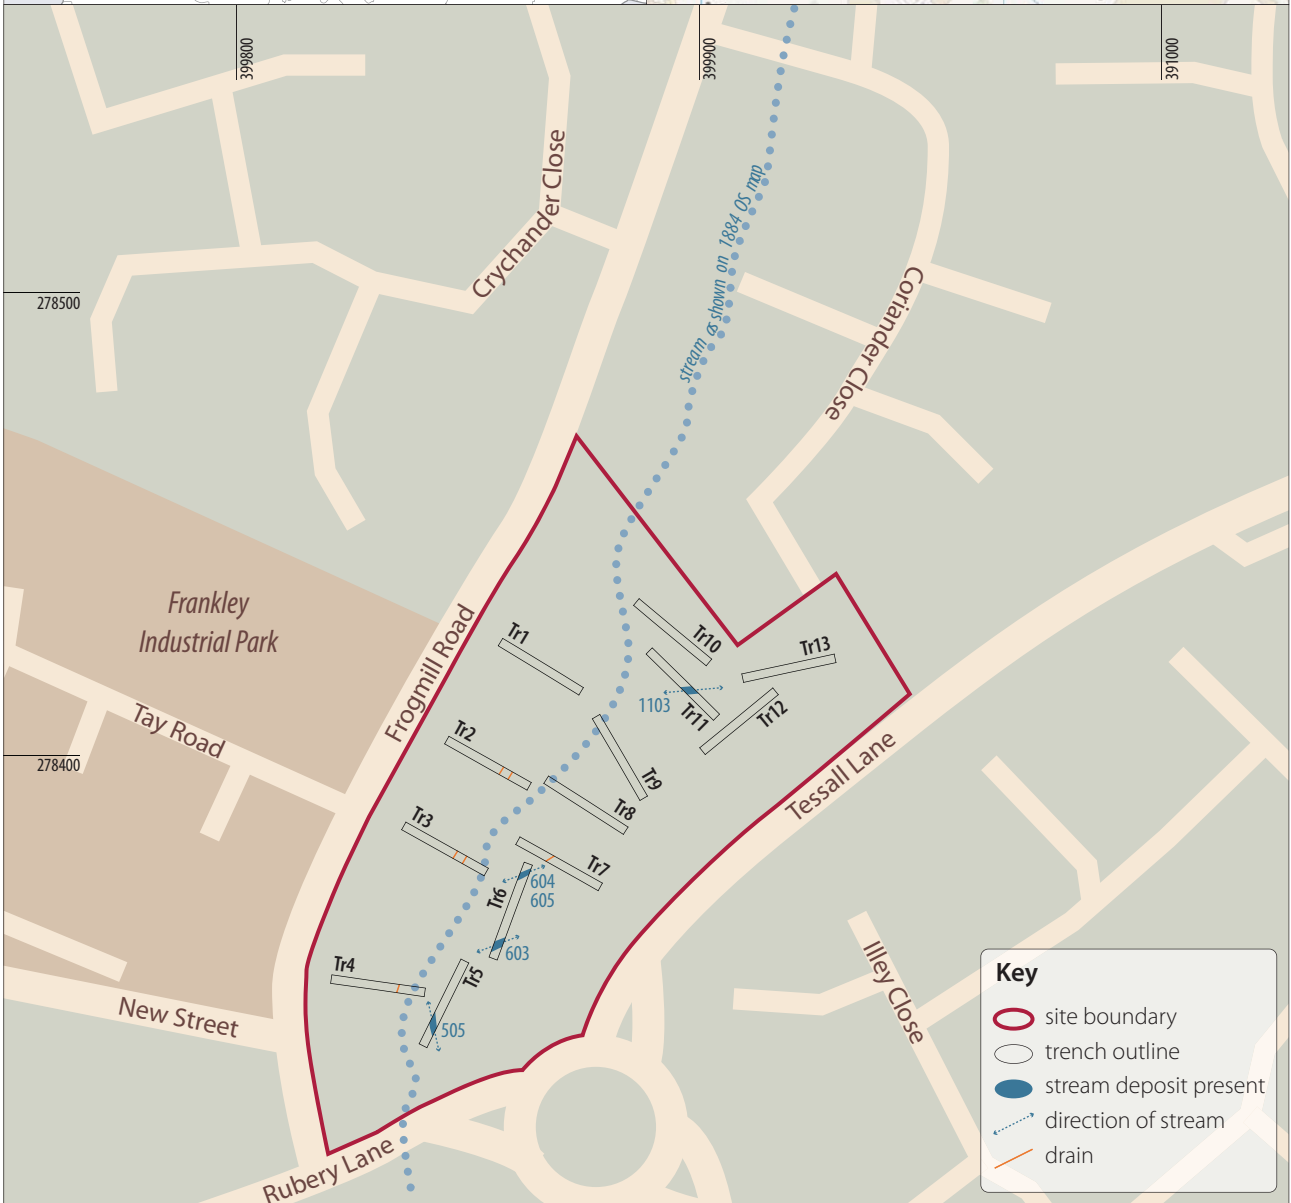
Illus 1

Site location

The location of the stream bed deposits (*Illus 1*) differ from the course of the stream depicted in the 1884 Ordnance survey map – all of the stream deposits are situated east of the historic stream course. It is likely that a degree of channel migration has taken place throughout the lifetime of the watercourse, and that those stream bed deposits encountered during the evaluation represent channels older than that mapped on the first edition OS.

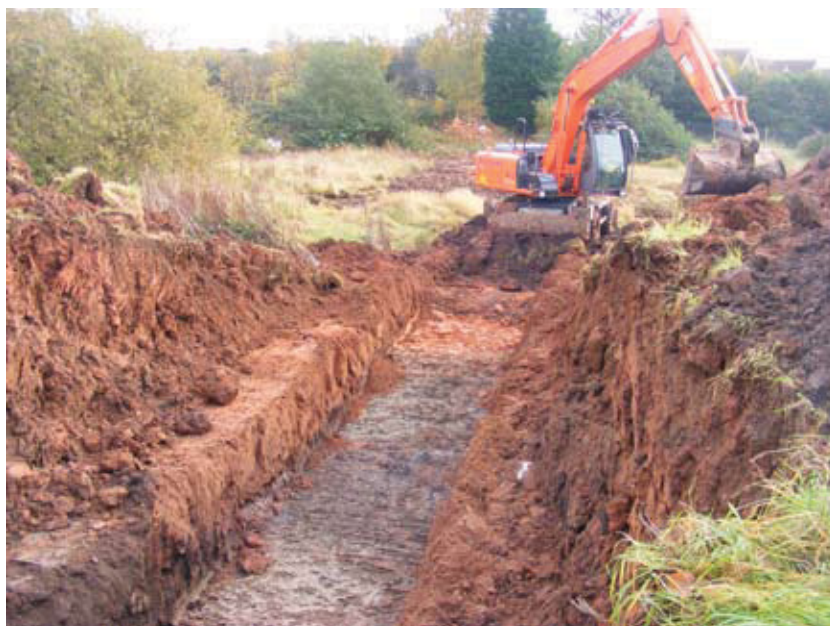
◀ **Illus 2**

Trench 2 showing bund

The natural geology beneath the western bund appeared to have been affected by some form of leaching or periodic waterlogging as the colour of the sediments was markedly greyer where they lay beneath the bund material (*Illus 2*). The construction of the bund may have affected drainage of water in this area causing post-depositional colour changes.

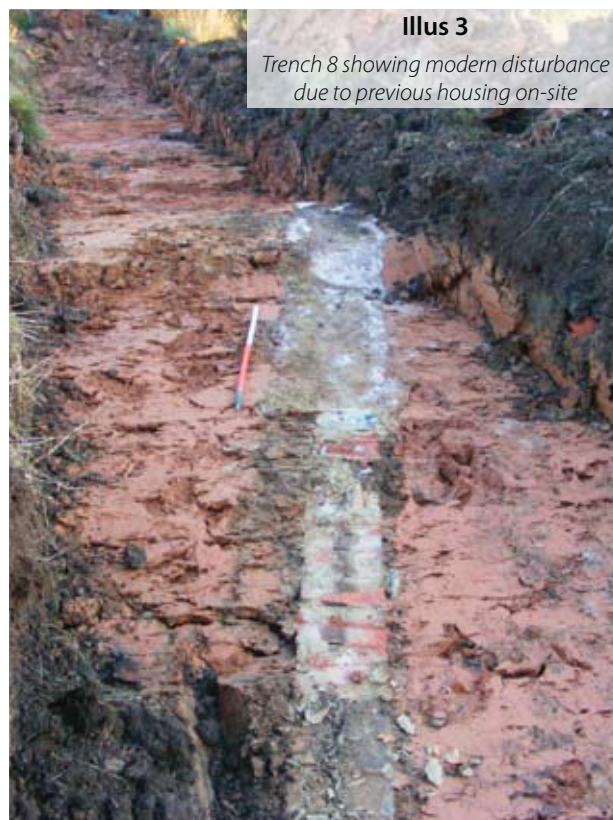
Illus 3

Trench 8 showing modern disturbance due to previous housing on-site

The majority of deposits encountered within the evaluation trenches consisted of modern debris and rubble likely the result of the former use of the site as a housing estate and its subsequent demolition (see Appendix 1.2). There was no evidence of the building shown in the 1842 Tithe map in any of the trenches located on the western border of the site (Trenches 1–4).

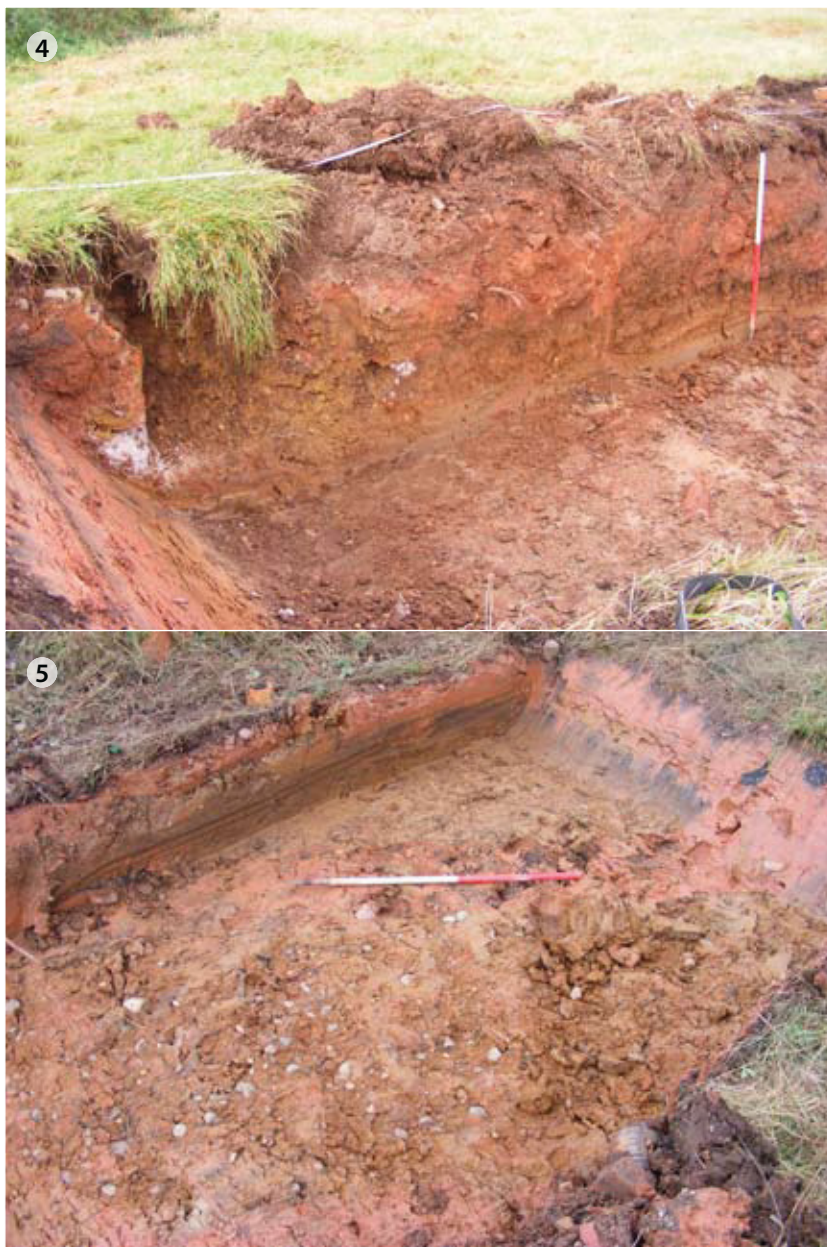
Illus 5

At the south end of Trench 6 the deposit [603] measured 0.35–0.4m deep, 1–1.5m wide and travelled through the trench in a roughly east-west direction. Furthermore, at the north end of Trench 6 deposits [604] and [605] likely represent to parts of a NE-SW running deposit cut by a modern trench [606], (*Illus 5*). Deposit [604] measured 0.4m deep by 1.0m wide and [605] measured 0.35m deep by 0.4–0.5m wide.

Stream deposits [604] and [605] in Trench 6
