ALAMO WORKS, STATION ROAD, SALFORD PRIORS, WARWICKSHIRE

Archaeological Evaluation

for Alamo Manufacturing Services Ltd

April 2013

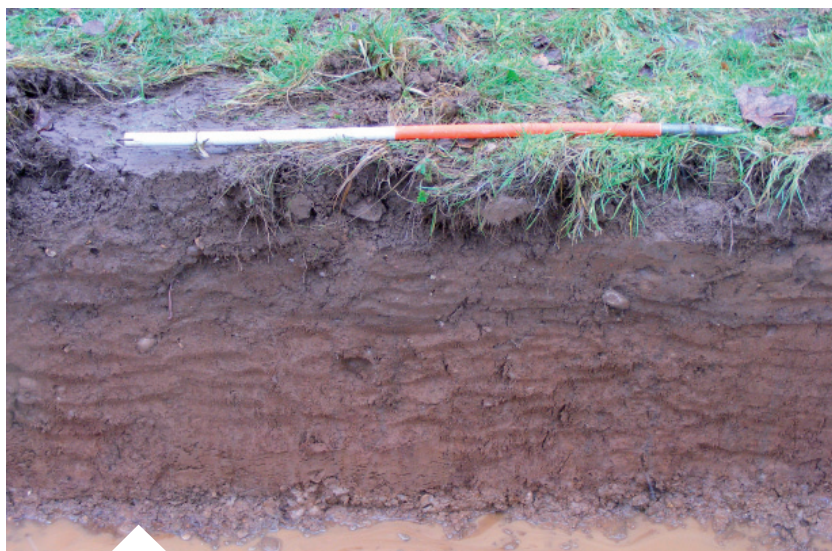
Illus 2

A consistent profile was present along the full length of Trench 2. Topsoil overlay a clean deposit of silt and clay alluvium [201] measuring 0.4–0.45m in depth. Natural gravels [202] were present below the alluvium at a maximum depth of 0.75m (*Illus 2*).

Trench 2, east facing section

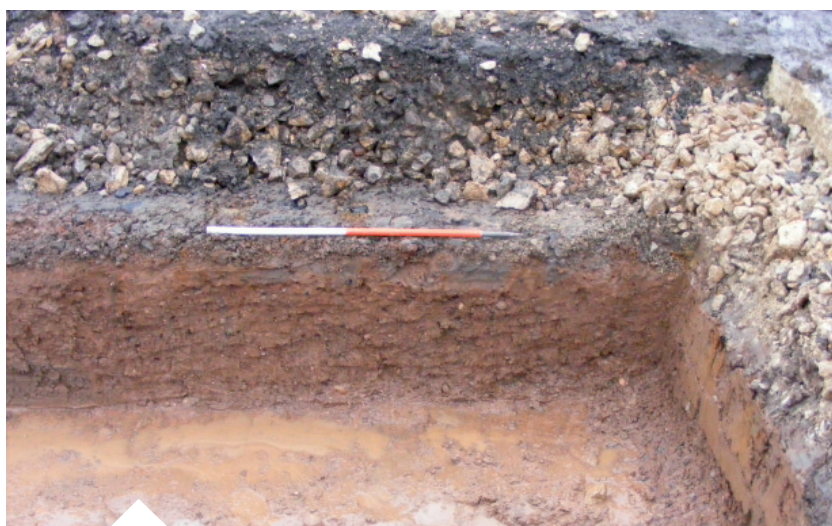
Illus 3

Located adjacent to the existing factory building, concrete and hardcore were present to a depth of 0.5m. Beneath the hardcore, alluvial deposits [302] surviving to a depth of 0.6m overlay the natural gravels [303] (*Illus 3*). In the southern part of the trench, modern deposits of contaminated ground were cut through the alluvium into the natural gravels beneath.

Trench 3, east facing section

The deeper deposits of made ground revealed in Trench 3 suggest that the area has been built up to raise the developed part of the site above the water table. Water ingress was evident in all the excavated trenches.

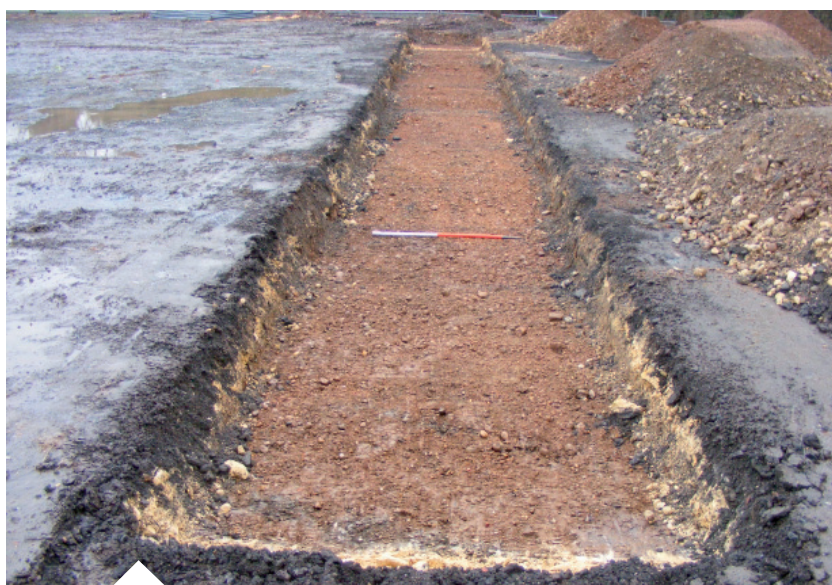
Illus 4

Tarmac hard standing overlay a deposit of stone hardcore [500]. Immediately beneath this deposit, natural gravels [501] were

Trench 5, natural gravels immediately below surface

present at a depth of 0.2m below ground level (*Illus 4*).

Alluvial deposits were not present with the northern part of Trench 4 and the entirety of Trench 5. Potentially alluvium was never deposited in these areas, although the presence of an area of hard-standing correlating with the absence of alluvium could suggest that such deposits had been stripped away from this part of the site prior to the laying of the hard-standing.
