## PERSHORE ABBEY, PERSHORE

*Archaeological ground monitoring*

*commissioned by The Vicar and  
Churchwardens of Pershore Abbey*

*June 2013*

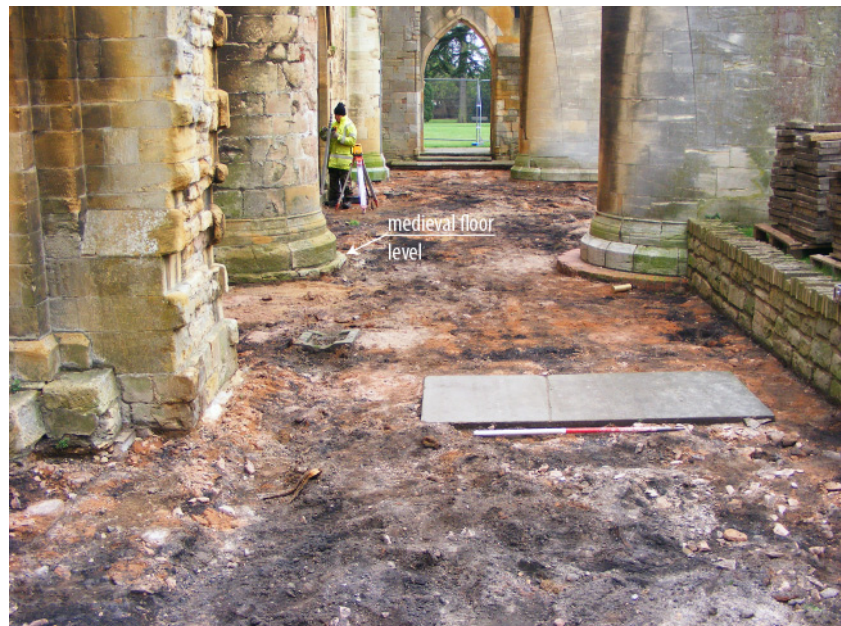
### Illus 3

General view of site facing S, before grading of ground levels

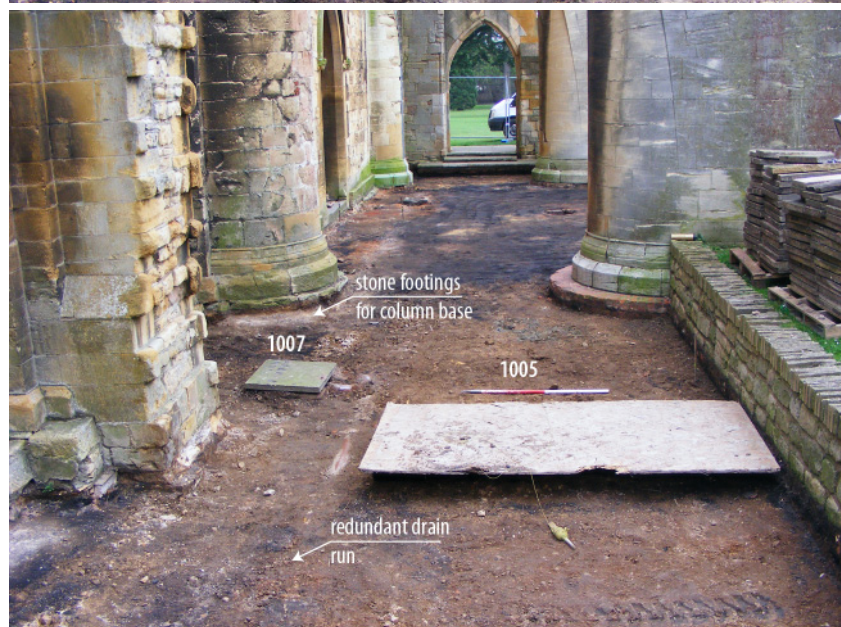
### Illus 4

General view of site facing S, after grading of ground levels

It is also interesting to note that during the re-grading of ground levels it became clear to observe a post-medieval grave slab that formed part of the modern paving was set on bricks, similar to the bricks surrounding the flying buttress, indicating that the grave slab had been raised to lie flush with the paved surface (*Illus 4*). The grave slab was left in situ and not disturbed during the observed ground works.

During the ground reductions work it was observed that the existing grave slab was set upon a brick plinth. The use of brick beneath the grave marker could indicate that there is a chamber beneath the slab or it could equally reflect the need to level up the slab to lie flush with the previous raised paved surface.

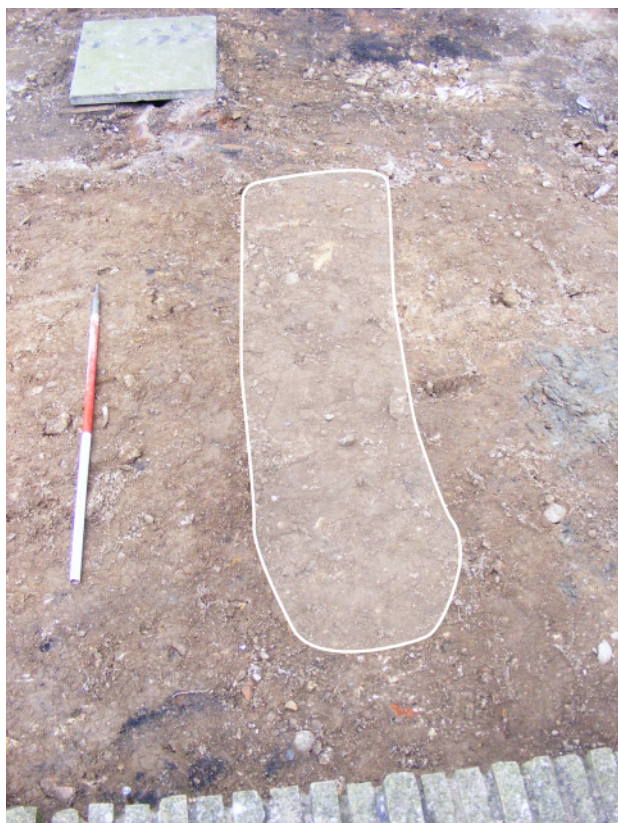
**Illus 5**

*Detail showing truncated grave cut*

Located within close proximity to the existing and retained grave slab, a grave cut was identified [1005]. The grave cut was aligned east-west and positioned within the line of the former north aisle of the nave. The cut was also truncated at the eastern end by the run of the redundant drainage system (*Illus 5*).

Grave [1005] was not excavated, however during further ground reductions required for drainage alterations, a number of disarticulated bones were identified within the upper fill, at the eastern end of the grave cut.

The identification of disarticulated bones within the grave fill of [1005] suggest, that when the grave was truncated by the existing drainage system, the disturbed bones were replaced in the fill of the grave cut, before the construction of the paved area was completed.

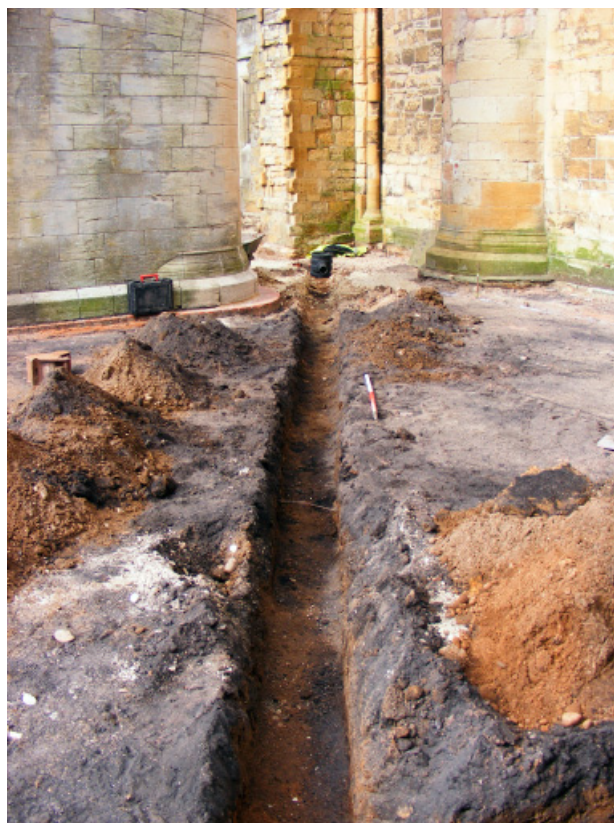
**Illus 6**

*General view showing drain cut*

Further work conducted during the reduction of the area around the northern drain sump (*Illus 6*) identified another grave cut [1007] also in line with the former nave aisle. The grave cut was heavily truncated by the drainage system, resulting in only a small portion of the original grave remaining at the western end.
