THE CIDER HOUSE, PUTLEY, HEREFORDSHIRE

*Historic Building Recording and
Archaeological Ground Monitoring*

N121032/F

May 2013

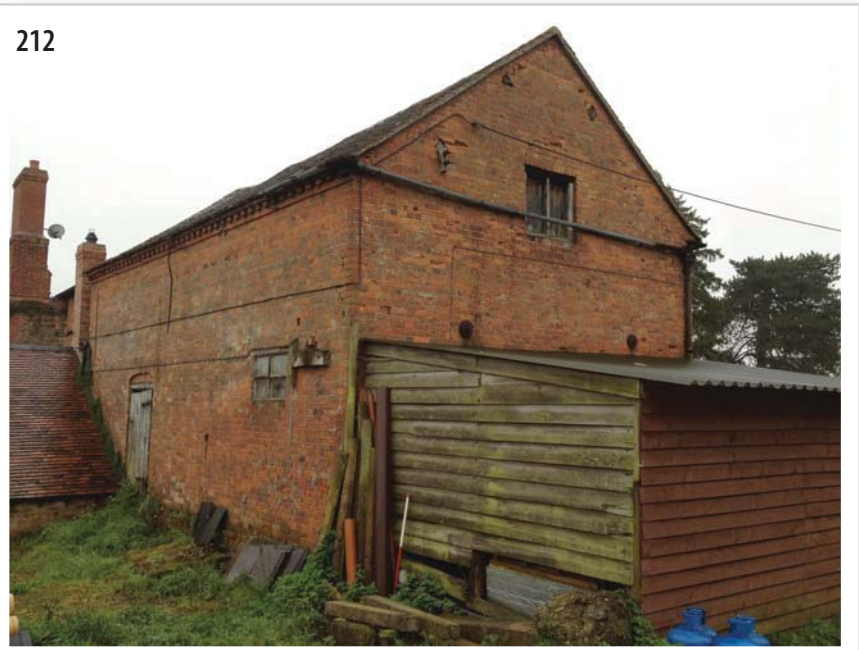
212
External view showing change in coursing for the alteration of the roof height

The alteration to the eaves are reflected externally, in the brickwork, the coursing patterns change from a Flemish bond on the first phase building to a variation on English cross bond used in the raised eaves.

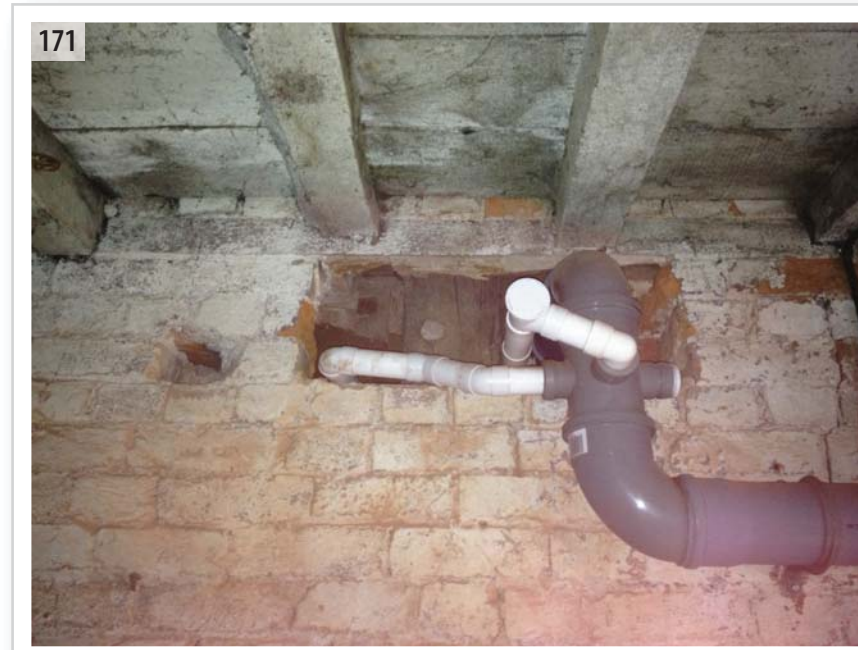
171
Internal view showing timber framing of abutting building, seen within modern hole cut for plumbing

Internal examination of the east gable wall shows a small brick arch located at ground level, which has recently been blocked up with modern cinder block, the use of such an arch not being obvious at the time of the survey. The gable wall has also been pierced by modern plumbing from the adjacent building, the subsequent hole allowing a glimpse of the peg-jointed timber framing of the aforementioned building.

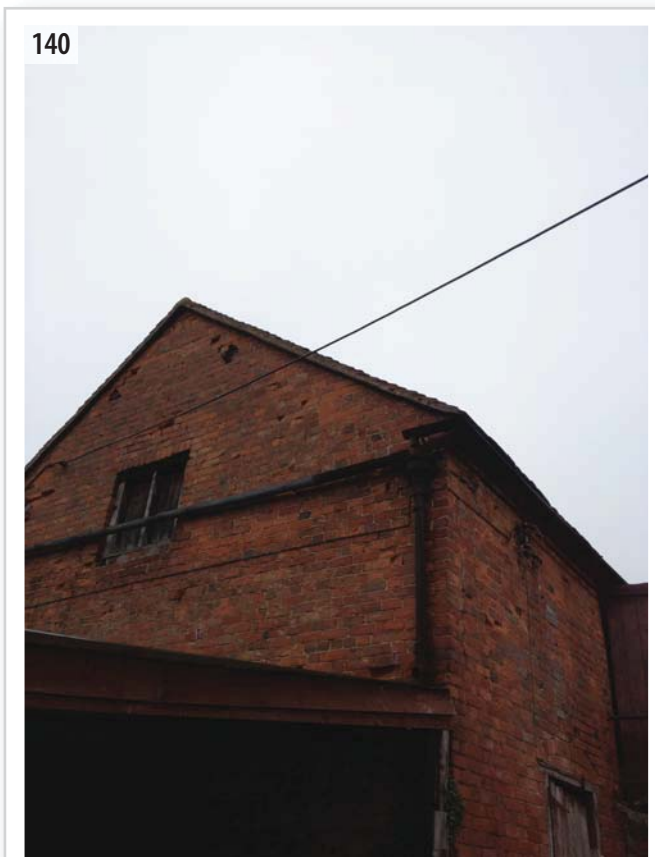
140
External view showing the gable end and change in coursing

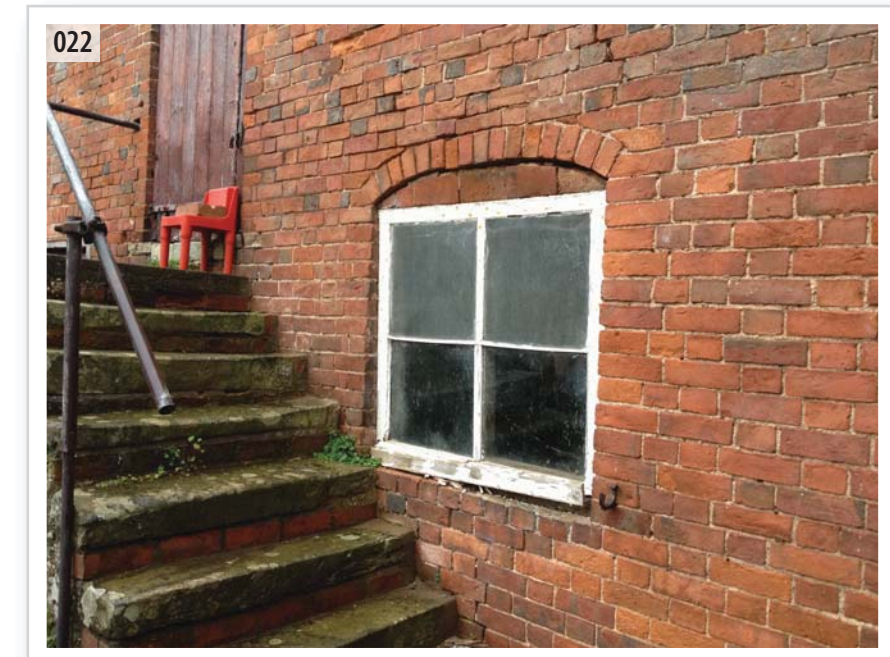
022
Arched brick lintel reflecting original lintels over inserted window, cut by later inserted staircase

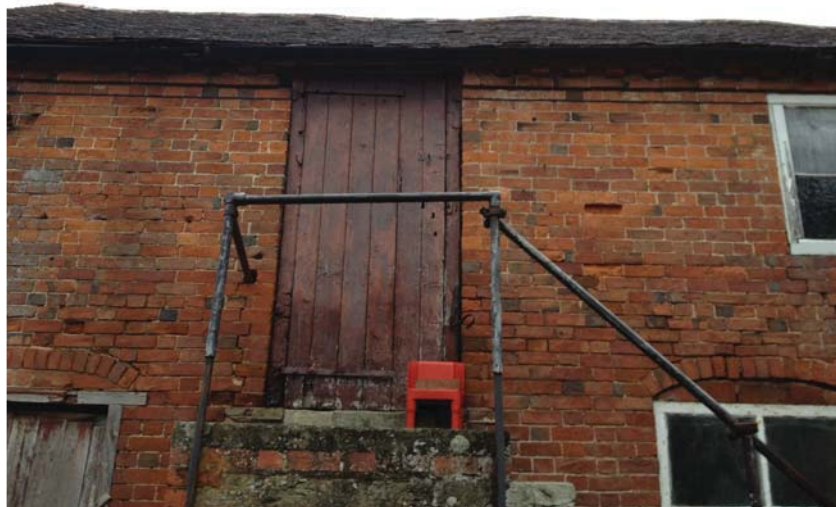
024

Doorway accessing upper level, due to the building constraints the lintel cuts the top of the wall below the roof level

Both the window and doorway are contemporary with the increase in eave height, the cutting of the corbelled dentil course was necessary to gain as much height for the doorway, subsequently the door utilises the wall plate as a lintel, and is positioned in line with the common rafters.

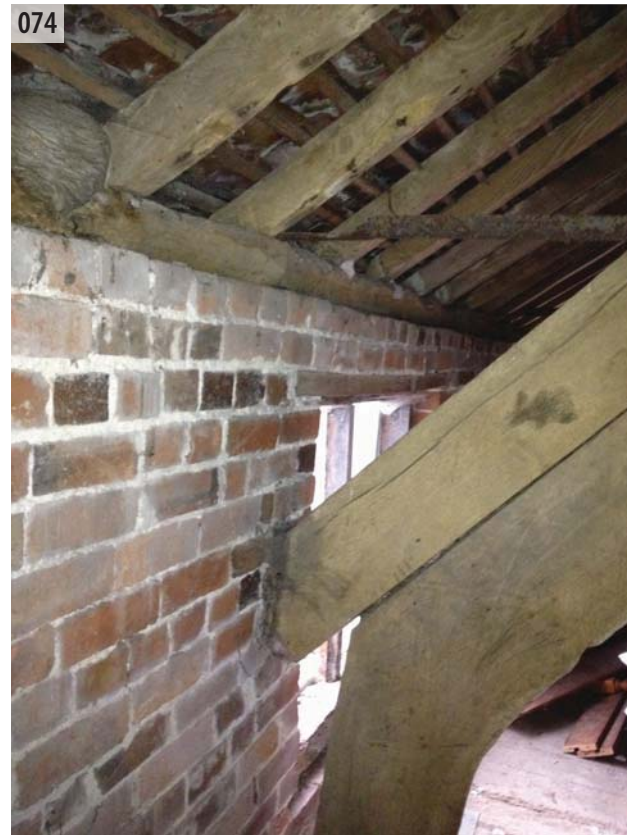
074

Internal detail showing change in roof height and rake angle

The building has been raised at the eaves by approximately 600mm resulting in a change of roof angle from approximately 45° to 35°.

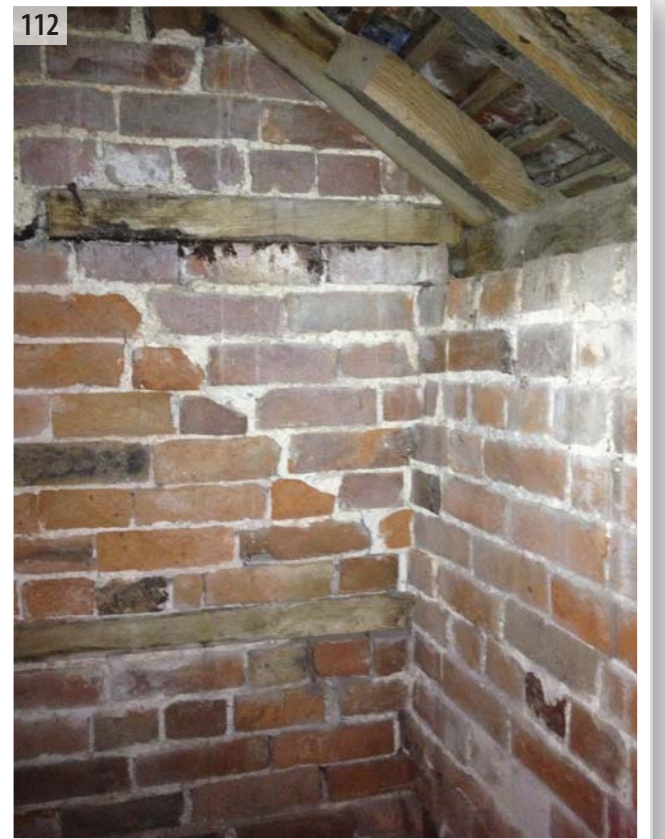
112

Internal view showing change in brick coursing required on the gable end because of the alteration to the roof angle and height

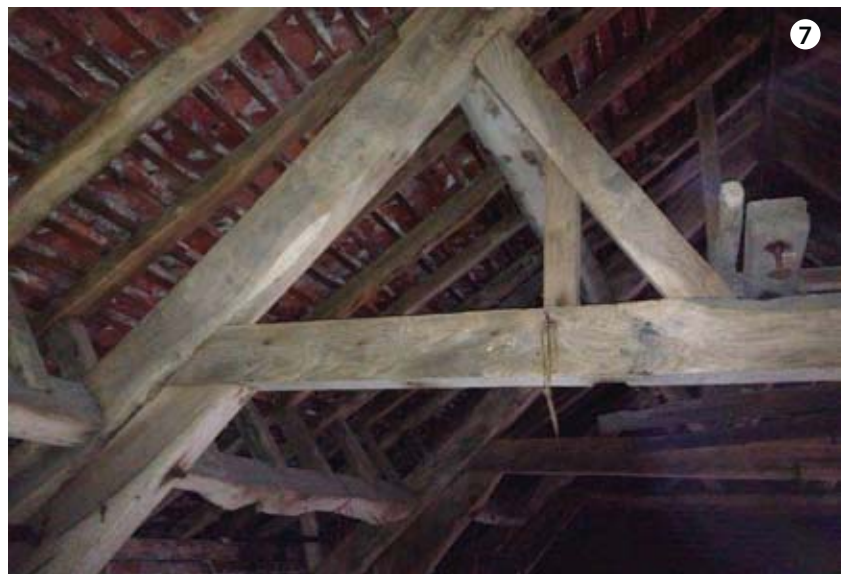
Illus 7

Internal view showing altered roof truss and ladder rack extension to the purlins

Within the first floor space, the roof trusses comprise a half-cruick design, supported on the lateral joists. The trusses have curved principles with collars supporting V-raked struts. Timber ladders have been added to the original purlins to facilitate the change in roof angle required by the raising of the eaves. The new purlins are supported by the ladders and project through the altered gable ends.

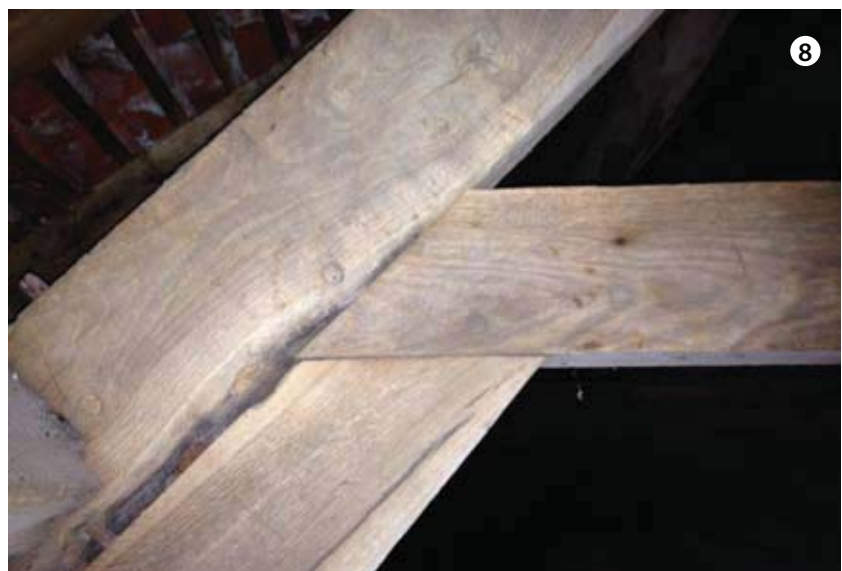
Illus 8

Internal view showing carpenters marks on main trusses

Examination of the carpenter marks on the three principle trusses suggest that they are original to the building. The carpenter's marks run consecutively, east to west, and are numbered 1 to 6.

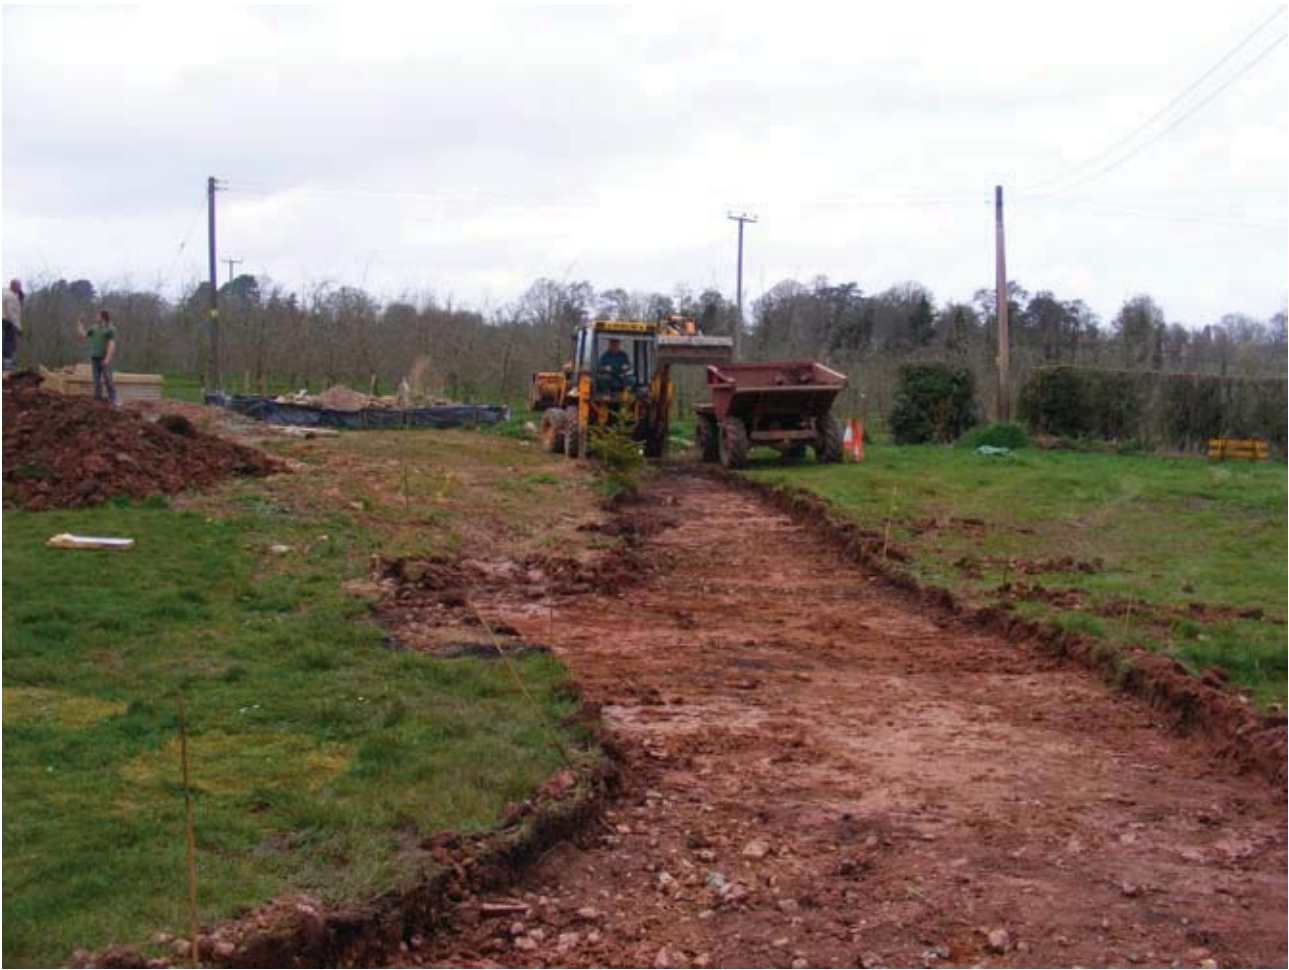
Illus 9

General view of the new road access being constructed
