# THE OLD FURNACE BUILDINGS, FURNACE FARM

## HISTORIC BUILDING RECORDING AND GROUND MONITORING

commissioned by Savills  
on behalf of Trustees of Sir RAB Mynors, Treago Settlement

September 2016

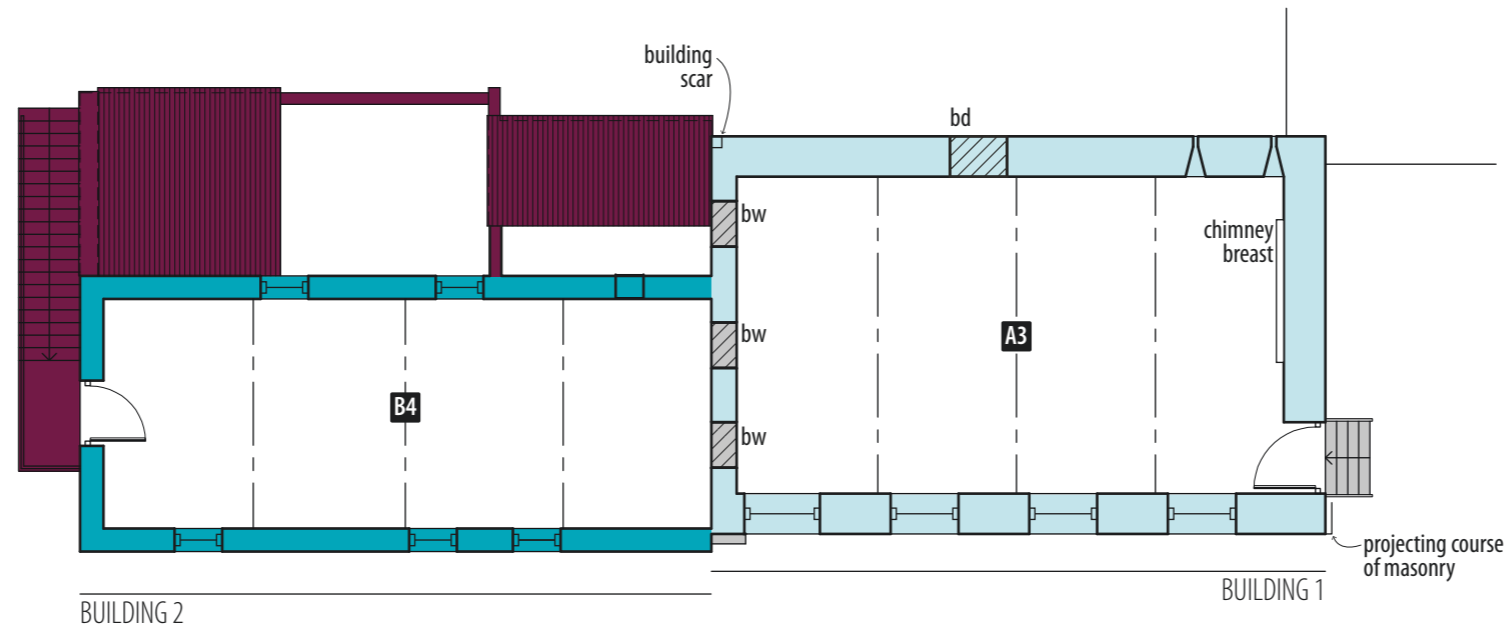
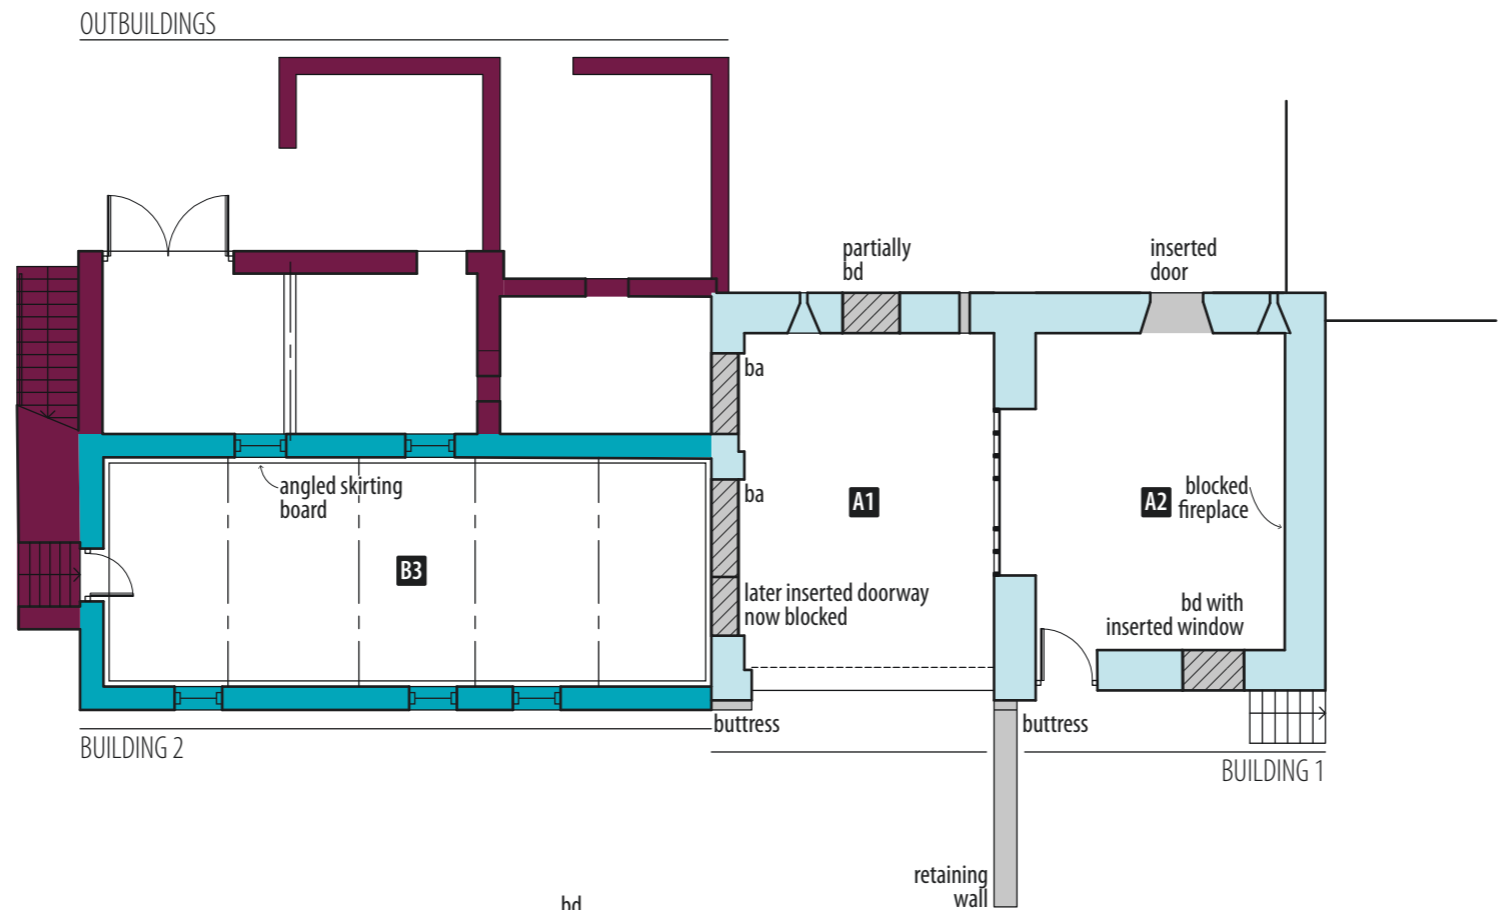
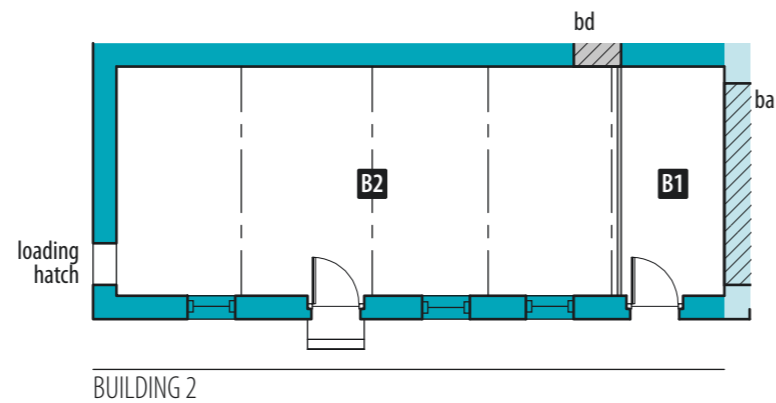
ILLUS 2 Plan showing main phases of construction

Three main phases of construction were identified (Illus 2-5), Building 1 being the earliest, with Building 2 added to its south end and later extended to the west.

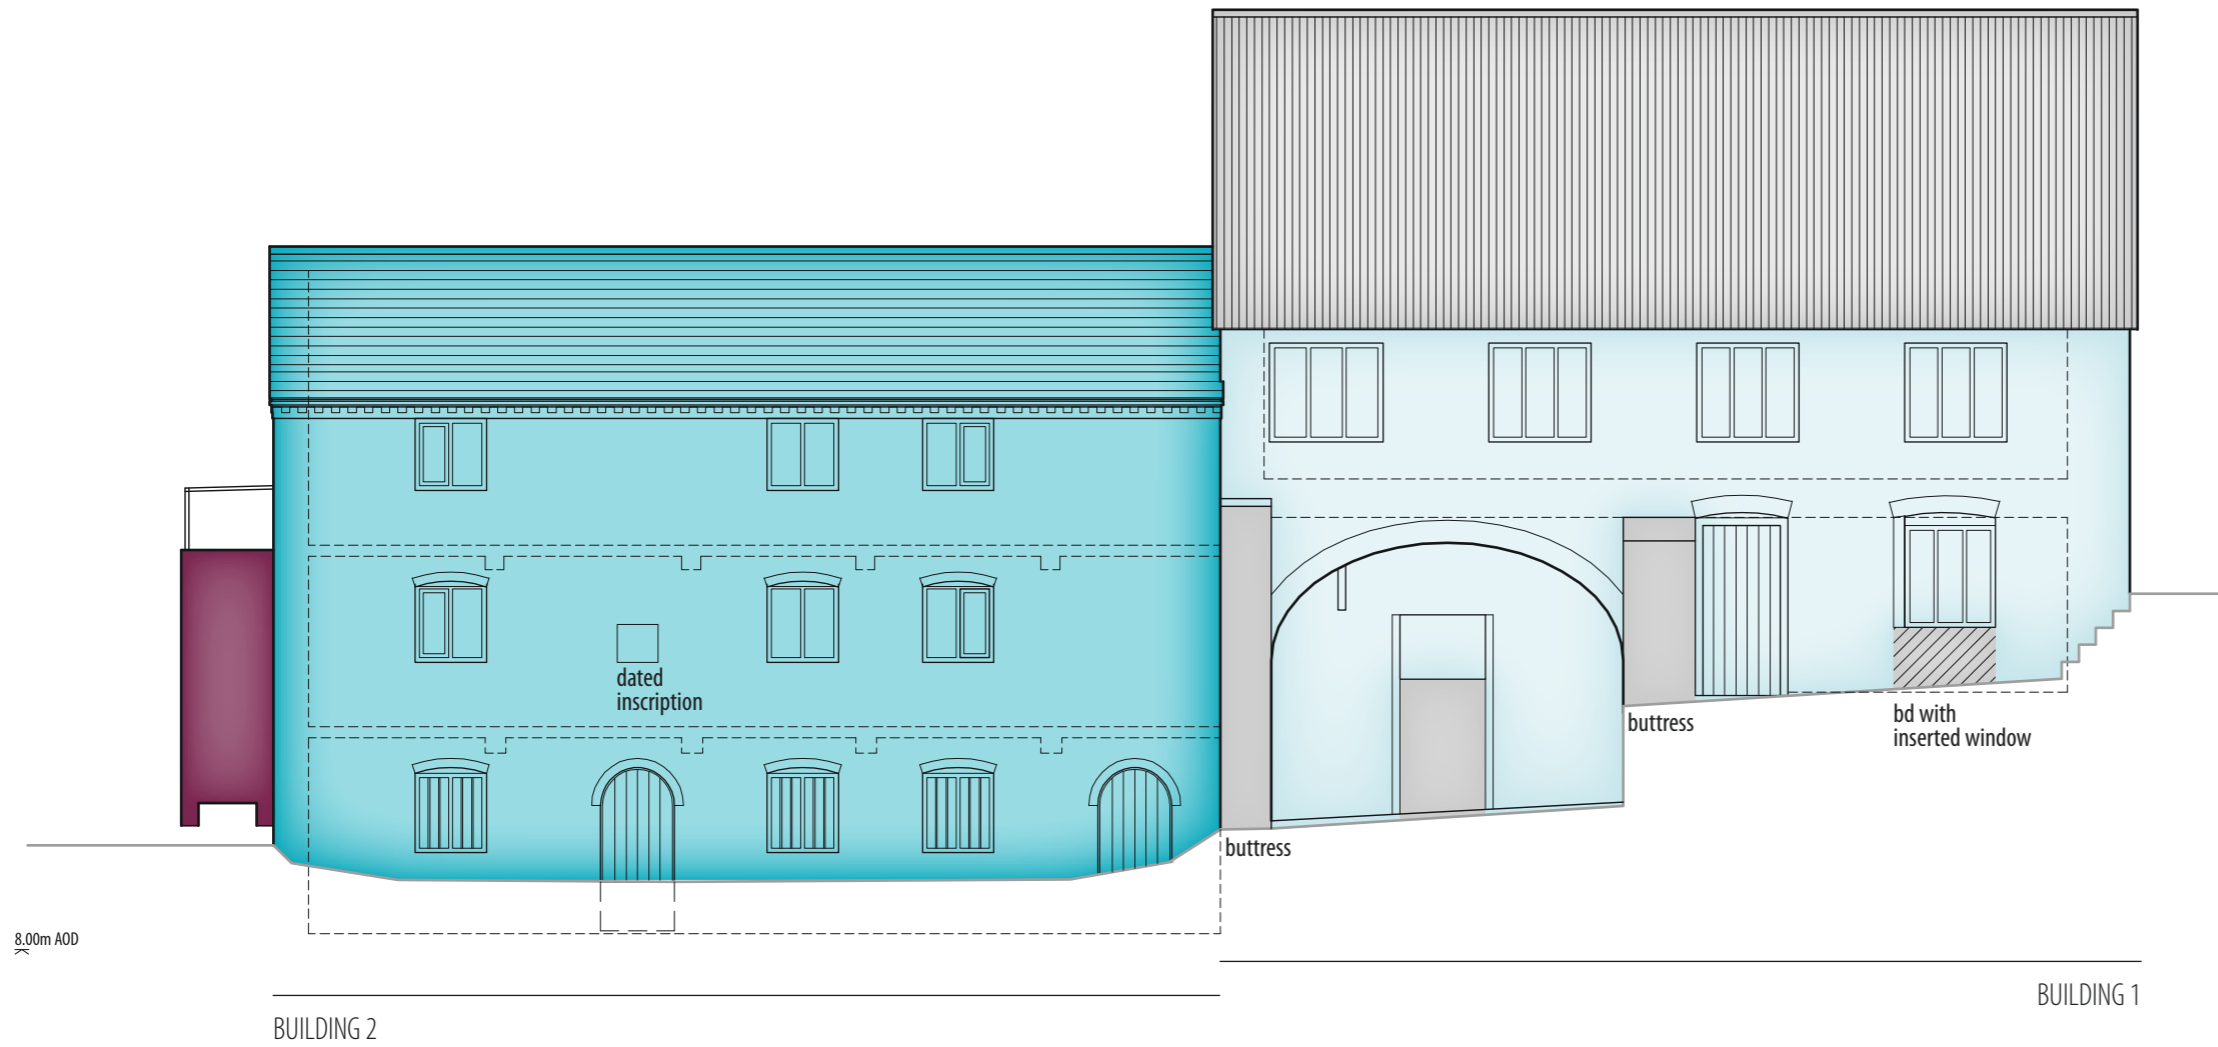
ILLUS 3 East elevation showing main phases of construction

The east elevation of Building 1 contains a large open arched entrance which allows access into the ground floor, the slope of the hillside allows this part of the building to have a double height ceiling (Illus 3). To the north of the elevation a straight cut segmental arch window and doorway provide light and access to the ground floor room, respectively.

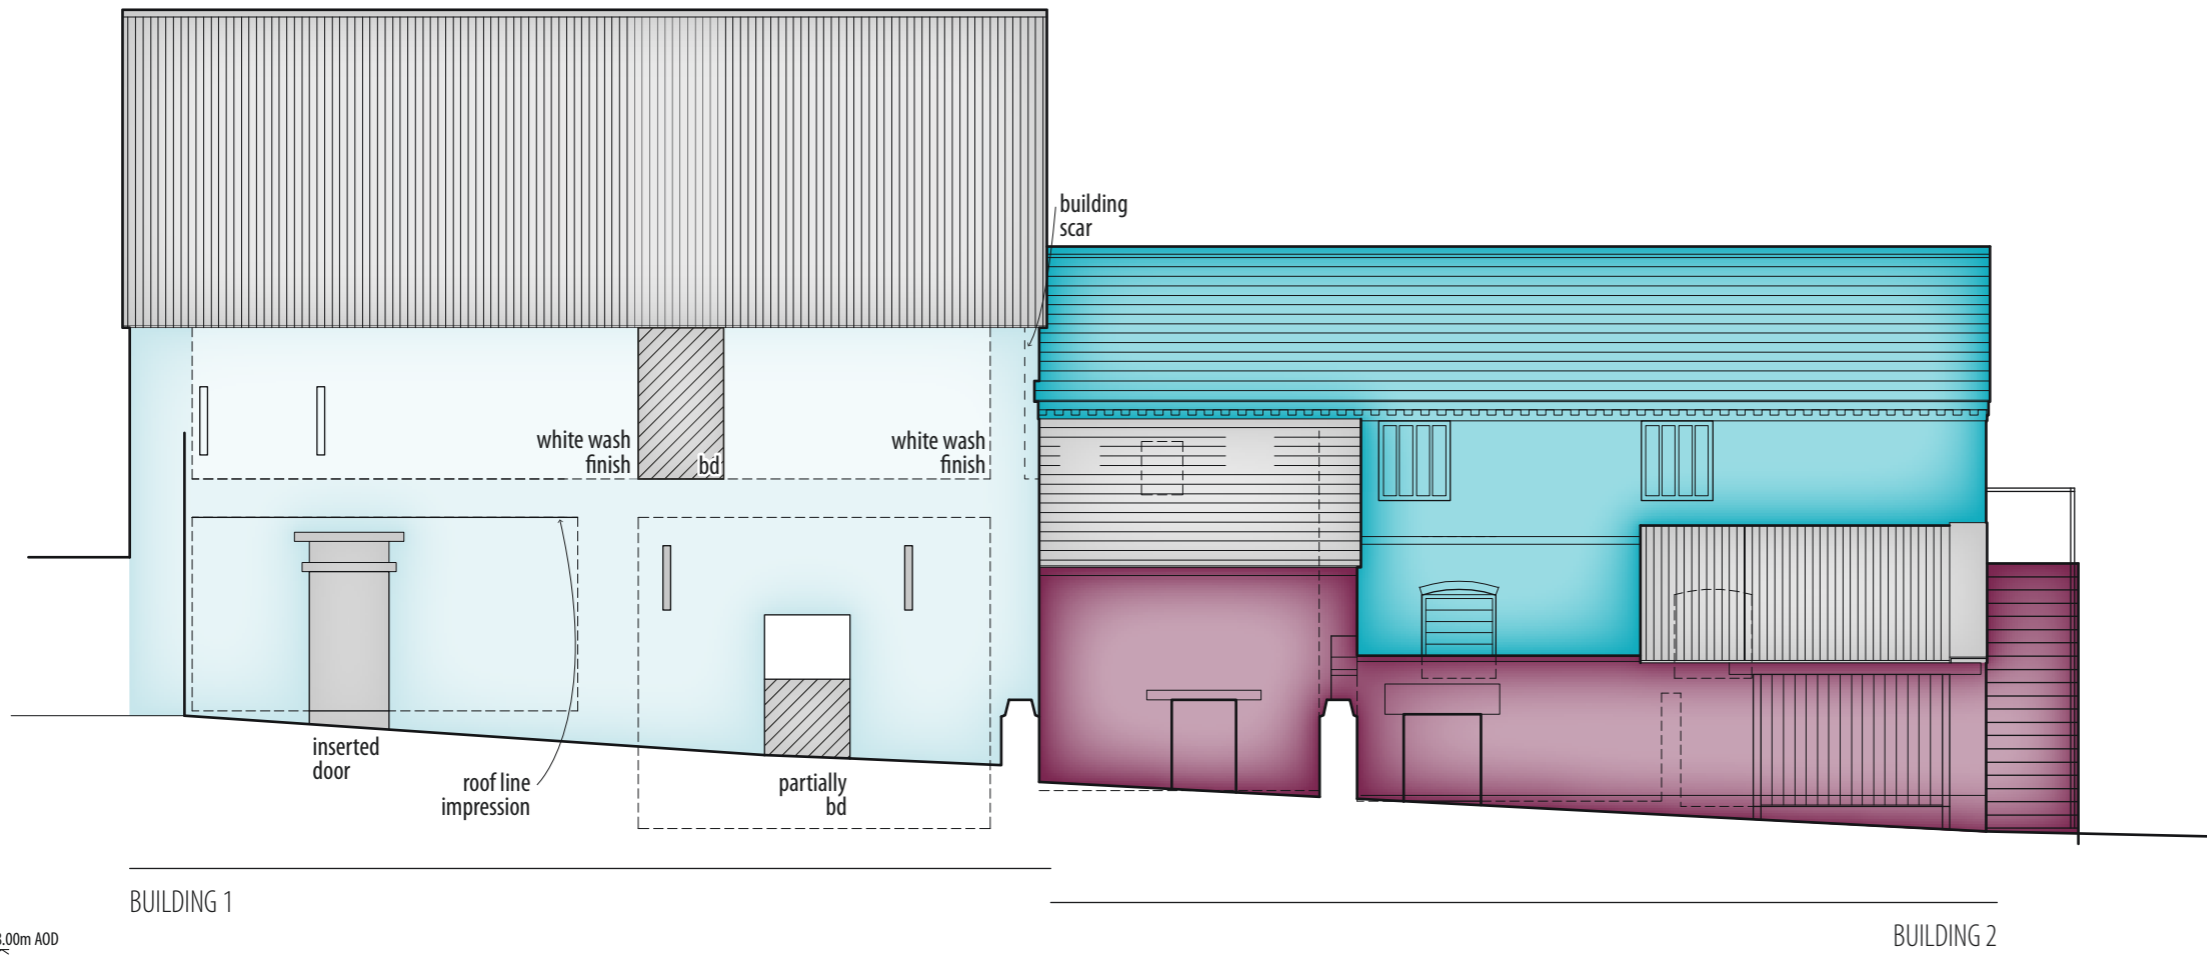
ILLUS 4 West elevation showing main phases of construction

The west elevation of Building 1 has undergone much alteration and contains some unusual features that are out of place on a possible industrial building and more akin to agricultural buildings (Illus 4).

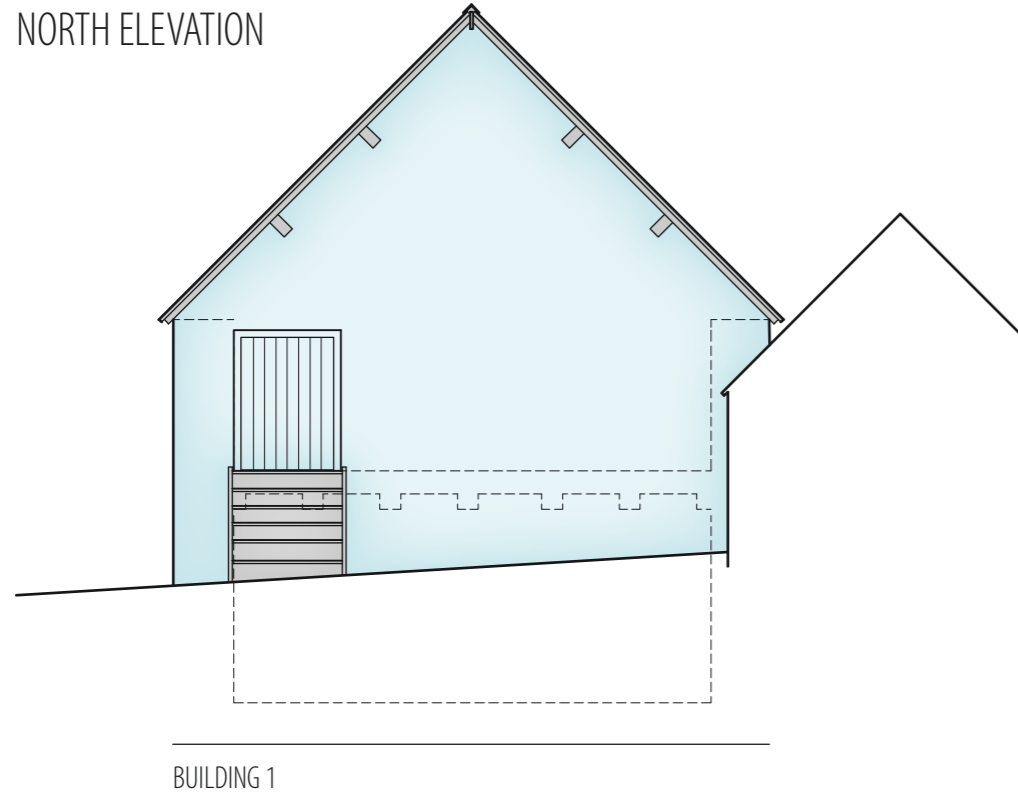
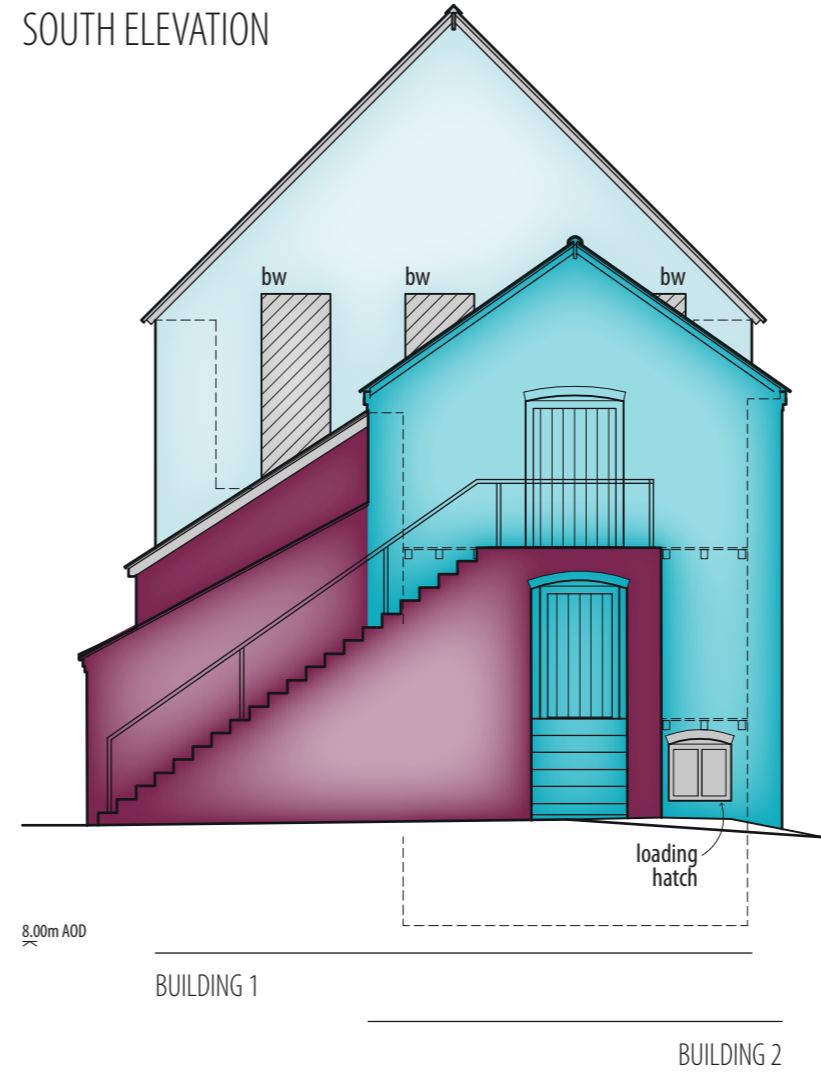
ILLUS 5 North and south elevation showing main phases of construction

Due to its positioning within the north-south slope, access to the upper floor of Building 1 was facilitated by an external wooden staircase of three flights, now in a derelict state (Illus 5).

The southern elevation of Building 1 is partly obscured by the presence of Building 2 (Illus 5); however the gable end at first floor level contains evidence of three large perpendicular window openings, two now blocked with red brick and one converted into a doorway to provide access to the upper floor of building 2 (Illus 17).

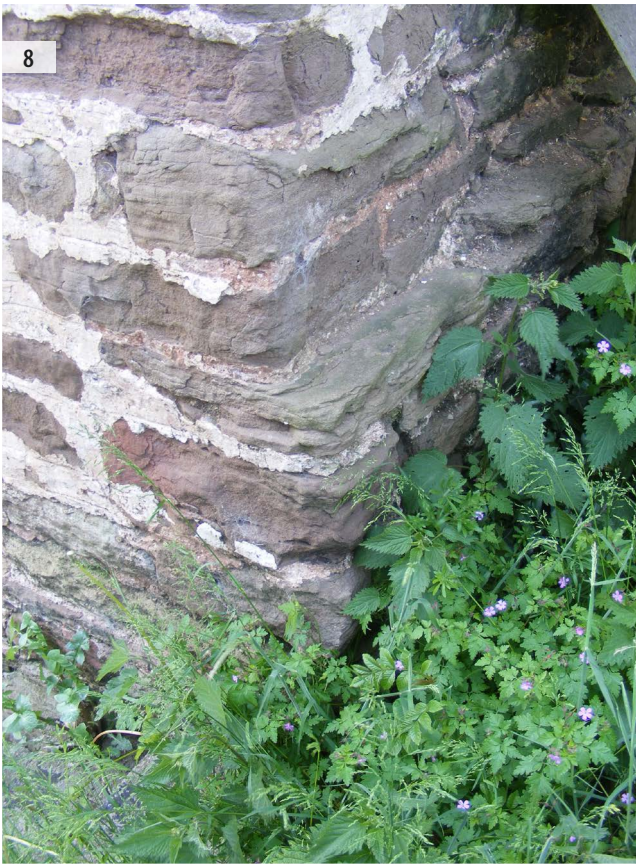
**ILLUS 7** View of original mortar (135) **ILLUS 8** Projecting masonry in the north wall of Building 1 (049) **ILLUS 9** Buttress and retaining wall, indicating the location of a possible demolished building (128)

The building is constructed in rough-hewn sand stone blocks of various dimensions and shapes, with an attempt to follow a levelled coursing albeit highly dependent on stone dimensions and shapes. Various stages of re-pointing have been undertaken, resulting in the external finish of the building being flush pointed with a mixture of cut back or weather joints. The style and abundance of flush pointing gives the building an impression of having an external render or white wash finish in places. The original mortar is red/pink colour, granular in appearance, containing inclusions of very small and small white flecks (0.01–0.04mm), where the mortar has been exposed to the elements it is relatively soft and crumbly (Illus 7).

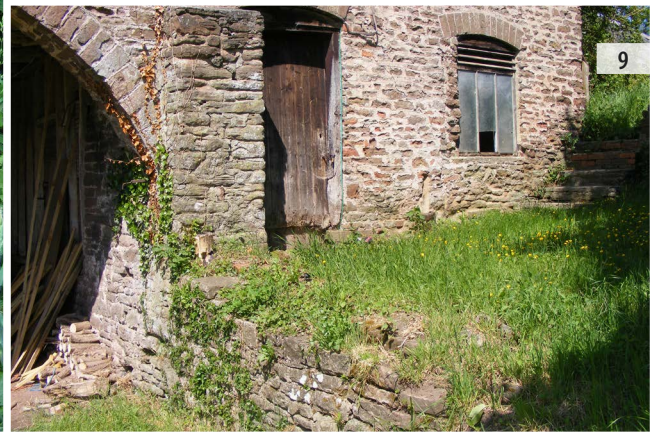
The main arch and doorway are divided at ground level by the construction of a buttress rising to the height of the segmental arch of the doorway. The buttress is located on the line of a stone built retaining wall that runs east from Building 1 (Illus 9).

A second buttress has also been constructed to support the southern half of the springer for the main ground floor arch. Combined with the projecting alignment in front of Building 1 with the eastern façade of Building 2 (see illus 2), it is probable that the buttresses were constructed to replace a now demolished building that projected eastward from Building 1. The existing low-level wall retaining wall may in fact be the surviving remains of the northern wall of a now demolished building.

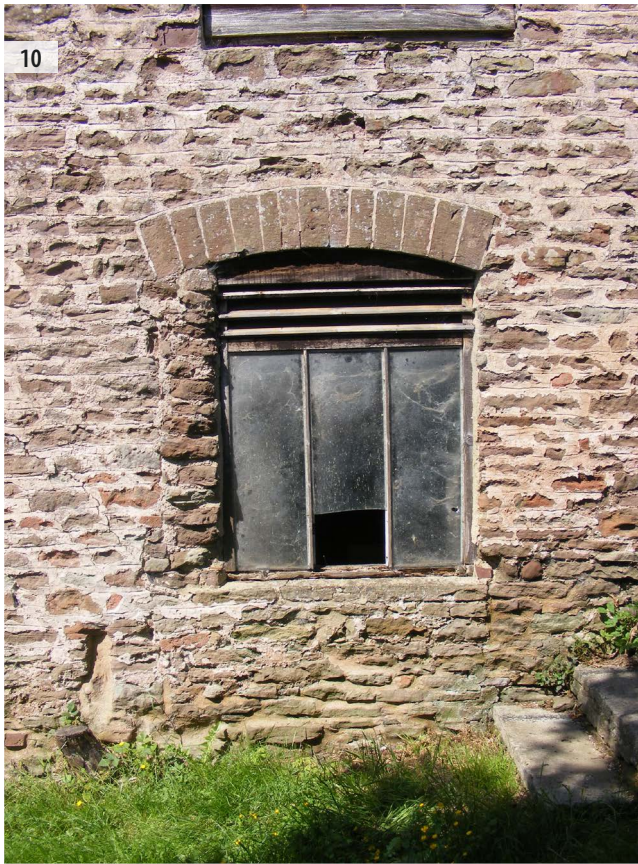
**ILLUS 10** Later inserted window within an original doorway in Building 1 (124)

replacing what was originally a second doorway to the north of the existing doorway (Illus 10). The height of the doors suggests this area was used as stabling and a series of later internal divisions confirm that this area was once used to house animals. However, a blocked fire place within the internal area A2 (Illus 2 and 11) indicates that this space was not originally intended to be used for this purpose.

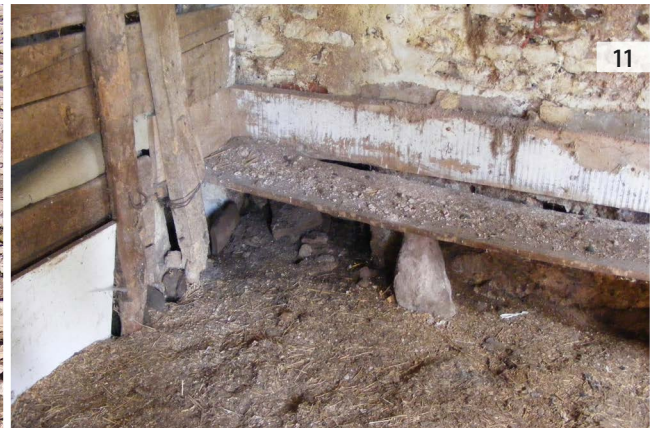
**ILLUS 11** Blocked fire place within the north wall of A2, Building 1 (052)

Within the northern elevation and hidden behind panelling for the stabling, a blocked fireplace is visible only at ground level where the blocking stones have collapsed. The construction of the chimney stack is unusual in the sense that the chimney stack is constructed within the thickness of the lower wall cavity, hence the chimney stack is only visible protruding from the thickness of the wall in the room directly above as the overall wall thickness of the building reduces with height.

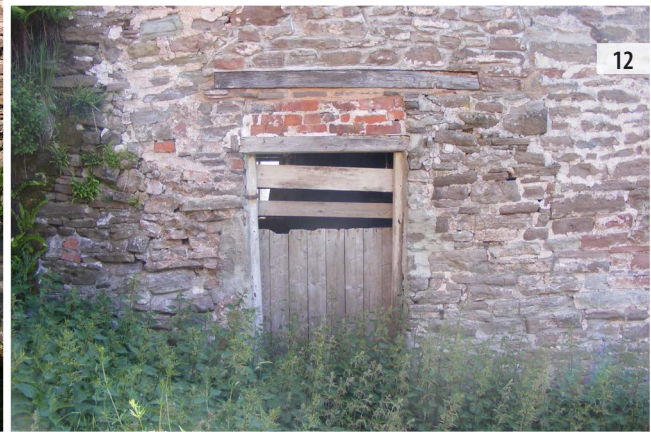
**ILLUS 12** Later inserted doorway Building 1 (109)

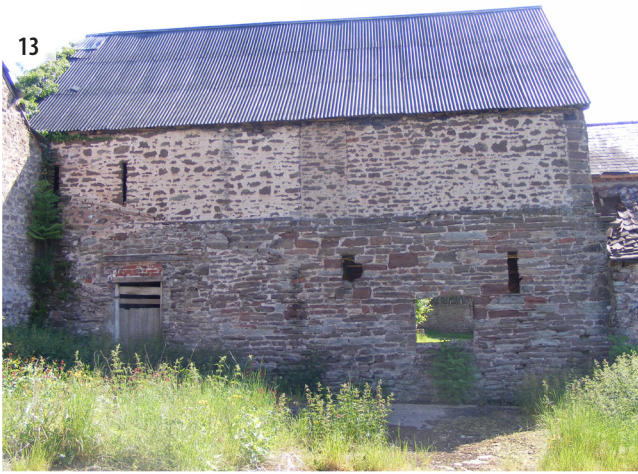
Located within the southern half of the lower elevation a rectangular opening reveals the location of full height single width doorway that once provided access to the lower ground floor room, the doorway has been blocked with similar stone to the fabric of the building (Illus 13).

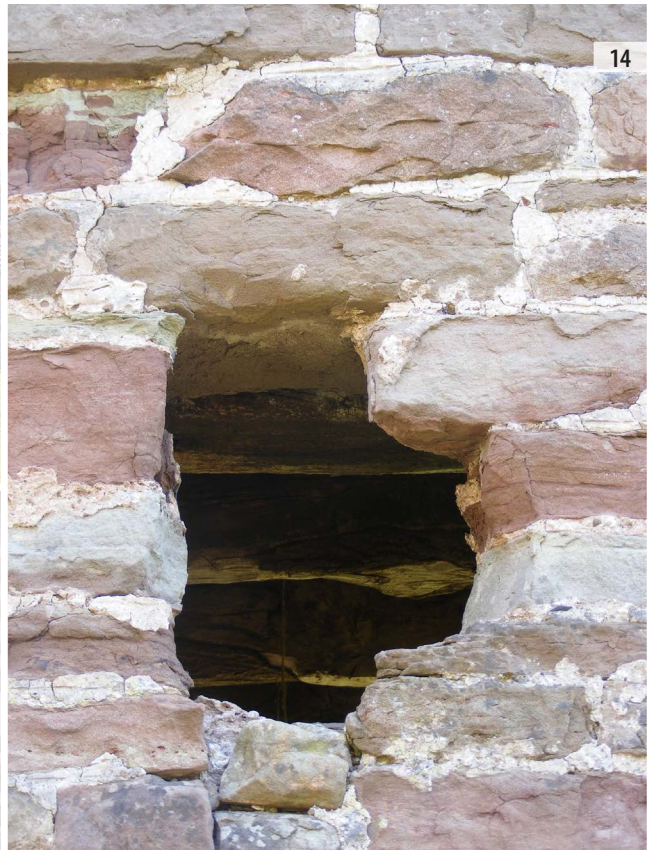
Flanking the blocked doorway are two lancet windows, the south one with has an internal splay unlike the northern one which is straight cut and has been partially blocked with stone and at some time widened, perhaps to accommodate a drive belt for some powered farm machinery (Illus 14).

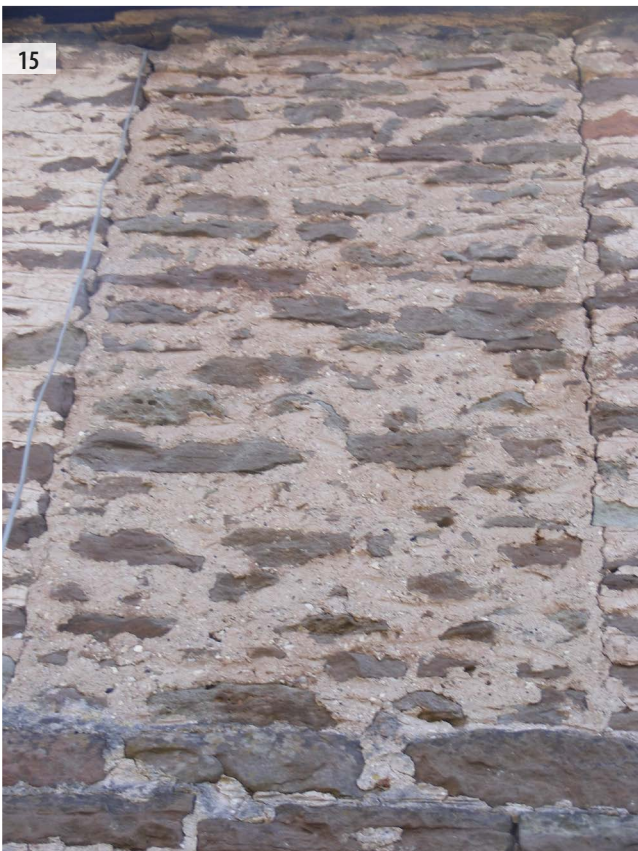
building, the doorway is a later insertion and possibly reflects a period of expansion and adaption to the original building (Illus 15).

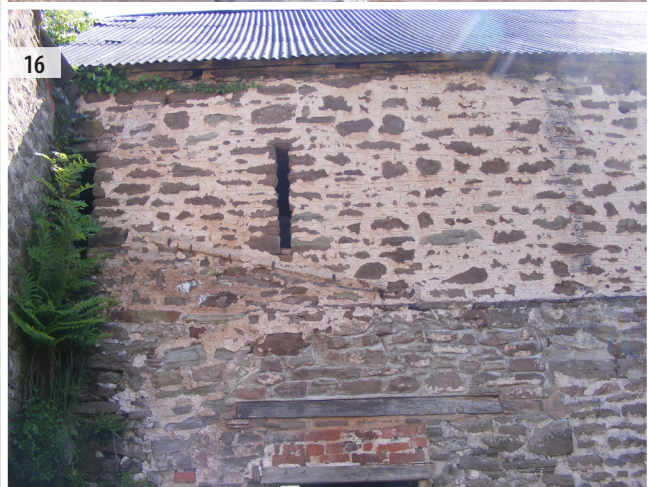
The external finish of the west elevation at the level of the first floor has been subject to half struck flush pointing and a coating of white wash which may suggests that the removed building was not purely agricultural. Sometime after the removal of the west building a later lean-to structure was constructed against the west elevation, evidence of which is visible in a diagonal mortar scar running across the elevation at the northern edge (Illus 16).

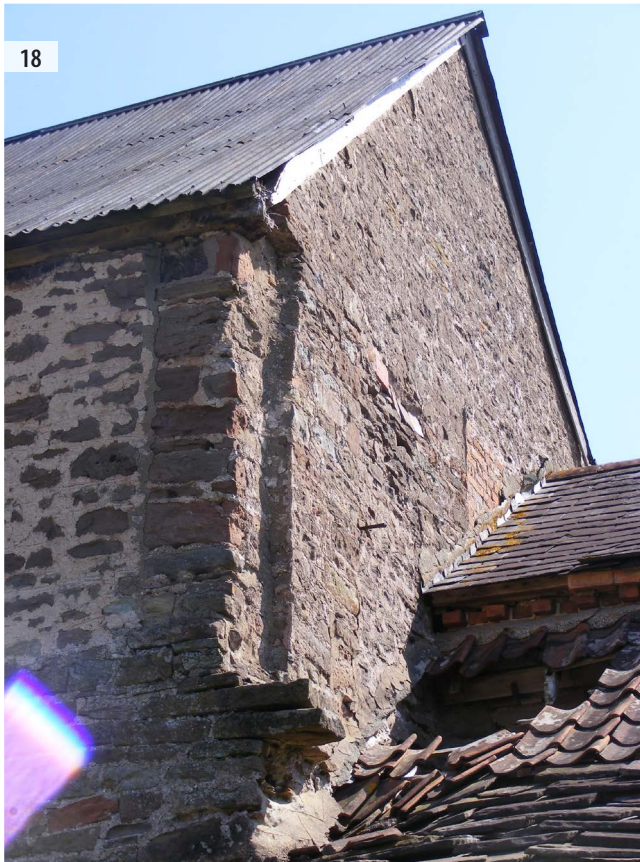
Located at the first floor level on the west side of Building 1, a vertical cut recess and small portion of projecting stone work possibly indicates the point where a now demolished building once butted up to Building 1 (Illus 18).

**ILLUS 18** Cut back recess, southern facing elevation, Building 1(101)

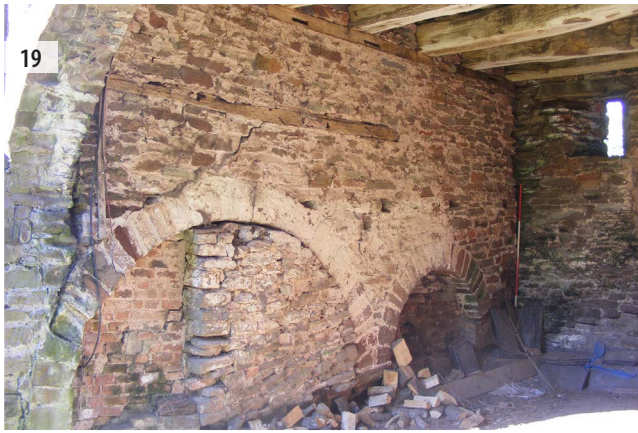
**ILLUS 19** Arched openings, Building 1, A1 and later blocking (008)

The southern internal elevation of this space poses questions for the identification and assessment of the building's function. Currently two blocked arches of different dimensions dominate the southern elevation. Both openings are blocked in a mixture of stone and brick. The eastern and larger of the two has two phases of blocking, the later brick blocking indicating that a doorway once allowed access to Building 2 (Illus 19).

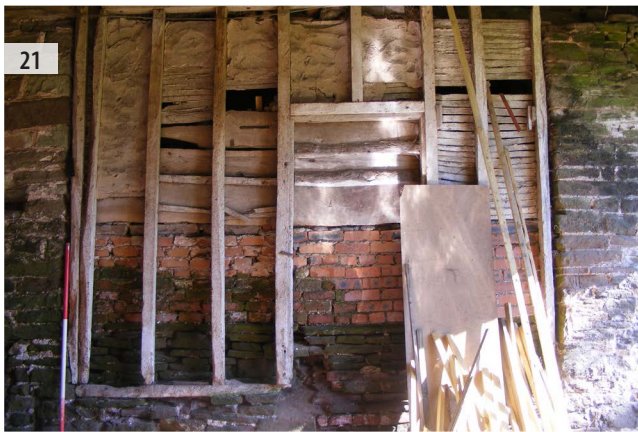
**ILLUS 20** Large rectangular opening between A1 and A2, Building 1 (010)

The smaller arch is completely blocked in stone, the stone blocking of the smaller arch being set back from the face of the wall. Above the larger arched opening a long wooden spreading or levelling lintel has been inserted, possibly to constrain some cracking and movement of the wall. The whole of the southern gable wall of Building 2 has pulled away from the fabric of the west wall, the tying of the two walls being non-existent and generally not reflecting the attention to detail seen in the overall construction of the building (Illus 20).

The most unusual feature of A2 is the large rectangular floor-to-ceiling aperture within the south elevation (Illus 20). The opening would have provided a large through passage into room A1, the difference between floor levels forming a raised loading platform within room A1. The opening has been blocked with a mixture of wood, brick and then plastered over, perhaps at the time room A2 was adapted for the use of stabling.

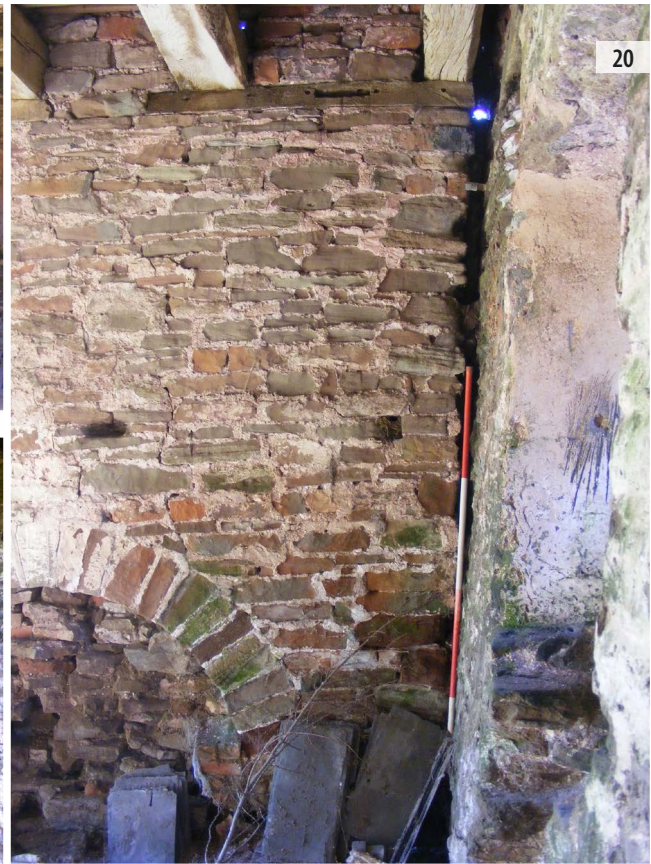
**ILLUS 21** Smaller arch, Building 1, A1 and poor bonding of southern gable wall (009)

The north elevation contains a large rectangular opening at waist height, now blocked with a mixture of wood, stone and red brick, which would have, when open provided a loading bay within A1 with access to the upper ground floor (A2) (Illus 21).

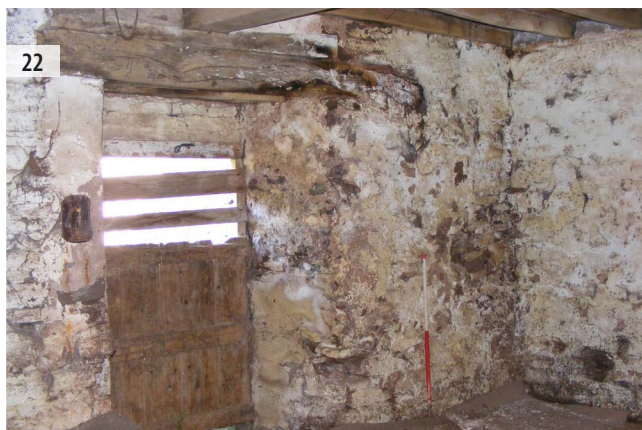
Within the west elevation a doorway provides external access to the west of the building, the doorway is a later addition, this is emphasised through the use of a substantial reused wooden lintel, the use of which was necessary to support the floor joists of room A3 above, which were truncated by insertion of the doorway (Illus 22).

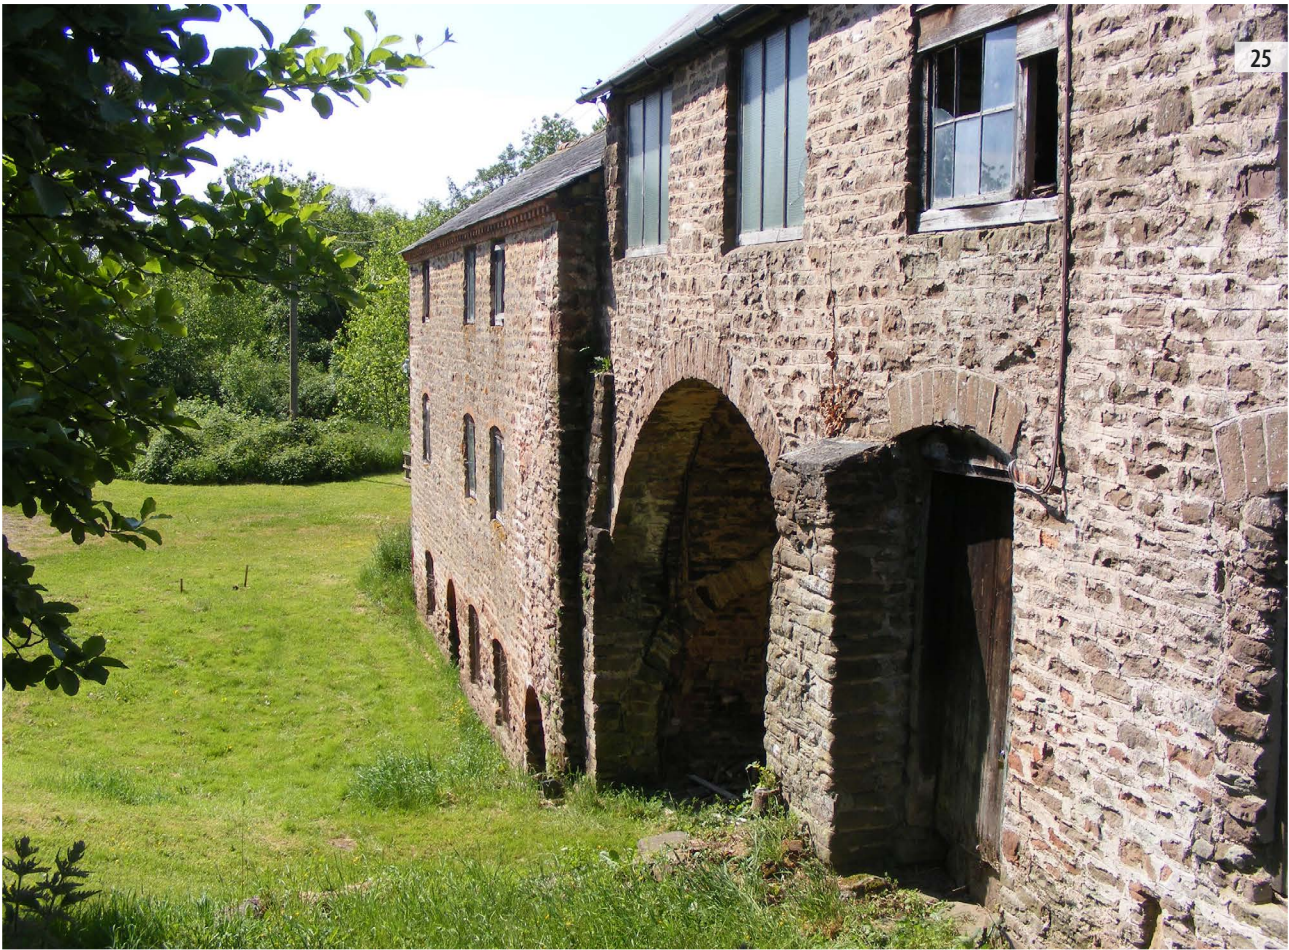
Building 2 comprises a large narrow rectangular structure of three storeys, built to the south of Building 1 and utilising its southern gable wall. The building is narrower than the footprint of Building 1 and the building line projects slightly forward of Building 1 on the eastern face (Illus 25).

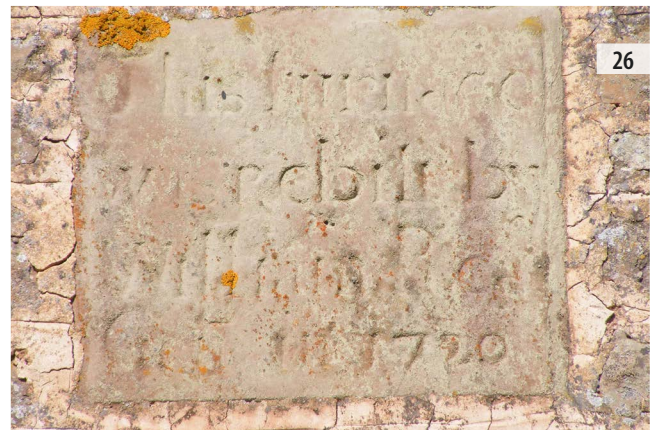
**ILLUS 25** Projecting building line of Building 2 in relation to Building 1 (121) **ILLUS 26** Carved inscription, Building 2 (016)

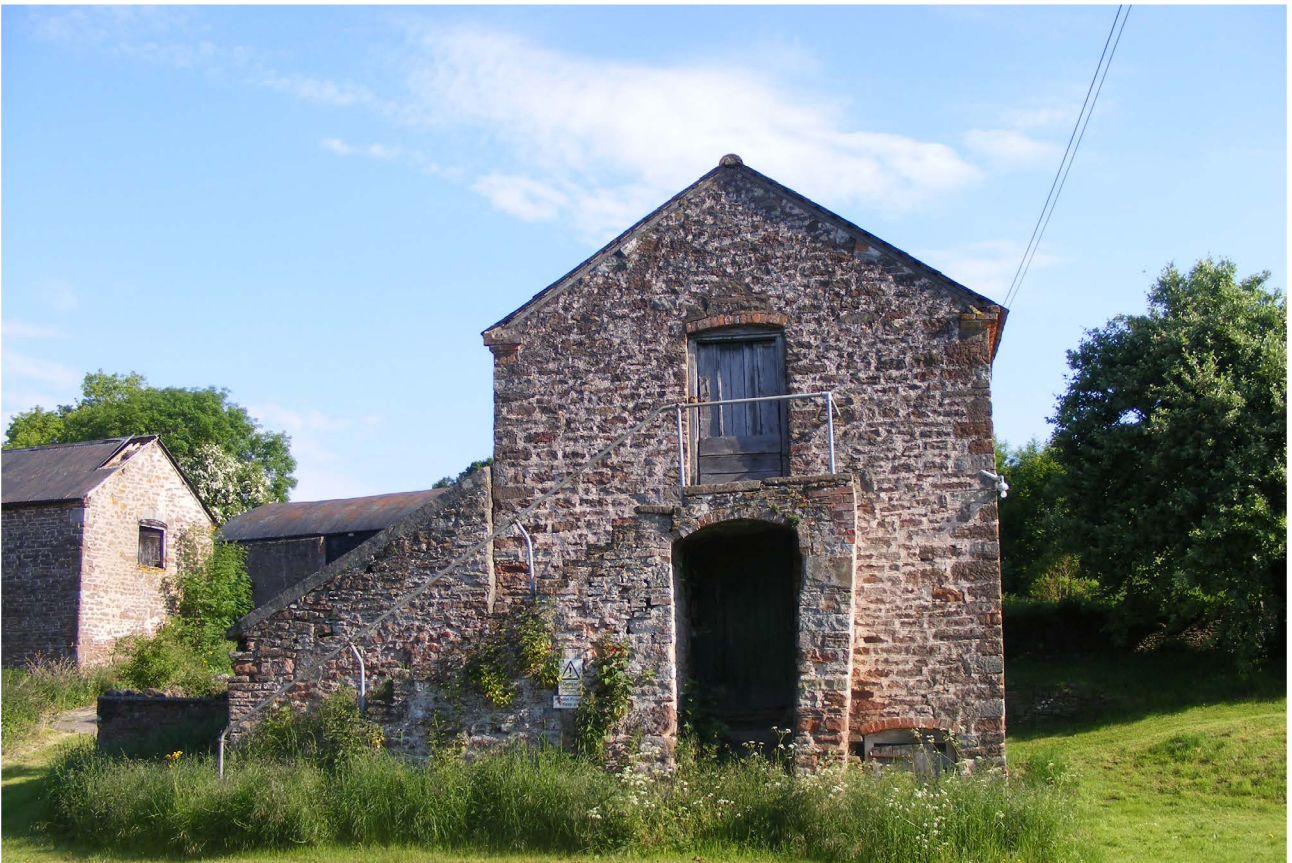
ILLUS 28 South facing elevation, Building 2 (003)

The southern gable elevation of the building (Illus 5 and 28) is partially obscured by an external stair case. The elevation contains two doorways with brick segmental arched heads, similar to the eastern elevation, providing access to the first and second floors. A

small loading hatch is provided to supply the ground floor, this too benefits from a segmental arch formed from red brick. Although the construction of the doorways is similar to that of the east elevation the overall appearance of the brick detailing is somewhat lacking in finesse when compared to the eastern elevation brick details and may reflect a later phase of works possible associated with the construction of the external staircase.

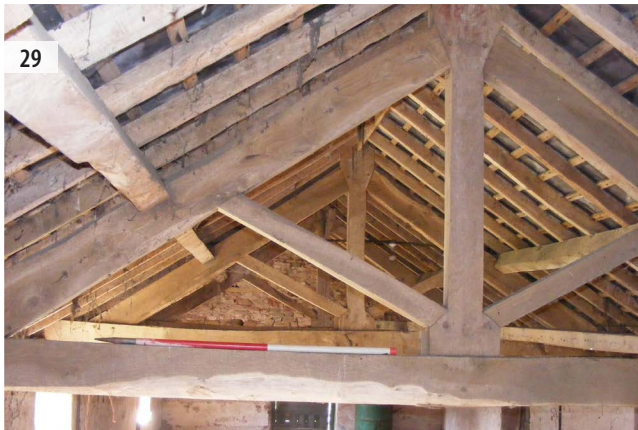
**ILLUS 29** Internal roof details, Building 2 (034)    **ILLUS 30** Blocked doorway and inserted wall, Building 2, A1 (023)  
**ILLUS 31** Interior of room B2 showing strap roller    **ILLUS 32** Angled and sealed skirting boards, Building 2, A4 (038)
