HEREFORD COUNTY HOSPITAL

Archaeological Watching Brief for Electric Cable Installation

commissioned by Western Power Distribution

November 2013

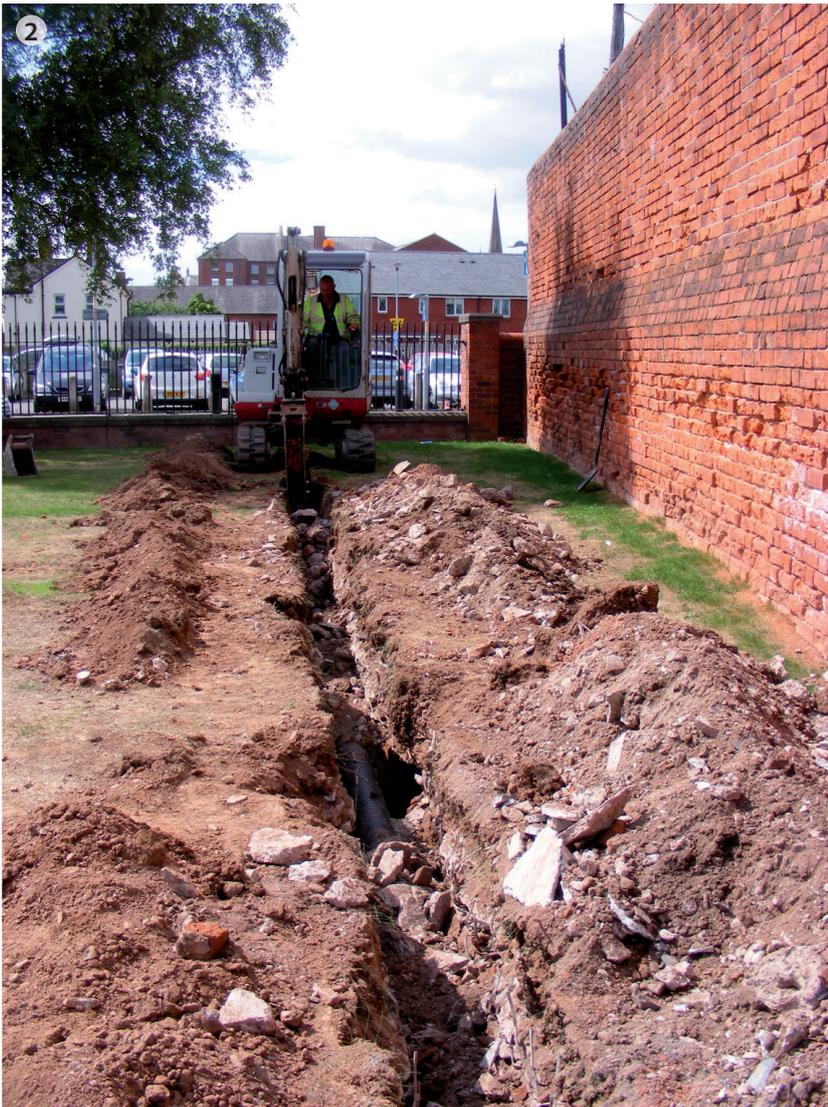
Illus 2

The watching brief was concluded in a single day (20th August 2013) with one trench orientated north east–south west being excavated by a JCB excavator. The trench was 20m long, 0.4m wide and 0.65m deep. It ran parallel to a modern upstanding red-brick wall (**Illus 2**).

Working shot

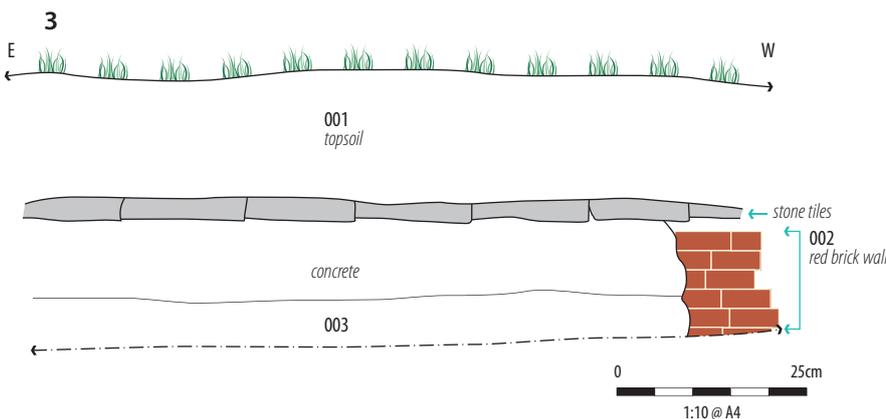
Illus 3

N facing sample section

The grassed topsoil layer [001] measured 0.18m in depth and overlay the remains of a modern building consisting of a concrete surface with red-brick walls underneath. Metal pipes were visible beneath the concrete surface and are likely to relate to the building's central heating system. The building was present throughout the whole length of the trench and extended beyond the 0.65m depth required for the cable.

Only at the south western end of the excavated trench another deposit, Context [003], was present and consisted of very dark brown loamy sand with occasional small stone inclusions. The building remains [002] truncated this deposit suggesting it may represent an older ground surface either contemporary or pre-dating the use of building [002] (Illus 3).
