KILPECK CASTLE, KILPECK

Archaeological Excavation

November 2013

HA Job no.: KCKH/03

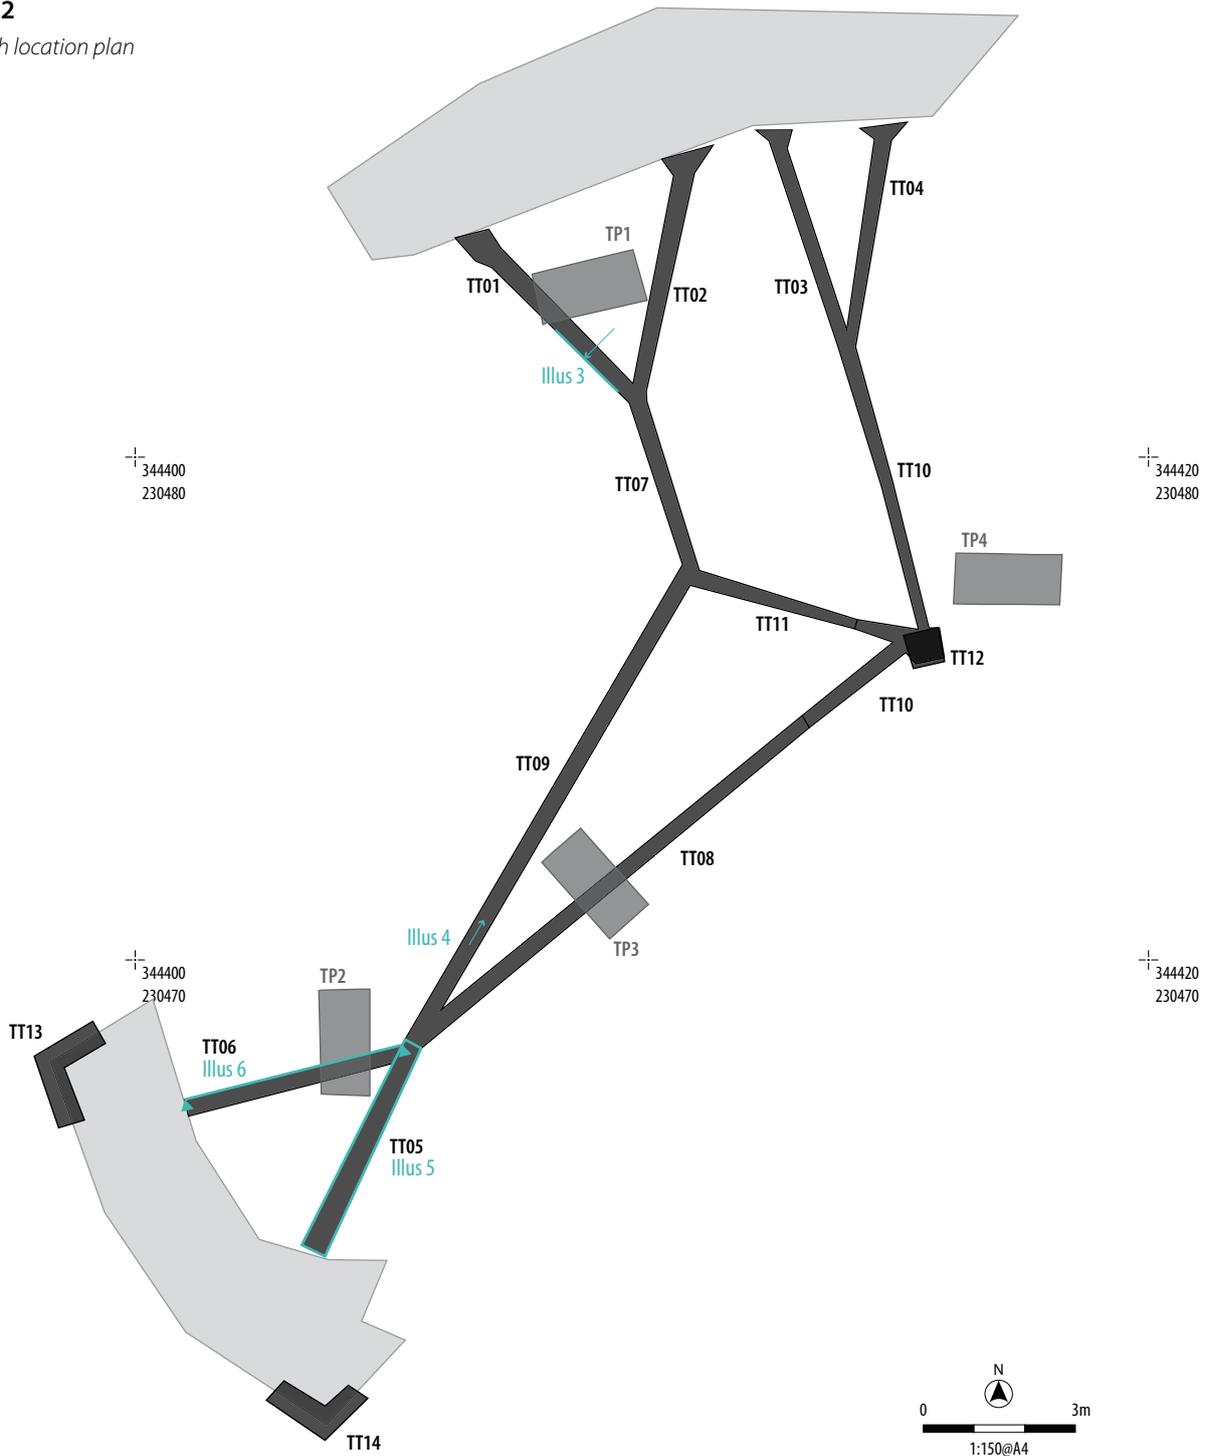
Illus 2

Trench location plan

To enable the installation of the horizontal tie rods a series of twelve interconnecting 0.30m deep by 0.30m wide trenches, of varying lengths, were excavated by hand by suitably qualified archaeologists. All trench positions were marked out by the structural engineer prior to the commencement of excavation (**Illus 2**).

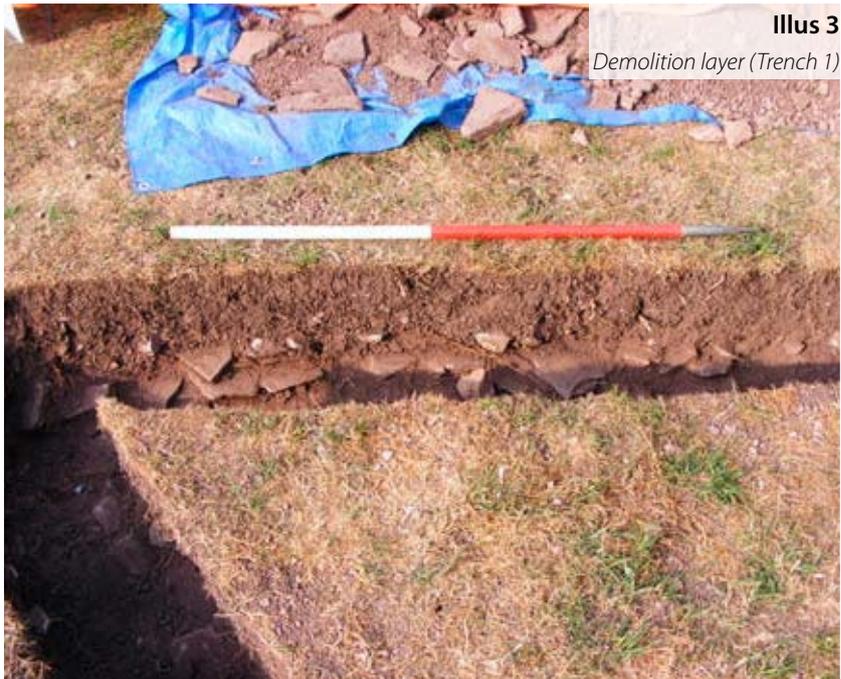
Illus 3
Demolition layer (Trench 1)

Beneath the topsoil, was a rubble deposit [1001/4/5, 2001, 3001] etc., which contained angular sandstone fragments, roof tile, pottery and mortar pieces (Illus 3).

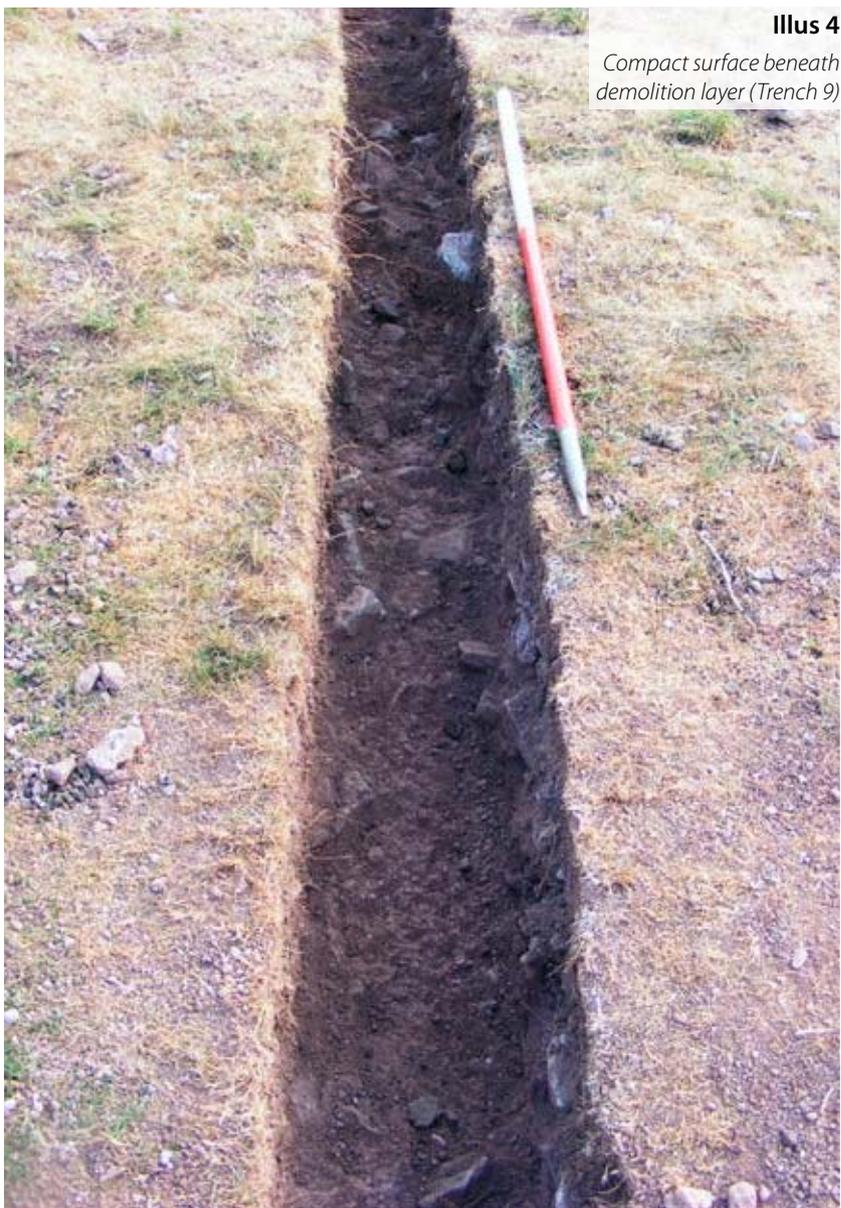
Illus 4
Compact surface beneath demolition layer (Trench 9)

site within Trenches 1–12. The deposit contained charcoal flecks throughout, medieval pottery and occasional stone fragments with mortar attached. Due to the limited excavation depth only the upper surface of this deposit was observed (Illus 4).

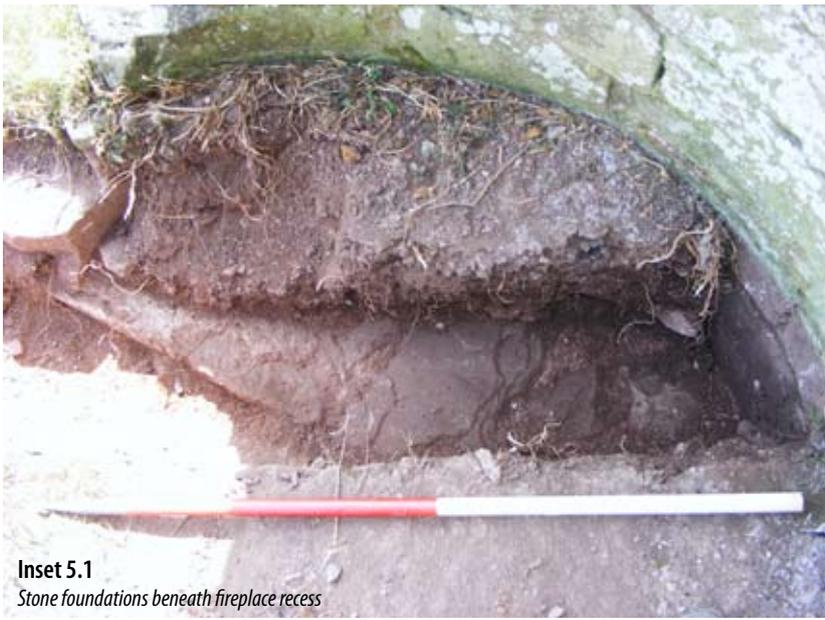
Inset 5.1
Stone foundations beneath fireplace recess

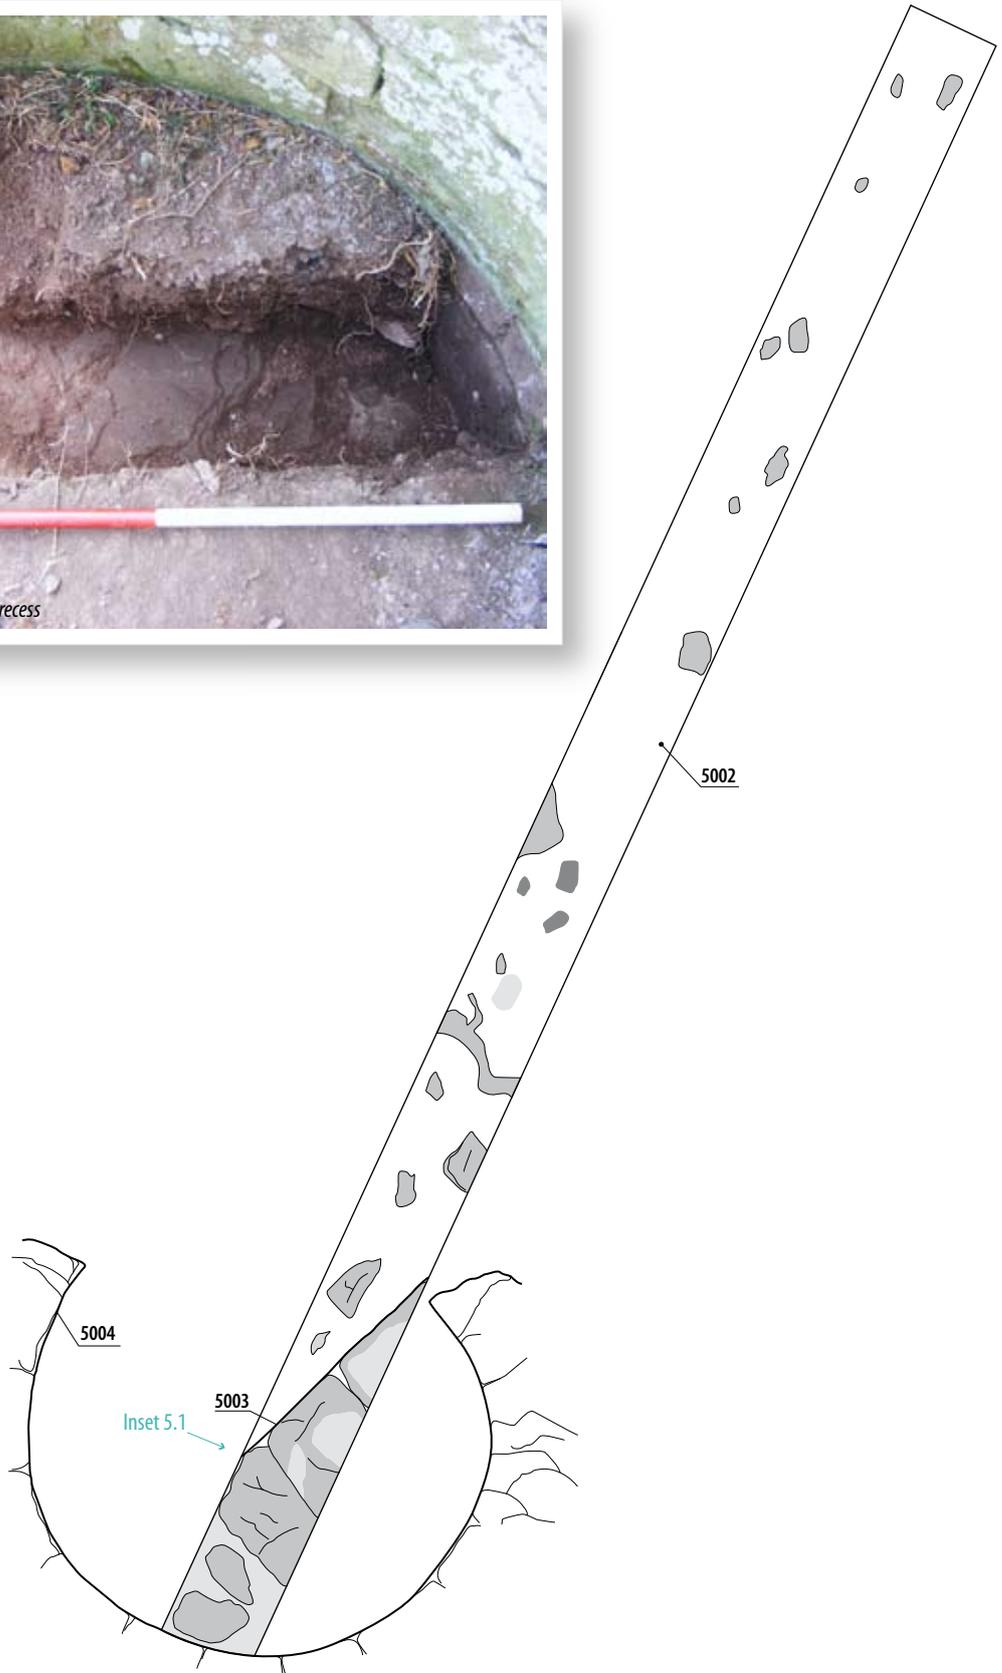
Illus 5

Trench 5, plan

Within Trench 5 the remains of a stone and mortar structure [5003] were encountered at a depth of 0.42m below ground level (Illus 5). Context [5003] consisted of a flat mortared stone structure with a smooth faced northern edge. Structure [5003] was located within the recessed round backed hearth in the south-western shell keep wall fragment, orientated approximately east-west. The depth of [5003] could not be determined as it continued below the level of excavation.

Feature [5003] may relate to an in-filled cellar. From what was observed within Trench 5, feature [5003] does not extend completely across the width of the recessed fireplace and is orientated on a different alignment to the shell keep wall above. There is no evidence to indicate that [5003] once continued above ground level. Feature [5003] terminates at a smooth edge on its northern face and extends below the depth of excavation.

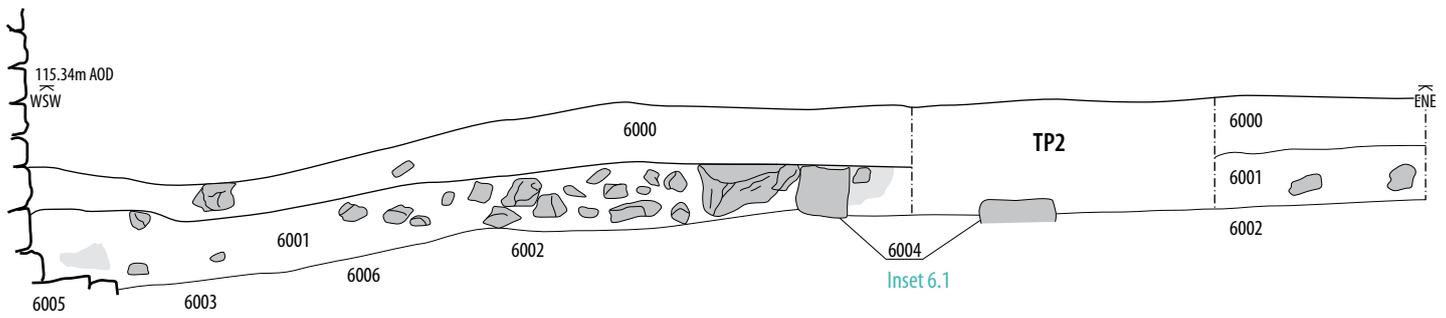
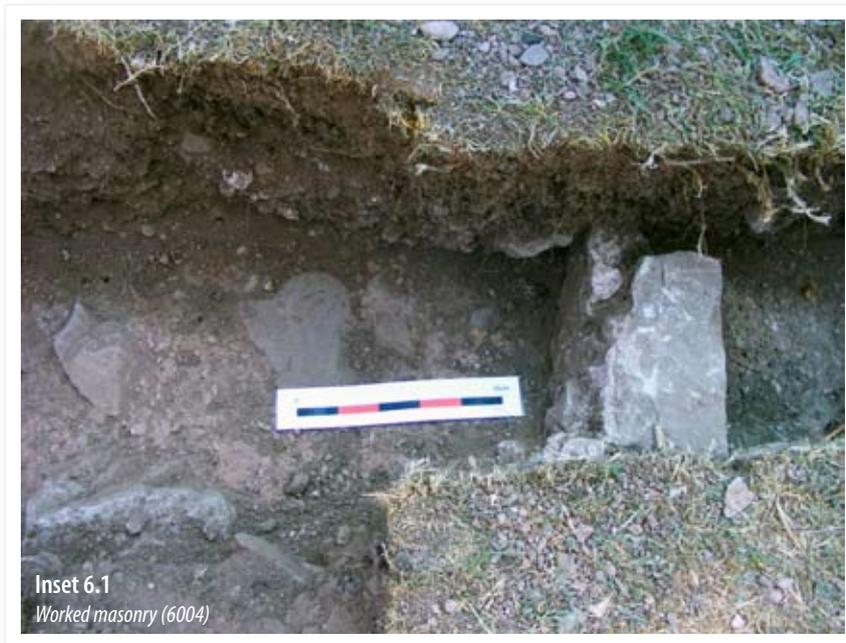
Illus 6
Trench 6, S facing section

A deposit of worked stone, [6004], measuring c.0.75m wide and encountered at a depth of c. 0.2m, was observed within Trench 6 (Illus 6). The eastern edge of [6004] consisted of a roughly squared sandstone block measuring 0.18m in width and 0.18m in depth. Further sandstone pieces protruded from the section in the area of [6004]. The squared sandstone block was not considered to represent an in situ piece of masonry, and following agreement with the Inspector of Ancient Monuments, the block was removed to allow the insertion of a tie-rod. Immediately below the sandstone block a concentrated deposit of charcoal overlying deposit [6002] was present.

The deposit of worked stone [6004], uncovered in Trench 6, seems likely to represent a collapsed wall rather than an in situ structure within the shell keep. The worked stone deposit that crossed Trench 6 was removed with the consent of the Inspector of Monuments. Deposit [6004] did not continue below the level of excavation and lay upon a thin lens of concentrated charcoal which in turn lay upon the medieval occupation deposit [6002]. The proximity of [6004] to the south-western shell keep may indicate that the deposit related to a collapsed internal wall, possibly associated with the 17th century demolition of the castle. The band of mortar [6006] observed to the east of the collapsed masonry seems likely to relate to the same event.

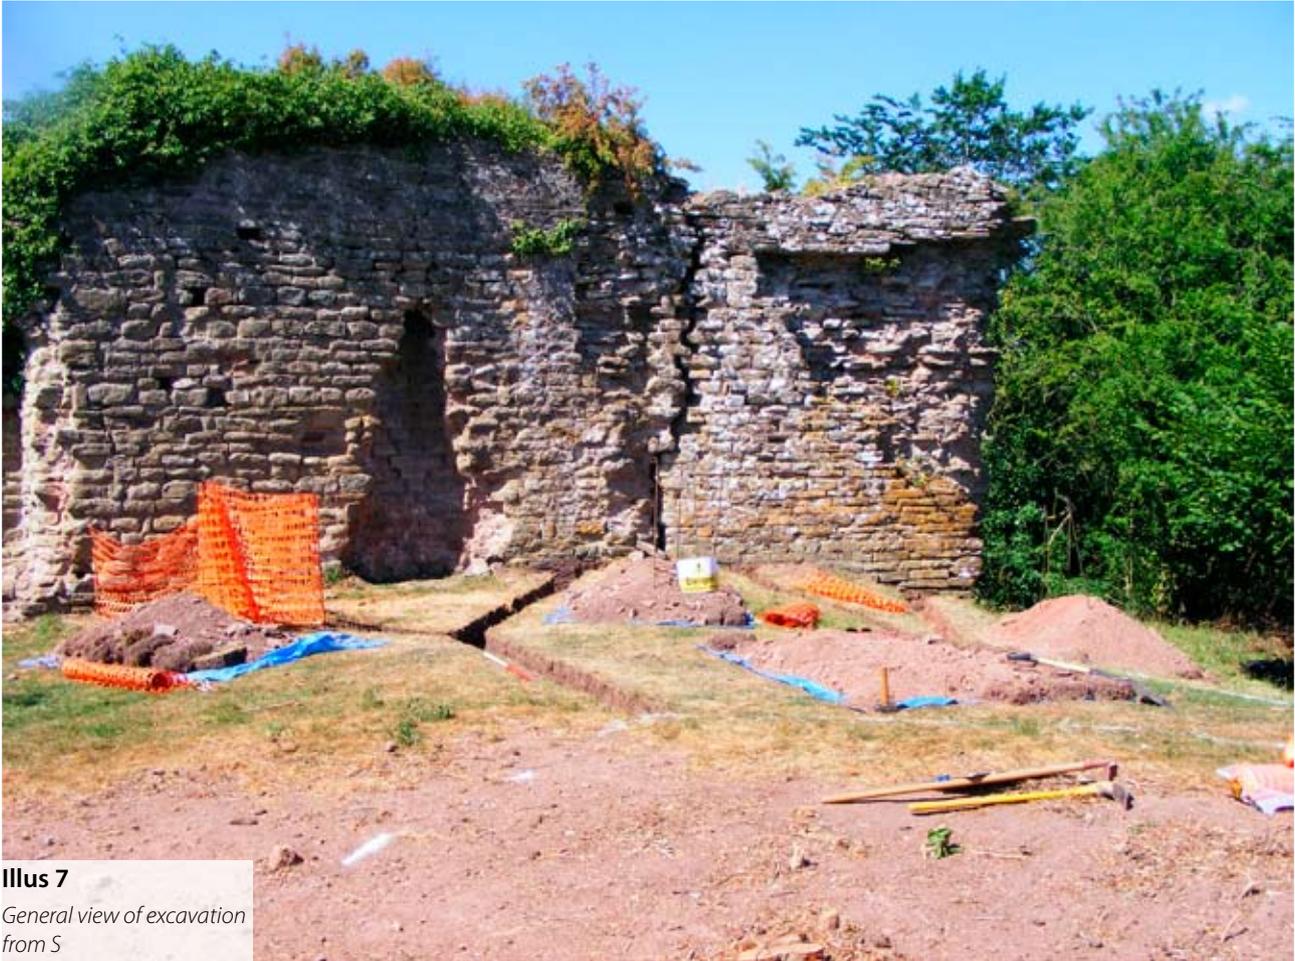
Illus 7
General view of excavation from S

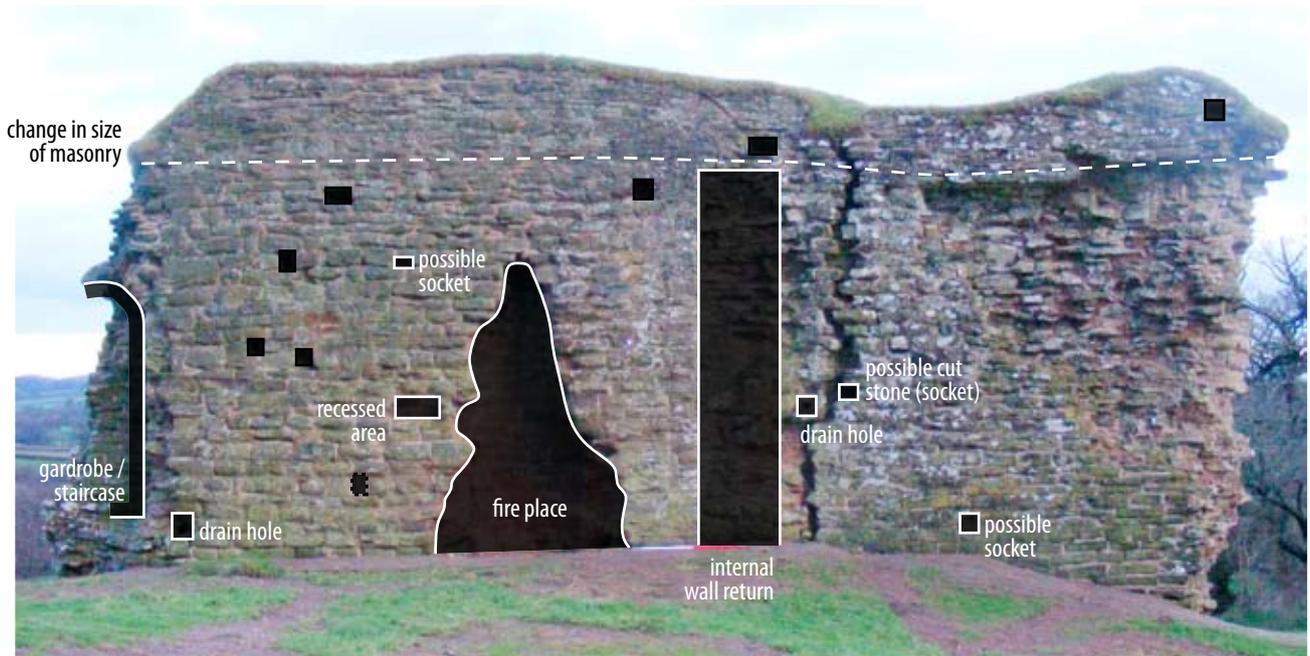
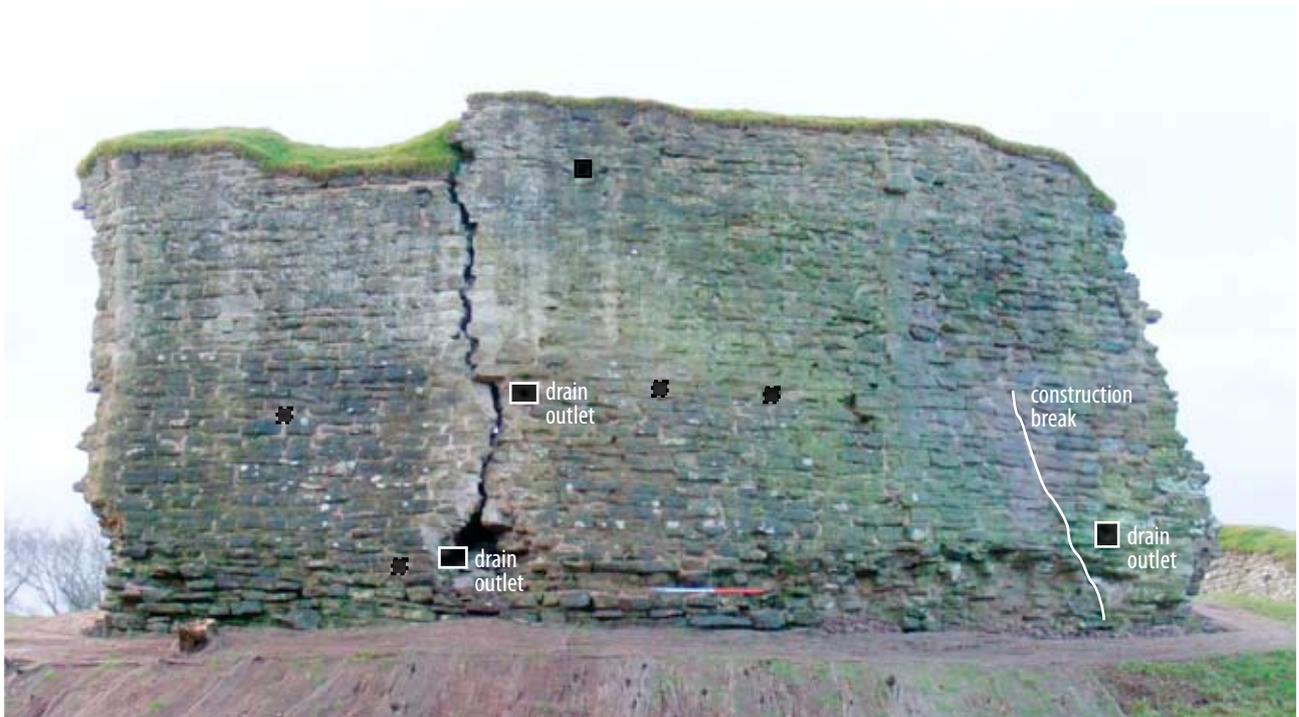
as drain holes, fireplaces and construction breaks. However, both remaining wall fragments A and B contain other evidence for open and possible blocked putlogs, drain holes, construction breaks and changes in the coursing of the masonry not commented on in the 1997 report. These minor features may play an important role in understanding the development of the building and have been marked on illustrations 8 & 9 to aid future interpretation. In particular the putlogs are evidence both for internal structures and possibly for the method of construction of the keep itself.

WALL B – INTERIOR

WALL B – EXTERIOR

■ putlogs ☒ possible putlogs

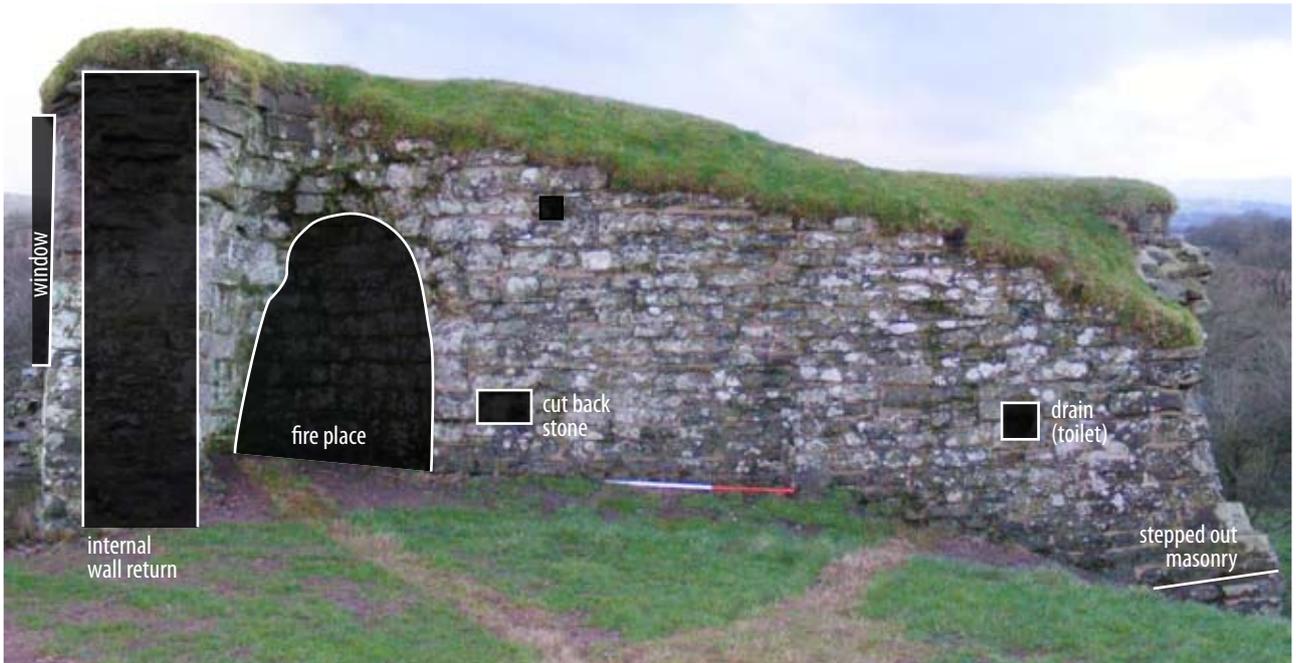
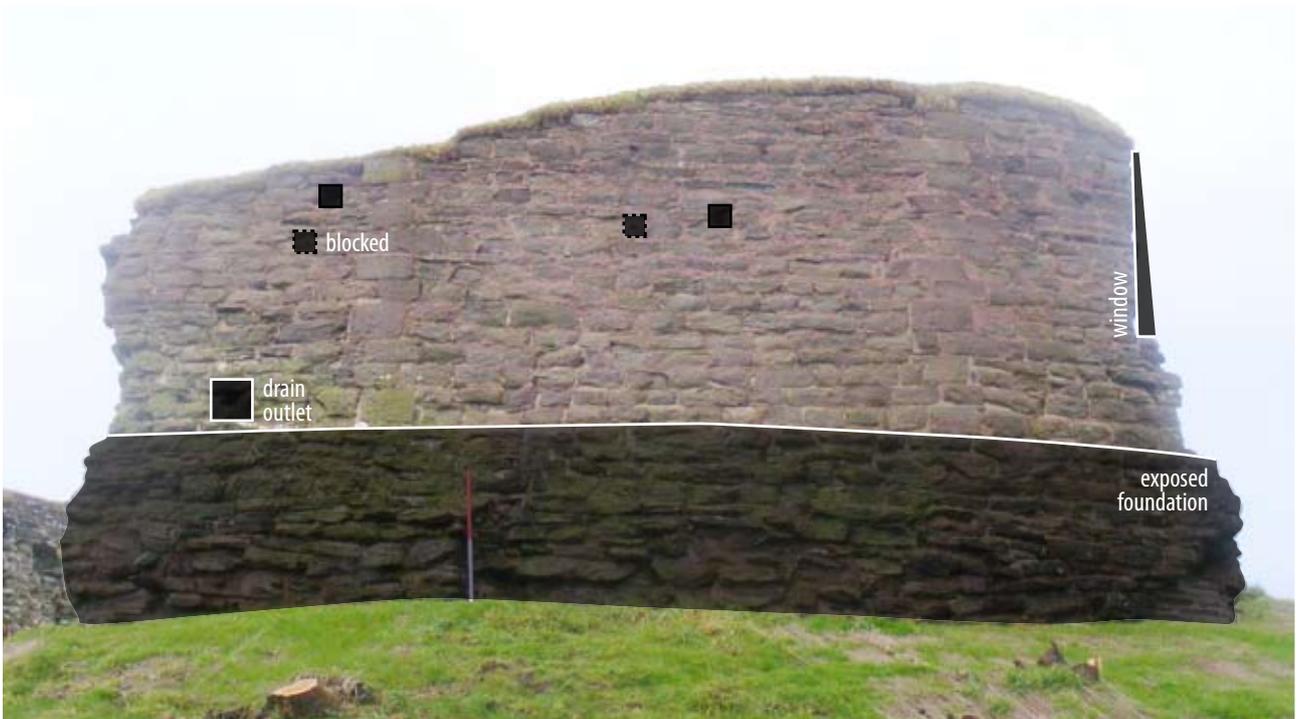
Illus 9

WALL A – INTERIOR

WALL A – EXTERIOR

■ putlogs ■ possible putlogs

Wall A
