# **WEDNESBURY LEISURE CENTRE**

Archaeological Evaluation

commissioned by Coleman and Co.

DC/08/50301

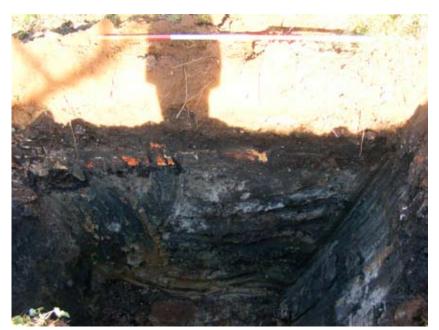
Beneath the present topsoil [2000] a series of Post-medieval brick structures (similar to the one seen in Trench 1) and the possible site of a demolished furnace were identified.

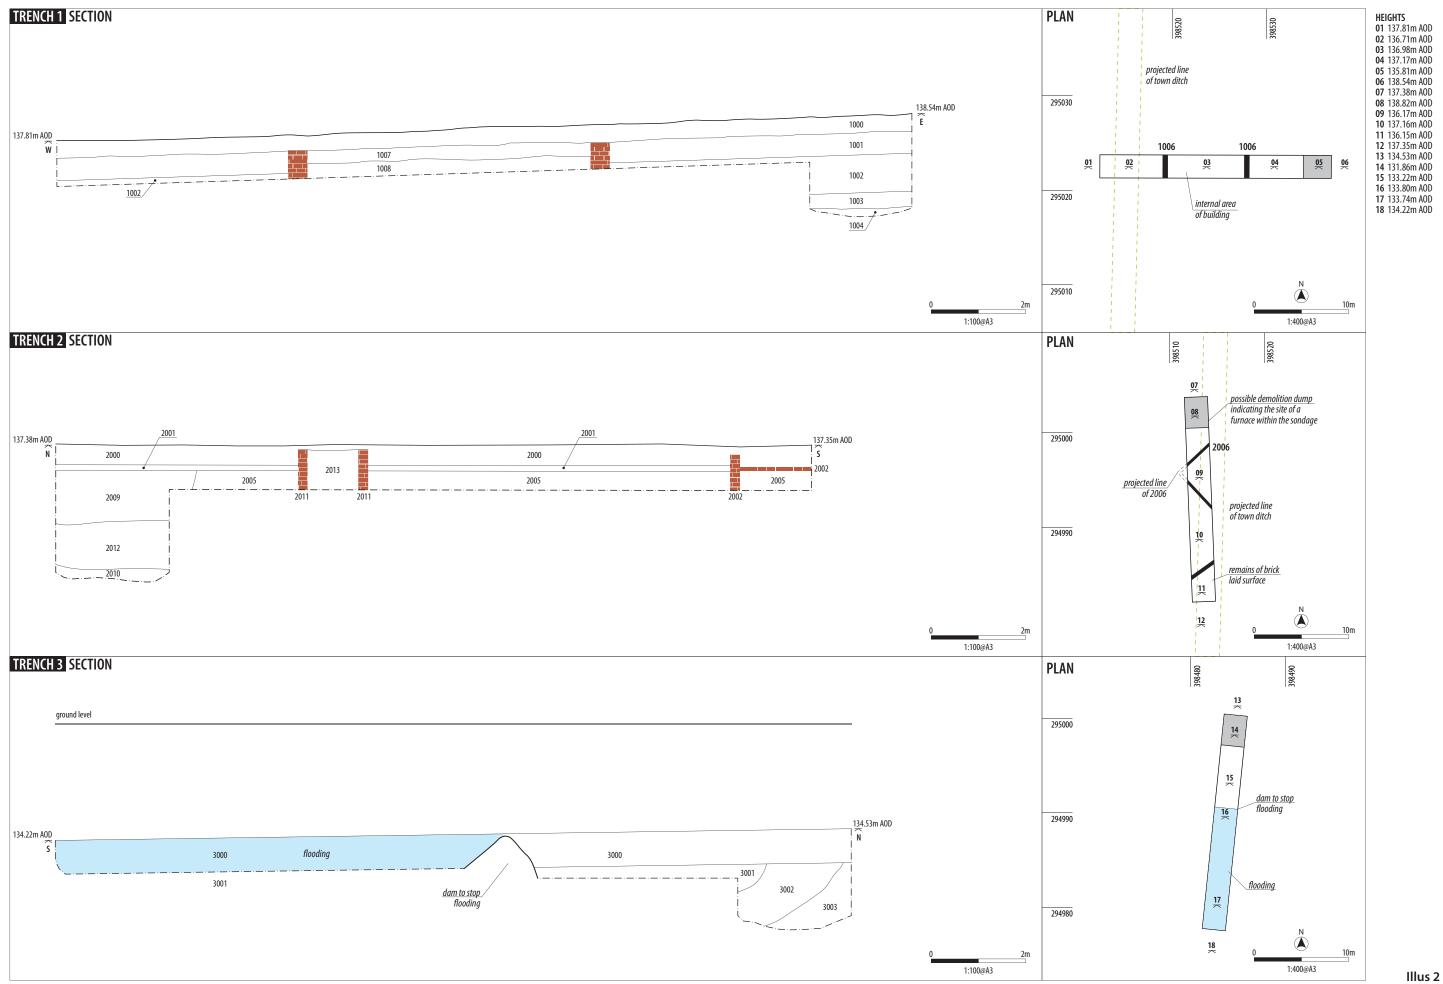
## Illus 3

Detailed view of the sondage cut within Trench 1

Towards the eastern end of the trench a sondage was excavated to a depth 2.73m, (135.81m OD (see **Illus 3**). Beneath the mixed deposit of [1001], a layer of dry and crumbly white clay with frequent inclusions of coal and clinker [1002] was recorded to a depth of approximately 1.0m (136.49m OD). The appearance of [1002] was suggestive of an a large deposit of mixed ash. Layer [1002] sealed deposit [1003] which was composed of a black layer of coal and clinker, to a depth of approximately 0.40m (136.09m OD), and which subsequently overlay a natural deposit of buff yellow brown clay (1004). The excavation of the sondage ceased at a depth of 135.81m OD (see **Illus 2**).

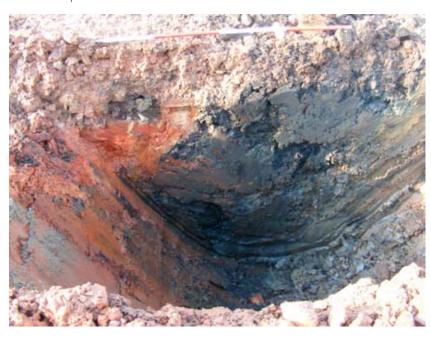
Illus 5

Detailed view of the sondage cut within Trench 3

A sondage was excavated within the northern portion of Trench 3 to a maximum depth of 131.83m OD before water ingress made the inspection of the sondage impracticable (see Illus 5). Within the section of the sondage a deposit containing traces of black organic material and clinker or coal debris was noted within a large shallow cut in the natural buff yellow clay of [3003]. The great extent of the deposit exposed within the sondage is such that it may represent the fill of the reservoir recorded on early 19th century mapping. No finds were observed within [3002], however, the inclusion of coal and clinker debris in the fill suggest a contemporary relationship to the comparable industrial deposits seen elsewhere on the site (see Illus 2).
