LAND ADJACENT TO ASHVILLE BUSINESS PARK, STAVERTON, GLOUCESTERSHIRE

Archaeological Evaluation

January 2014

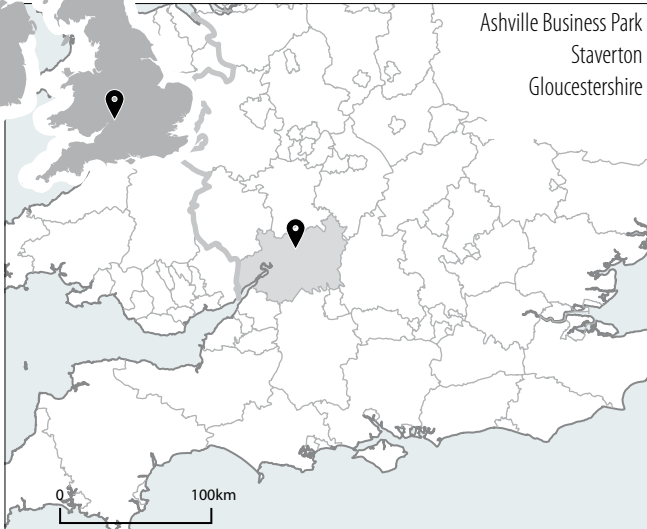
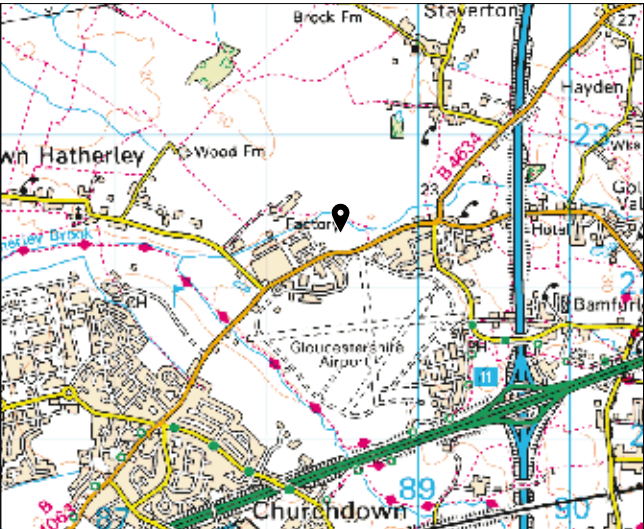
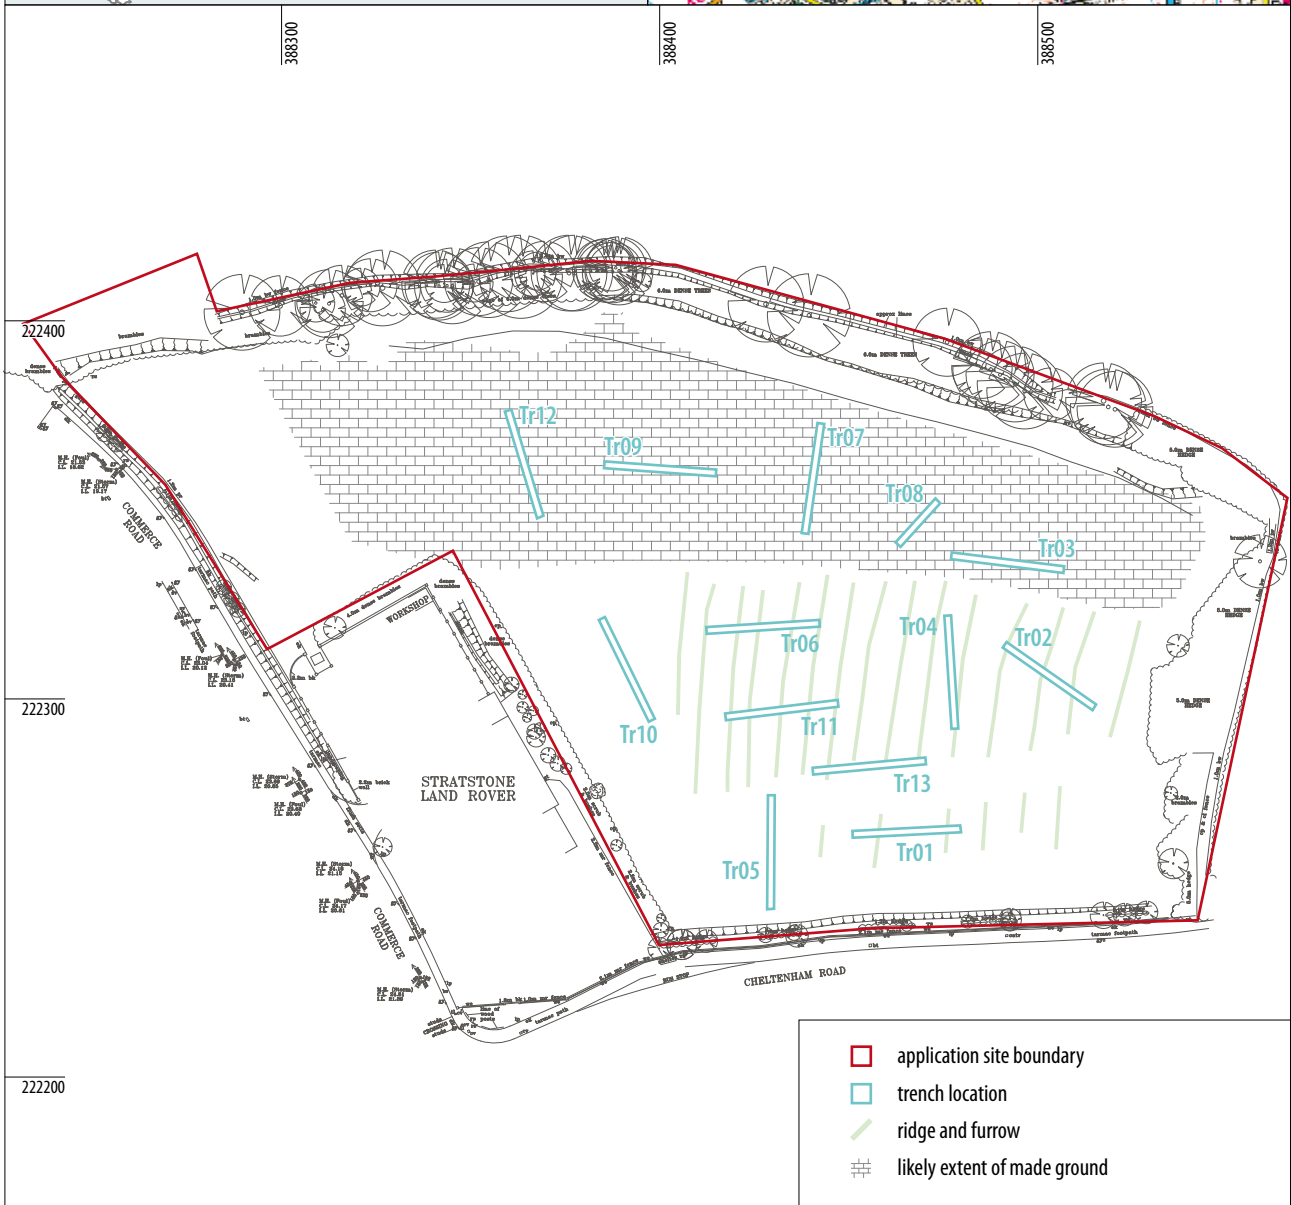
Illus 1
Site location

scale 1:2,000 @ A4

A total of 12 30m trenches and one 15m trench was excavated (**Illus 1**) taking into consideration the results of the geophysical survey. All of the trenches, except Trench 05, had to be moved from the original planned locations due to a number of factors affecting the site. These included a rising water main running along the northern edge, a possible badger sett to the north-east, possible fuel assets located in the south-east, and finally landscaping of adjacent properties to the west of the property. The geophysical survey results were taken into account during the relocation of the trenches to allow all significant anomalies to be investigated.

Evidence for ridge and furrow was observed in two trenches, numbers 06 and 11, in the centre of the field (**Illus 1**). The geophysical survey (Stratascan, forthcoming) had indicated that features relating to ridge and furrow existed in this area and this was seen in the soil profile, although visible earthwork evidence for these features is negligible at the surface (**Illus 2**). According to the geophysical results, trenches 01, 02 and 13 should have also transected the ridge and furrow. However, no evidence for these earthworks survives within the soil profile of these trenches.

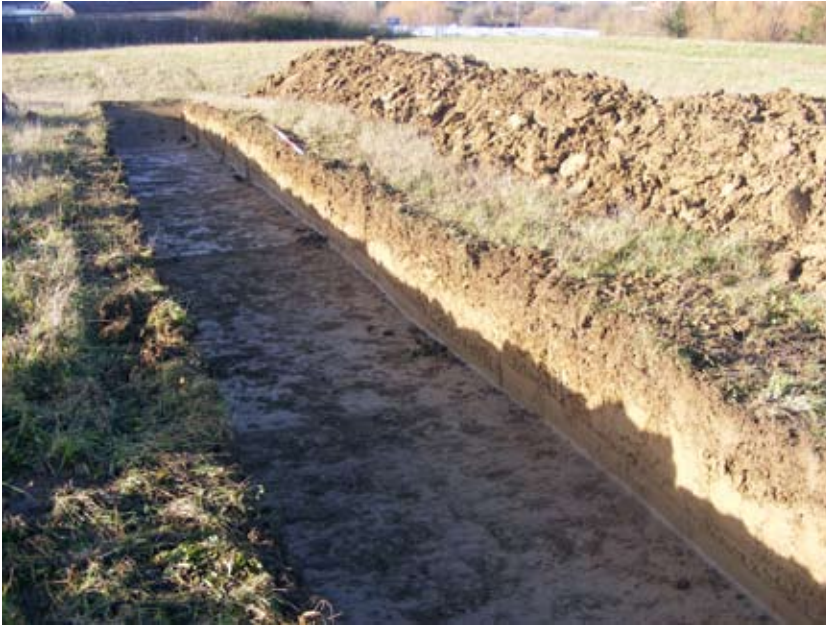
Illus 2

Trench 06 – evidence for ridge and furrow

4.2 Trenches with ridge and furrow; Trenches 06 and 11

Ridge and furrow observed in trench section
