76–84 ST OWENS STREET, HEREFORD

Archaeological Watching Brief

commissioned by Perfection Homes Limited

February 2014

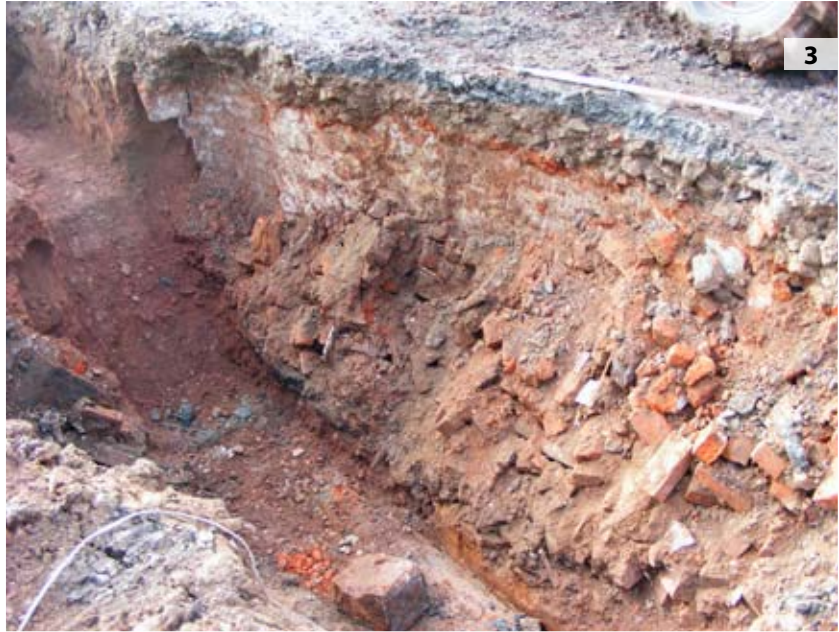
Illus 3*SW facing shot of coal store [2021]*

A coal store [2021] was discovered in the north-west part of the foundation trench and was lined with brick and stone walls [2022] and had been back filled with demolition rubble [2023] from when the building was demolished in 2013 (Illus 3). It was approximately 5m by 3m in plan and 2m deep. Exact measurements could not be taken due to the unstable nature of the ground surrounding the store. It is possible that this cellar is part of the original domestic dwelling constructed here in the early 1800s.

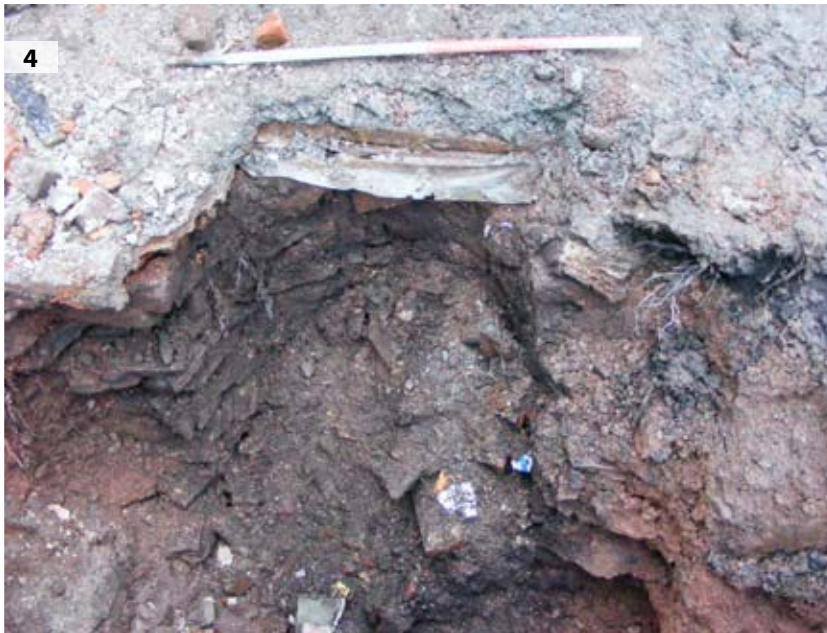
Illus 4

SSW facing shot of well [2016]

A well [2016] was uncovered in the south-east corner of the foundations lined with stones [2017] and then back filled with demolition rubble from an earlier phase of construction [2018] (Illus 2). It was 1.40m wide and excavated to a depth of 1.80m. The foundations of the previous building had truncated it on its northern edge and slabs had been placed on top. It is possible that this well served the original properties which existed on this site built in the early 19th century.
