# FORMER C OF E PRIMARY SCHOOL, PENSAX, WORCESTERSHIRE

*Historic Building Recording*

*commissioned by RDS Construct Limited*

*HER Ref. No.: WSM55836*

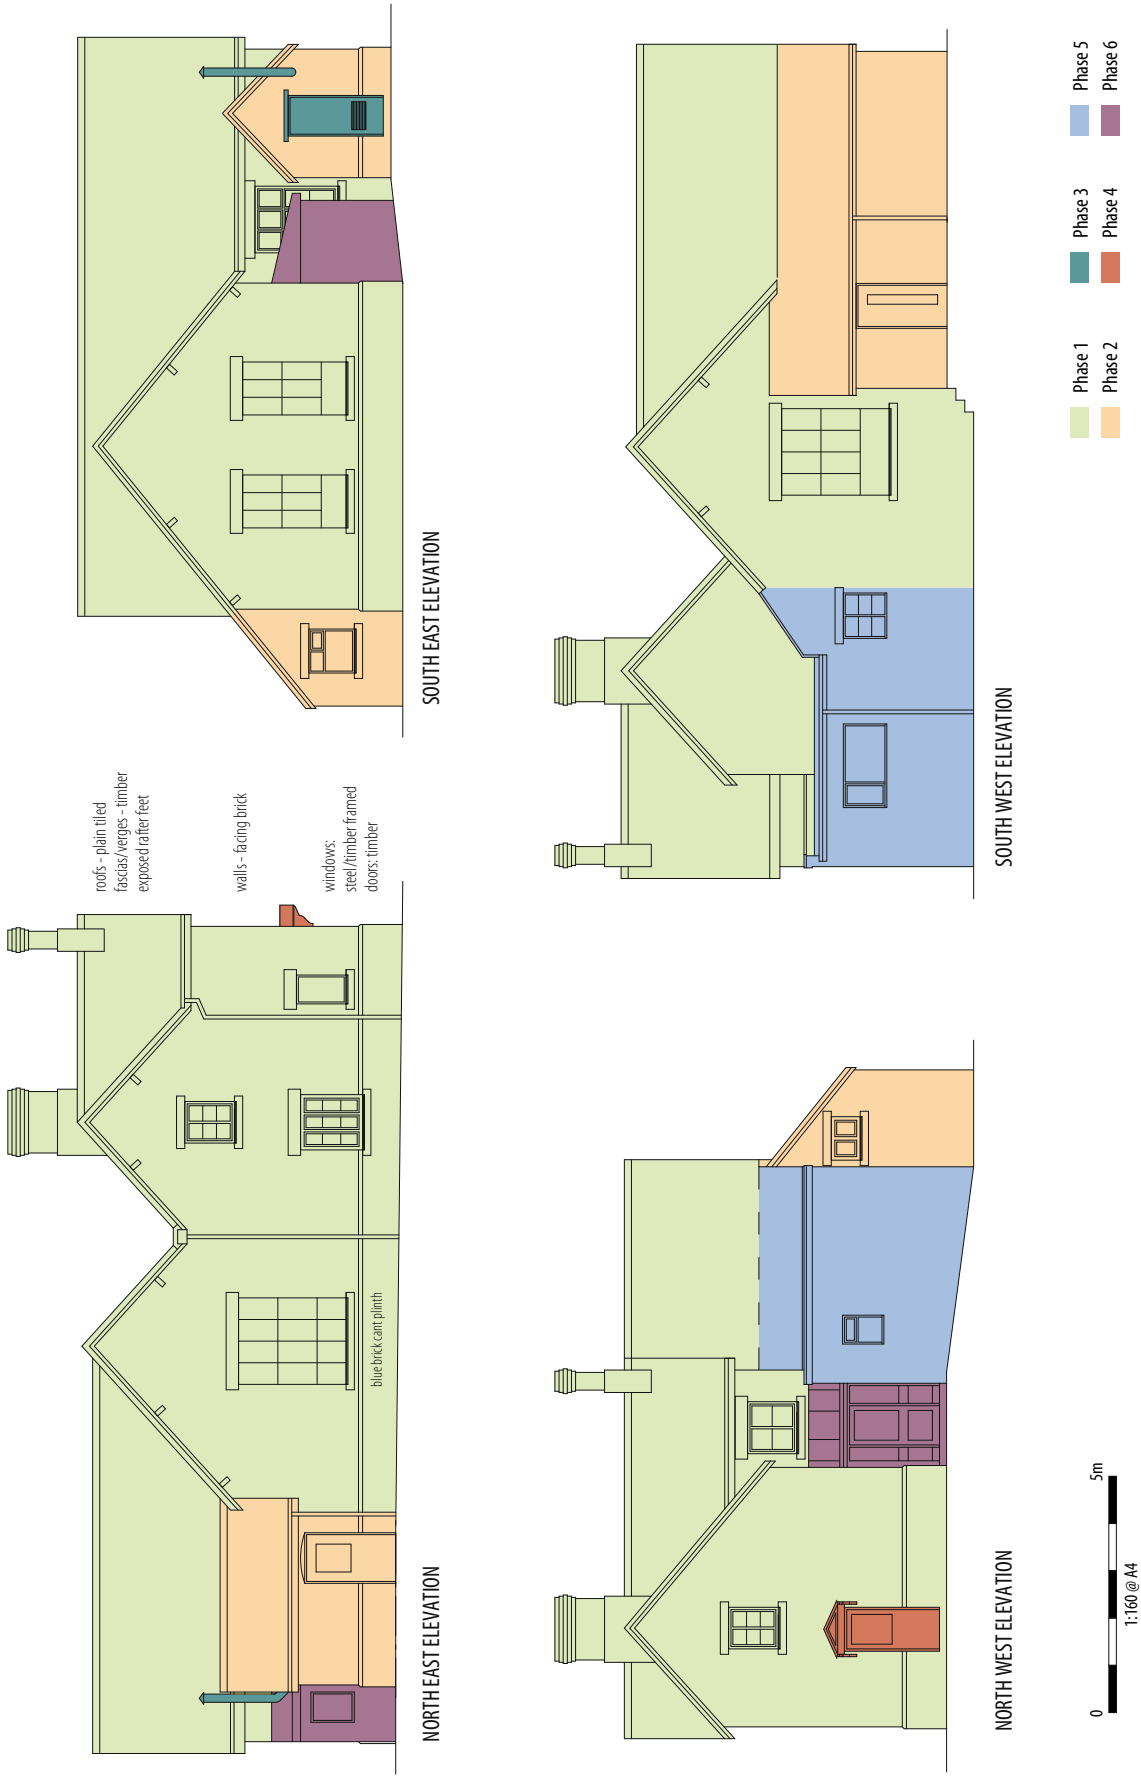
**Illus 2** and **3** show the development of the building and the location of key photographs. A summary of the building in its current form is included in Appendix 1.

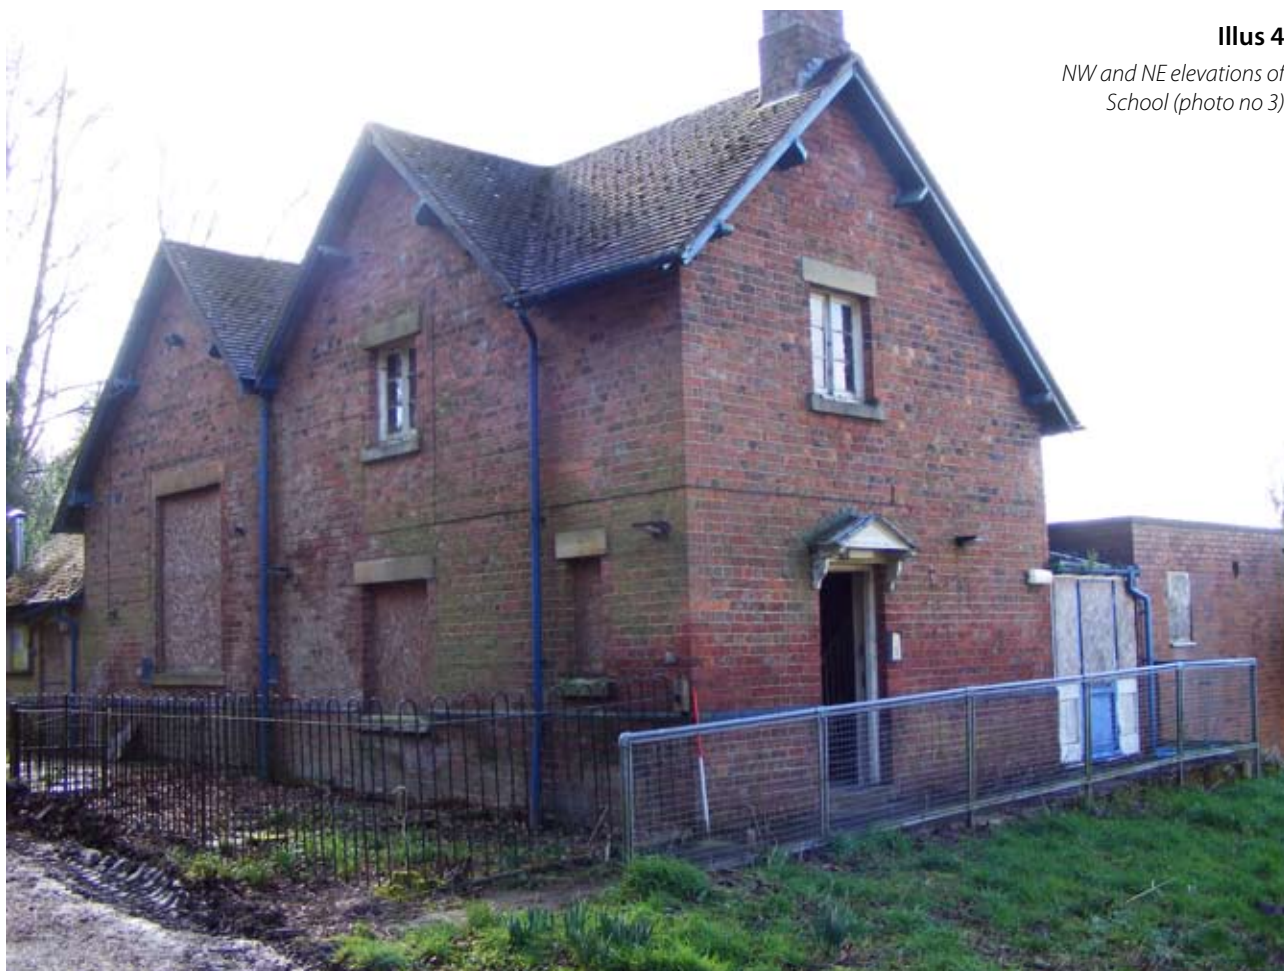
**Illus 4**

*NW and NE elevations of  
School (photo no 3)*

school master consisting of two principle ground floor rooms with three above and a large double height hall with attached class room constructed to the north east of the accommodation block (**Illus 4**).

The original building is constructed in red brick (220 x80 x110mm) with a creamy white soft grit mortar and laid in an English bond and forms a compact unit around which further extensions to the school have been added. Original windows and openings are framed with simple stone lintels and carved stone sills; a chamfered course of blue gray brick provides a moulded detail at ground floor level that identifies the original phase of the building.

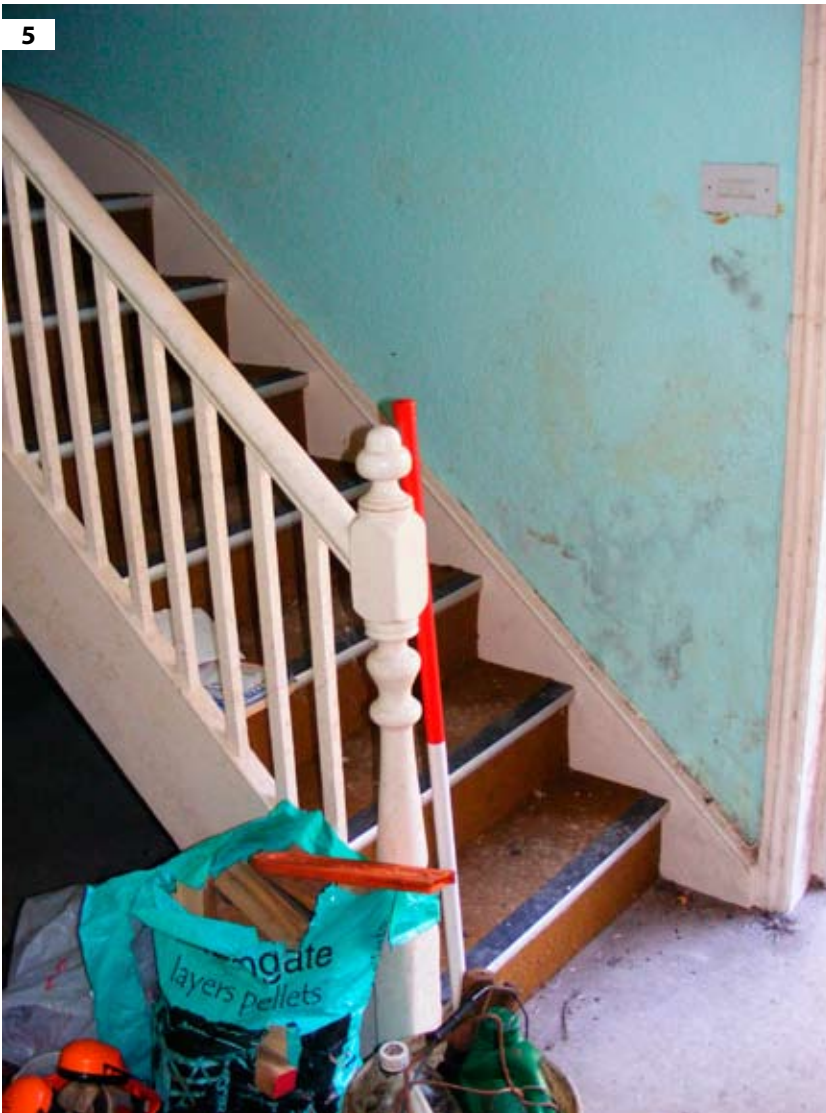
### Illus 5

Within the accommodation block a winding staircase with machine turned newel post and railings (**Illus 5**) provides access to the first floor accommodation. First floor accommodation comprised three

Within the main hall the remains of a wood and glass partition are visible within the ceiling space; this once formed a folding partition that could be used to divide the main hall into two areas (**Illus 6**).

*Detail of machine turned newel post (photo no 54)*

*Detail of glazed partition within the main hall (photo no 51)*

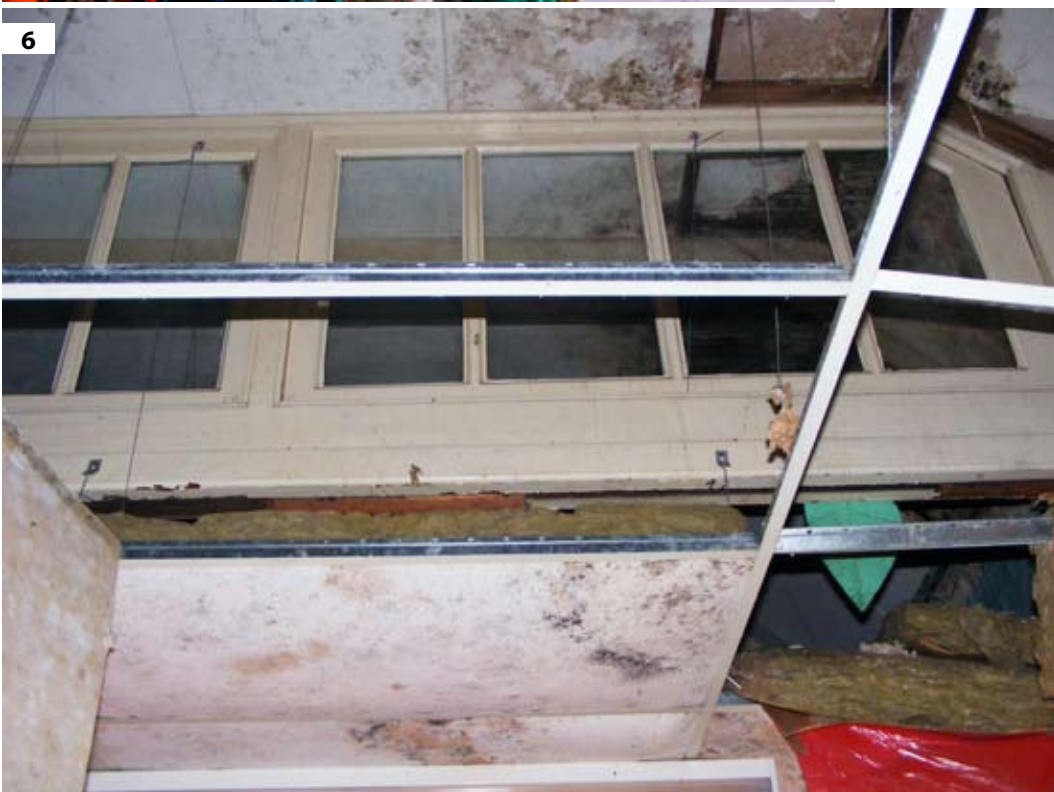
**Illus 7**

The main windows in the hall and within the attached class room are flanked by metal ventilation boxes (**Illus 7**) that by the means of a rotating flap could be opened and closed to vary the amount of ventilation provided to the occupants of the class rooms.

Located to the south-east of the main hall, a small entrance lobby was constructed, providing both an entrance vestibule and cloakroom, which was later converted to house the heating boiler (Phase 3). The extension pays homage to the overall style of the school buildings. It is constructed in red brick with dimensions (220 x 70 x 110mm) matching those of the phase 1 construction, and retaining the blue-grey chamfered brick detail of the phase 1 building (Illus 8).

*Detail of internal vent housing (photo no 114)*

*Detail of brick work and chamfered course  
(photo no 74)*

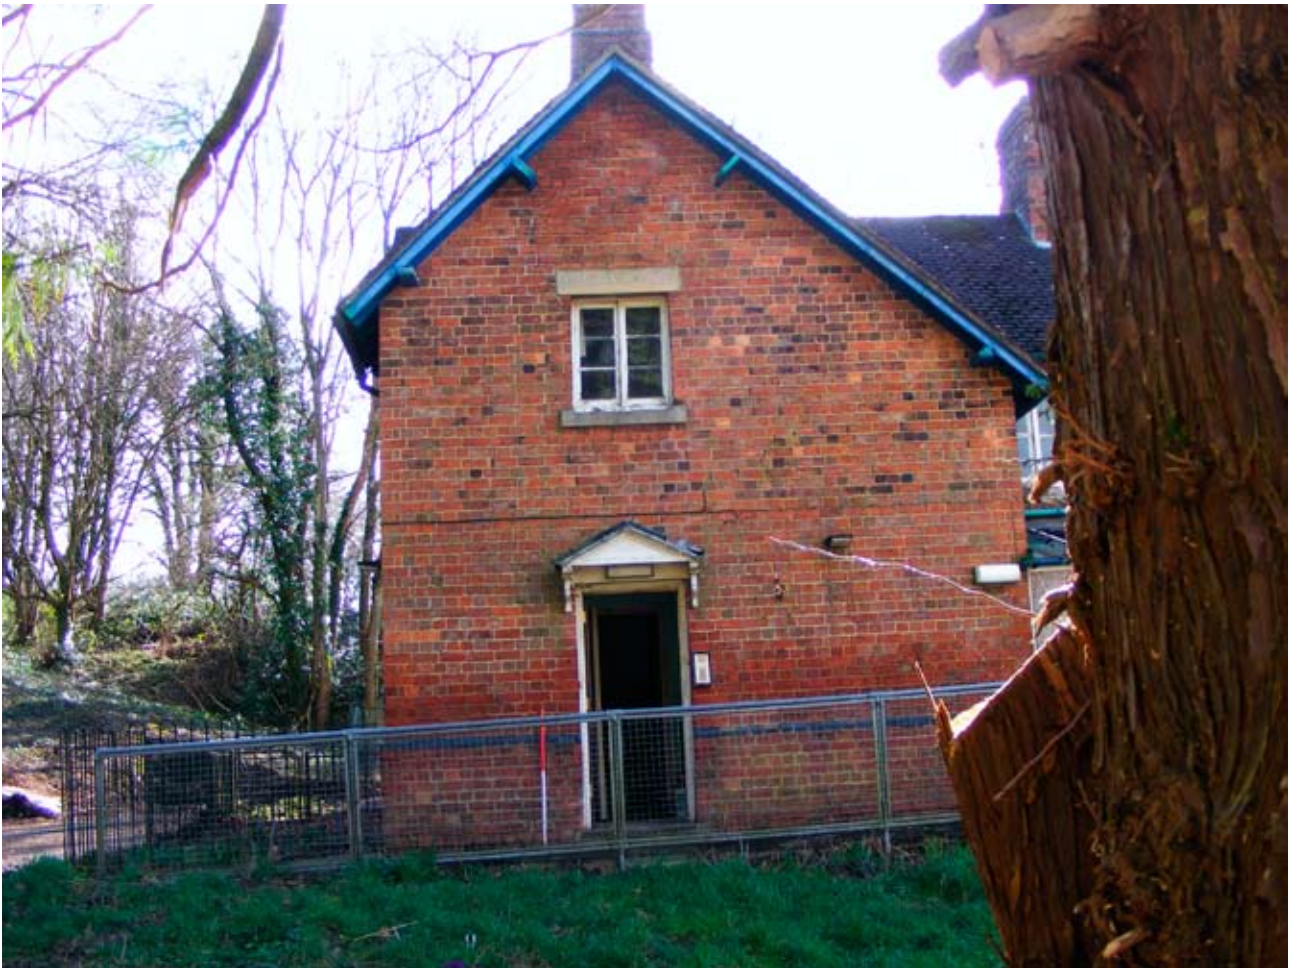
**Illus 9**

*NW elevation detail of inserted door (photo no 65)*

The new entrance has a small half portico canopy over the door and is considerably narrower than the original entrance to the accommodation block. The overall width of the new doorway reflects that of the window above (**Illus 9**), suggesting that the doorway actually replaced an original window opening.
