# LAND ADJACENT TO THE A49, WISTANSTOW, SHROPSHIRE

*Archaeological Watching Brief*

*commissioned by Amey OW Ltd*

*May 2014*

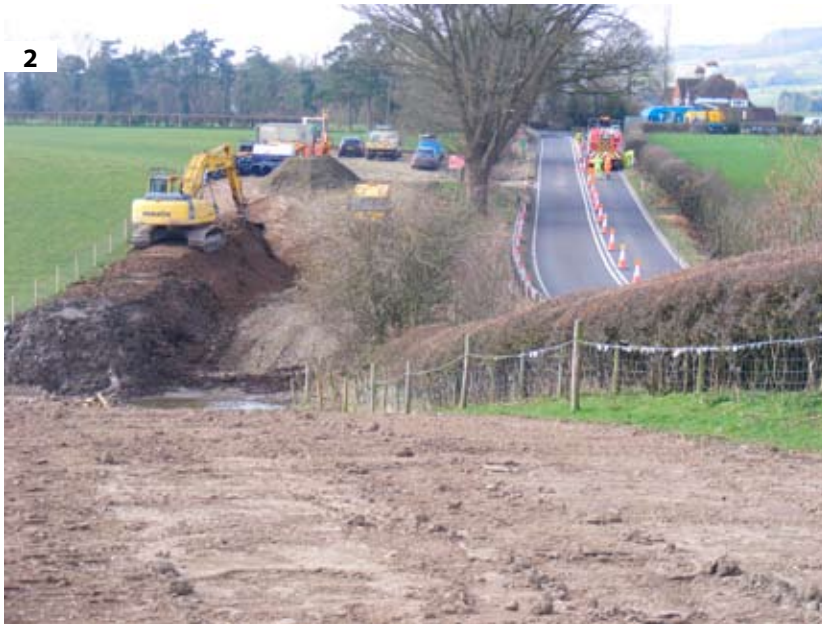
## Illus 2

To enable the repair works to the embankment an adjacent area of arable land was used to provide access. An area measuring approximately 6900m<sup>2</sup> on the south-eastern side of the A49 was fenced off for the construction of a site compound and access track (NGR SO 43833 85377). This area was subject to archaeological monitoring (**Illus 2**).

General view of site after topsoil strip, looking SW

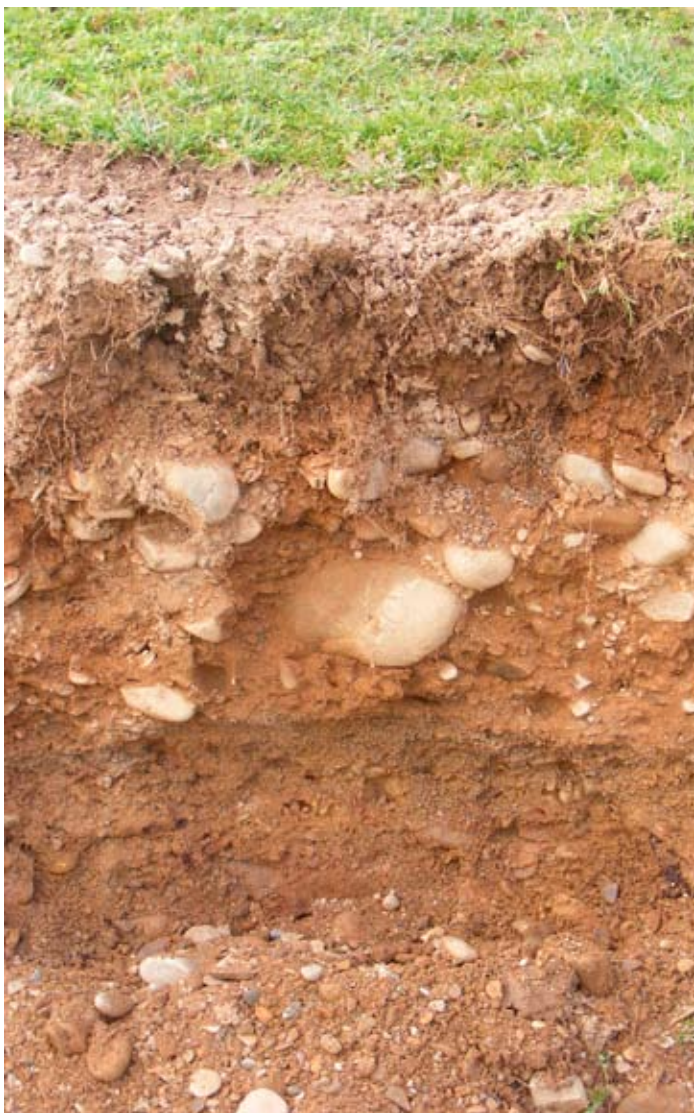
## Illus 3

NE facing section through deposits in compound area

1001

150mm

1002

320mm

1003

230mm

In order to create a level surface for the site compound area in the south-west of the site, deeper excavations were undertaken to remove the south-west to north-east fall of the land. At the south-west boundary of the site deposits were removed to a depth of 0.7m. No deposits or finds of archaeological interest were identified. The exposed north-east facing section (**Illus 3**) revealed a thin layer of topsoil [1001] overlying a light brown sandy clay subsoil with frequent rounded and sub-rounded stone inclusions [1002]. At a depth of 0.47m below ground level, a loosely compacted deposit of mid brown sand with frequent small stone inclusions [1003] was recorded.

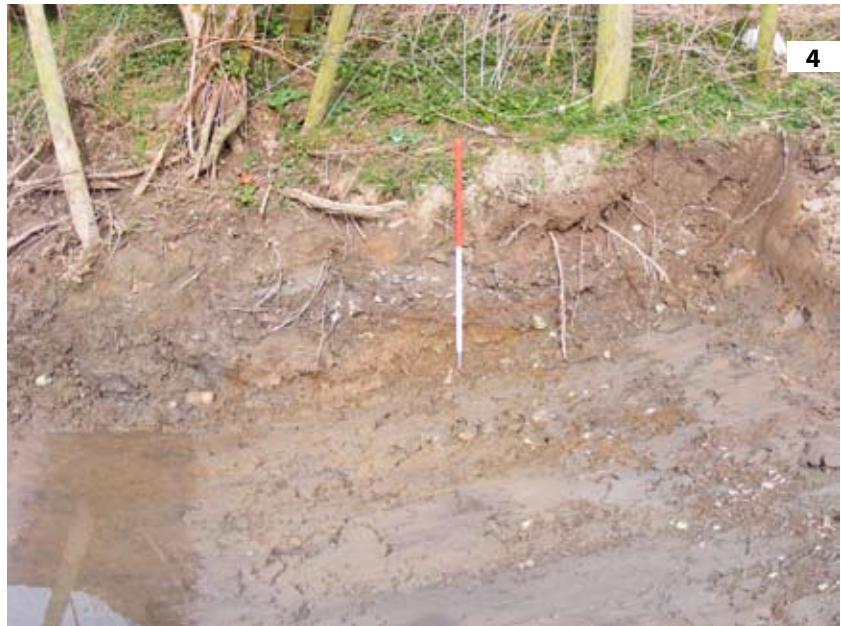
**Illus 4**

*SE facing section through deposits in valley base*

In order to consolidate the embankment it was necessary to repair the existing culvert pipe passing beneath the embanked road. To facilitate this repair, excavations were undertaken adjacent to the outflow of the culvert pipe in the base of the valley (**Illus 4**). The flow of water was diverted during this process.

Waterlogged alluvial clay deposits [3002] were excavated to a depth of 1m below ground level over an area measuring 35m x 14m. Excavation continued to a total depth of 1.5m below ground level. Fragmented mudstone deposits (natural geology) [3003] were encountered beneath the clays and continued down to excavation depth. No archaeological finds or features were identified.

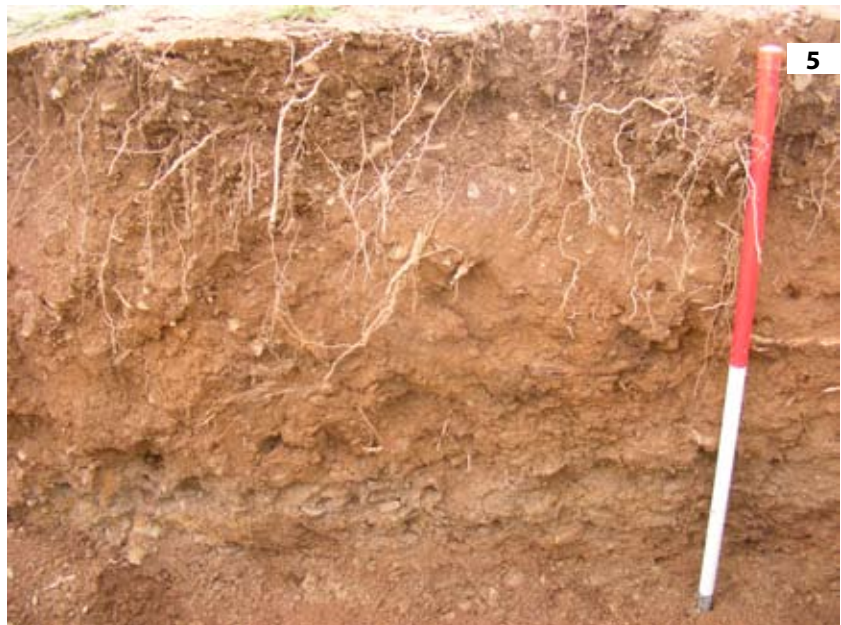
**Illus 5**

*NW facing section through deposits in gabion trench*

The trench was excavated to a maximum depth of 1.1m. Topsoil [2000] and subsoil [2001/2002] deposits were recorded to a depth of 0.75m below ground level. Geological deposits of grey sand [2003] and orange, grey and black sand with degraded bedrock inclusions [2004] were present below this depth (**Illus 5**). No archaeological finds or features were identified.
