# LAND OPPOSITE THE BOOT INN, FLYFORD FLAVELL, WORCESTERSHIRE

*Archaeological Field Evaluation*

*commissioned by Bloor Homes Western*

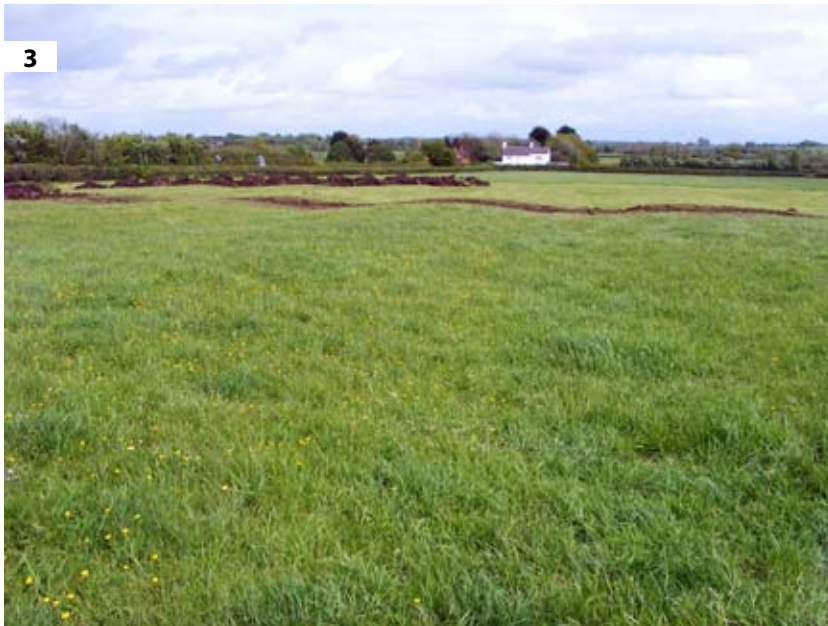
### Illus 3

*Ridge and furrow – looking east towards Trench 06*

At the time of excavation the site was in use as pasture land. Ridge and furrow was visible as upstanding features across the site (**Illus 3**), albeit with varying levels of preservation.

Evidence for ridge and furrow was identified both as topographic undulations and subterranean features. Trench 06 was orientated at 90° to the ridge and furrow within the area of greatest preservation. Ridges were comprised of a modified subsoil deposit which was both mounded on top of the geological horizon, and cut into it (Illus 4). An average distance of 15m between ridge tops was recorded. The maximum height of the extant ridges was 0.55m.

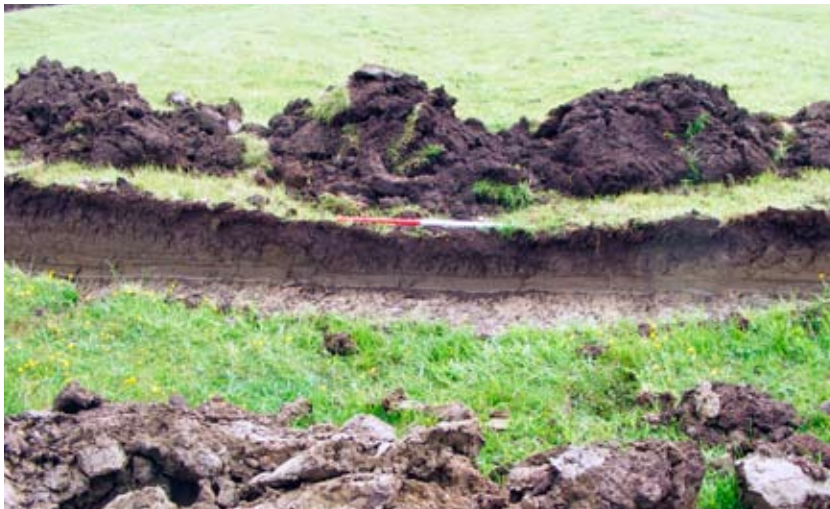
#### Illus 4

W facing section through ridge and furrow (Trench 06)

No archaeological deposits identified. Trench orientated at 90° to best preserved area of ridge and furrow. Excavation continued beneath modified subsoil to level of undisturbed natural. Service trench on NW-SE alignment identified. Blue plastic water pipe on E-W alignment also present.

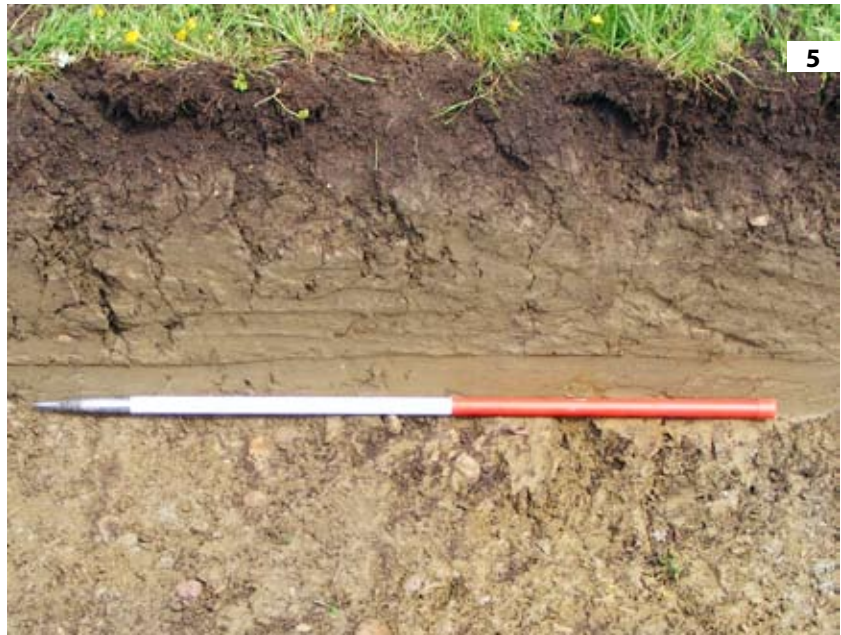
**Illus 5**

*Trench 07 (S facing section)*

deposits were encountered at a depth of 0.44m (Illus 5) .

Trenches 04, 07 and 09 were located along the top of ridges. The depth of topsoil and subsoil deposits within these trenches reflected the levels of preservation of the ridge and furrow. Where preservation was poor and the ridges indistinct (Trench 04) geological deposits were encountered at a depth of 0.31m. Within Trench 07, where preservation was at its best, geological

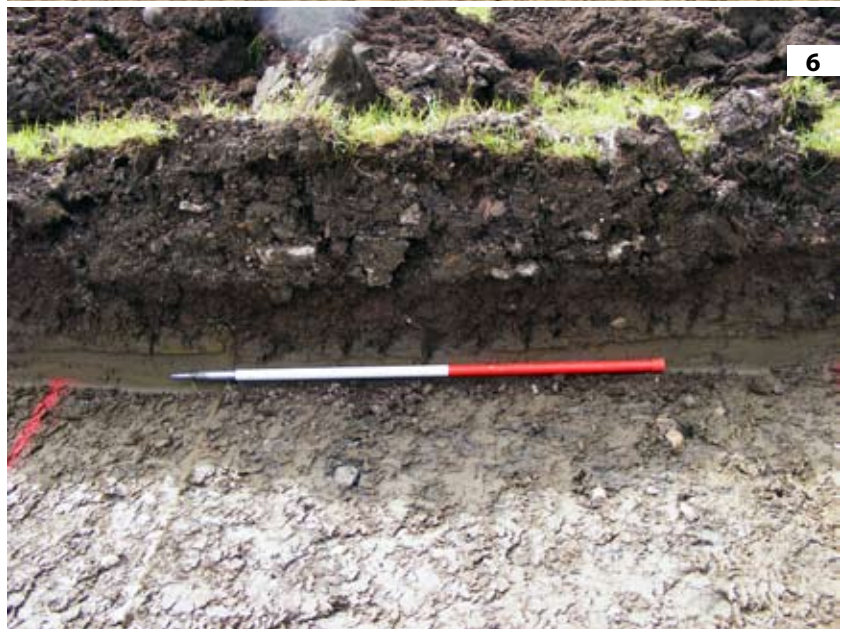
**Illus 6**

*Modern rubble deposits (Trench 08)*

Ridge and furrow was evident as topographic undulations within Trench 08. Immediately beneath the topsoil and located within the furrow bases were deposits of crushed brick and rubble [0804] which appear to have been laid to level the field in this area (Illus 6). A similar rubble deposit was identified with the topsoil at the western end of Trench 09. The deposits appear to relate to a spread of magnetic anomalies identified during the geophysical survey.

Preservation levels vary across the site, with extant ridge and furrow being less pronounced in the south and east of the site. Within Trenches 08 and 09 brick rubble had been deposited to infill the furrows. This has resulted in a flat trackway being present across the site on SSW-NNE alignment.

No archaeological deposits identified. Trench orientated at 90° to poorly preserved area of ridge and furrow. Furrows had been filled with brick rubble [0804] to create a track across the site on a NE to SW alignment. Position of rubble correlates with geophysical anomalies. Narrow (0.15m) service trench identified on NE-SE alignment.
