ENGLISH BICKNOR PRIMARY SCHOOL

Archaeological Evaluation

commissioned by Asset Management and Property Services,
Gloucestershire County Council

June 2014

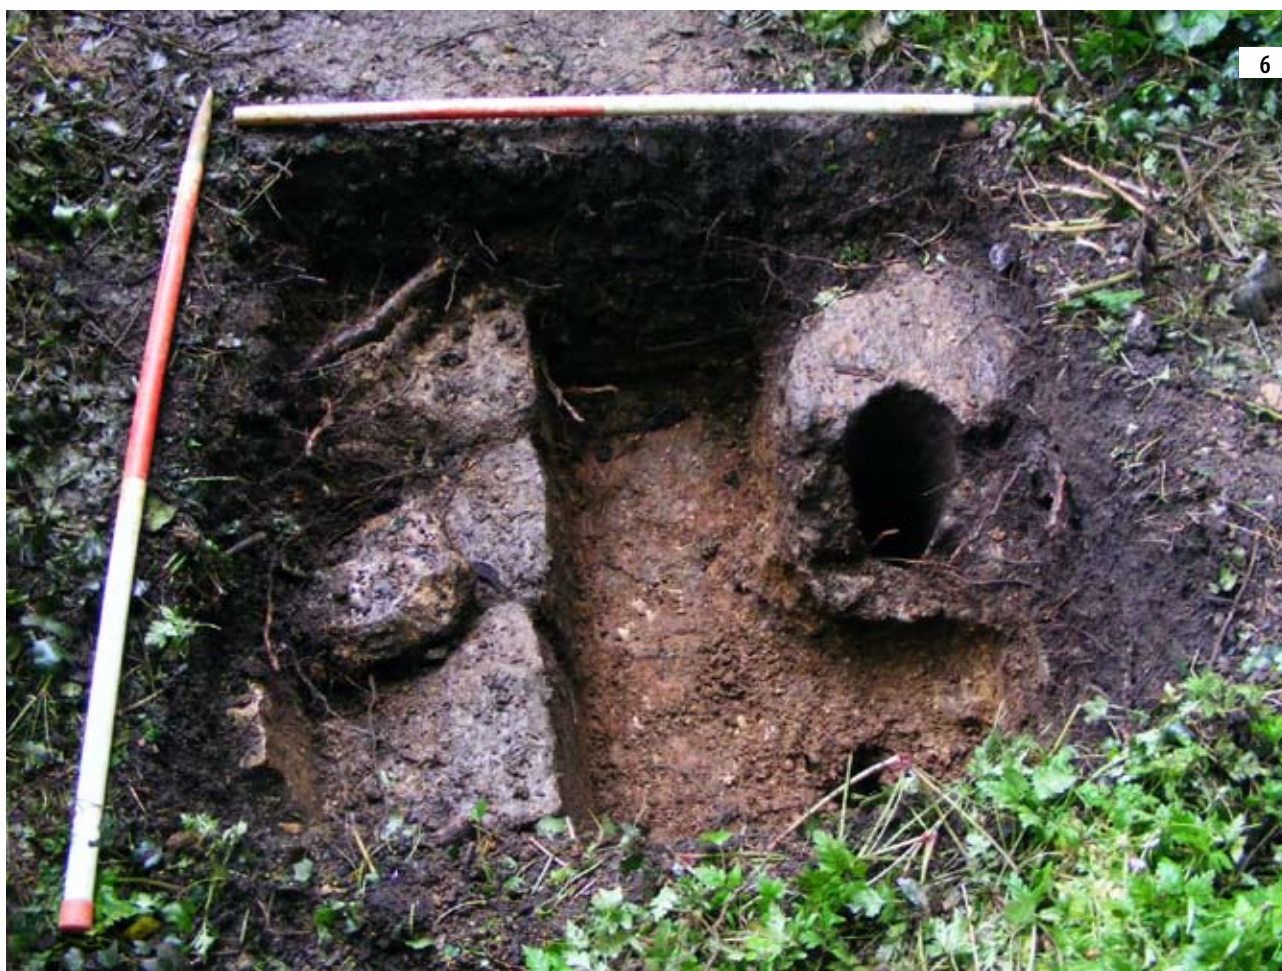
ILLUS 6

Trench 1; structural remains (camera facing N)

An alignment of three limestone blocks [1004] standing one course high, measuring approximately 0.30m wide x 0.25m deep, was identified 0.20m below the existing ground level (ILLUS 6). The structure was aligned north-south and overlay a red clay deposit [1003]. Also overlying the clay, and situated adjacent to the structural feature was a large limestone block [1005] with a circular hole (0.18m diameter) cut into the surface and extending through the block to a depth of 0.40m.

The structural features identified in Trench 1 appear to relate to a small building evident on the 1881 Ordnance Survey map (and more clearly illustrated on the map of 1922). The location of the building at the southern extent of the school house garden raises the possibility that it is an external toilet or garden building contemporaneous with the house itself.

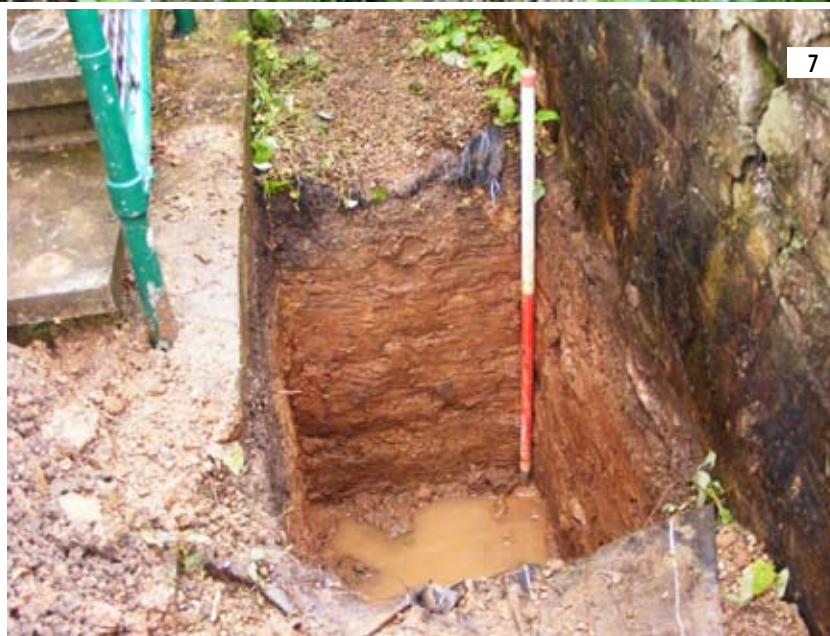
ILLUS 7

Trench 2; redeposited clay (N and E facing sections)

Trench 2 was hand excavated to a depth of approximately 1m below ground level (ILLUS 7). Modern pea gravel [2001] and topsoil [2002] overlay a deposit of red clay [2003] similar in composition to the red clay deposit identified in Trench 1. The clay extended to a depth of 0.80m below ground level, at which point a clean deposit of yellow clay [2004] believed to be natural was identified. Augering was undertaken in the base of the trench. The yellow clay deposit

continued to a depth of 1.70m before resistance, believed to be bedrock, prevented further augering.

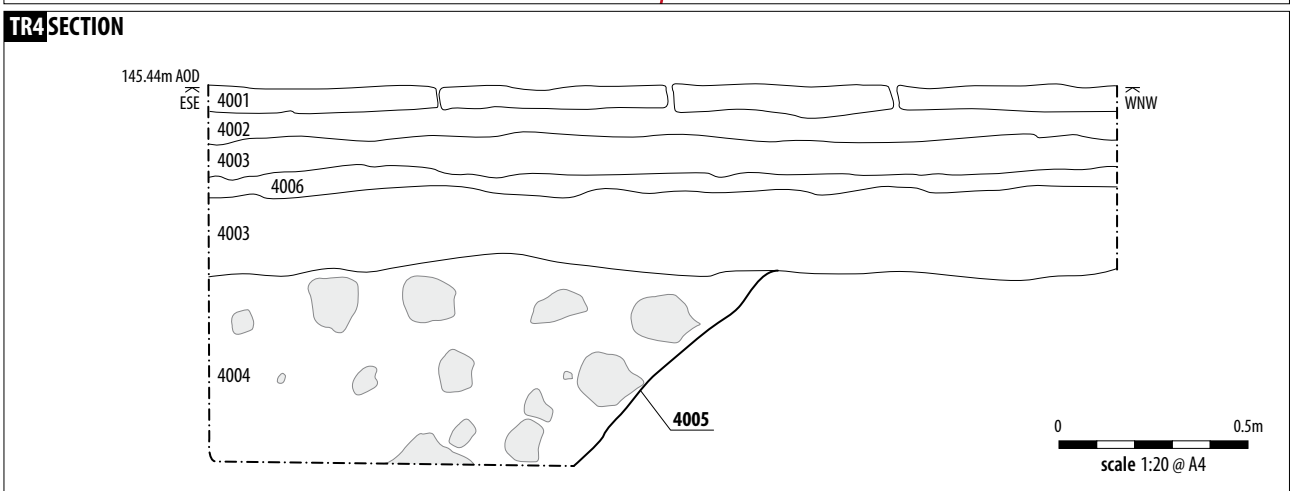
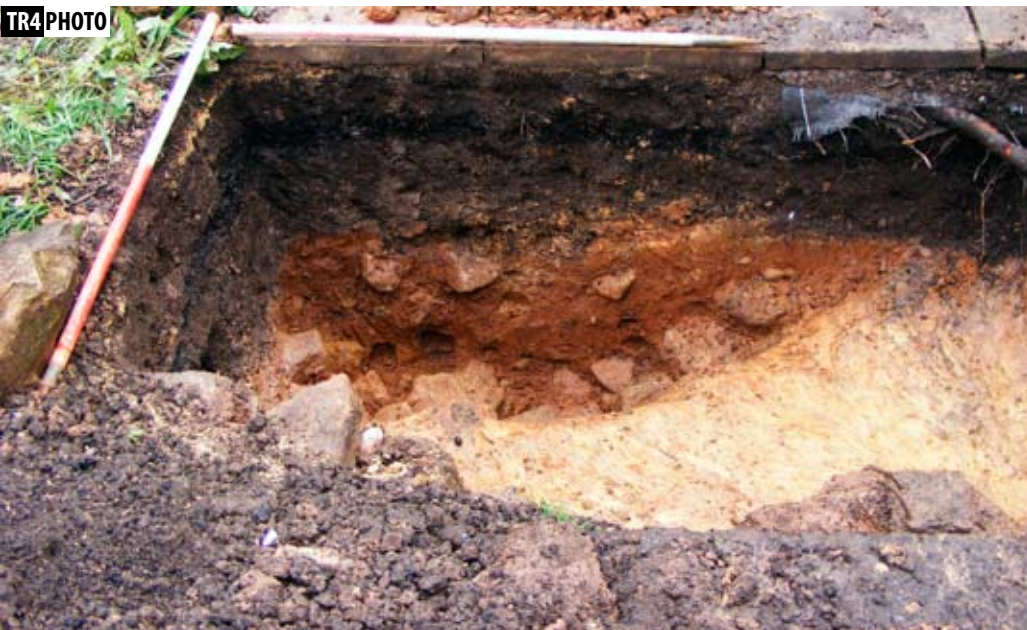
ILLUS 8
Trench 4 (inner moat fill)

Beneath a black, ashy 19th century levelling deposit, natural yellow clay deposits [4007] were identified at a depth of 0.45m below ground level. Cut into the natural clay was an east-west orientated feature [4005], coinciding with the postulated position of the northern edge of the moat (ILLUS 8). The feature was filled with a firm red clay [4004] with frequent large stone inclusions. Due to the stoney nature of the deposit attempts to auger into the deposit were unsuccessful.

The cut feature [4005] identified within Trench 4 correlates with the position and orientation of the inner moat as recorded on historic maps of the site. The heavy red clay deposit identified in all the trenches appears to relate to the capping or the backfilling of the moat. The deposit was devoid of dateable material and appears to have been rapidly deposited in order to backfill the moat and level the site. The deposition of the clay and levelling of the site would appear to relate to the events described by Maclean (1880) and date to c.1876.

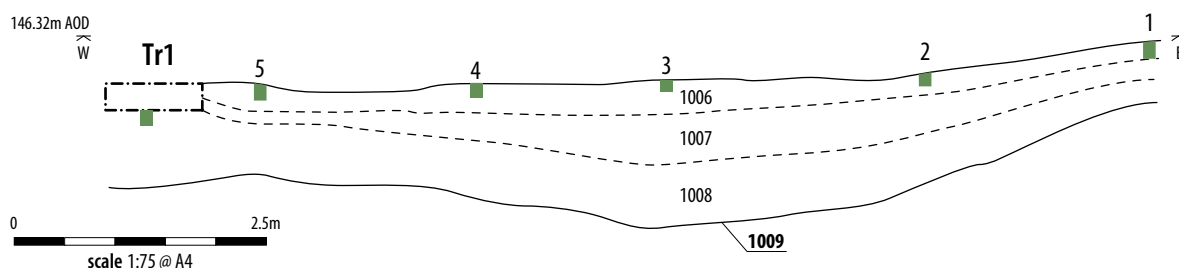
ILLUS 9

Profile of moat based on results of auger survey

A line of five auger holes was excavated to the south of the present school classrooms in an area of undergrowth (ILLUS 9). Excavation indicated a profile consisting of 0.30m of humic topsoil [1006], a deposit of limestone backfill [1007] approximately 0.60m thick, overlying a deposit of red clay [1008]. Firm deposits thought to be bedrock were identified at 1.2 to 1.4m below ground level. The indications were of a shallow ditch profile although the results were inconclusive. No boreholes were excavated in this part of the site.

The profile of the moat identified from auger survey and Trenches 1 and 2 in the south of the site suggests a gently sloping eastern edge to the moat with an undulating base. The western edge of the moat was not identified, and therefore must be located to the west of Trenches 1 and 2.
