ELECTRICITY CABLE INSTALLATION, PRIORY GARDENS, LUDLOW

Archaeological Watching Brief

commissioned by Western Power Distribution Ltd

September 2014

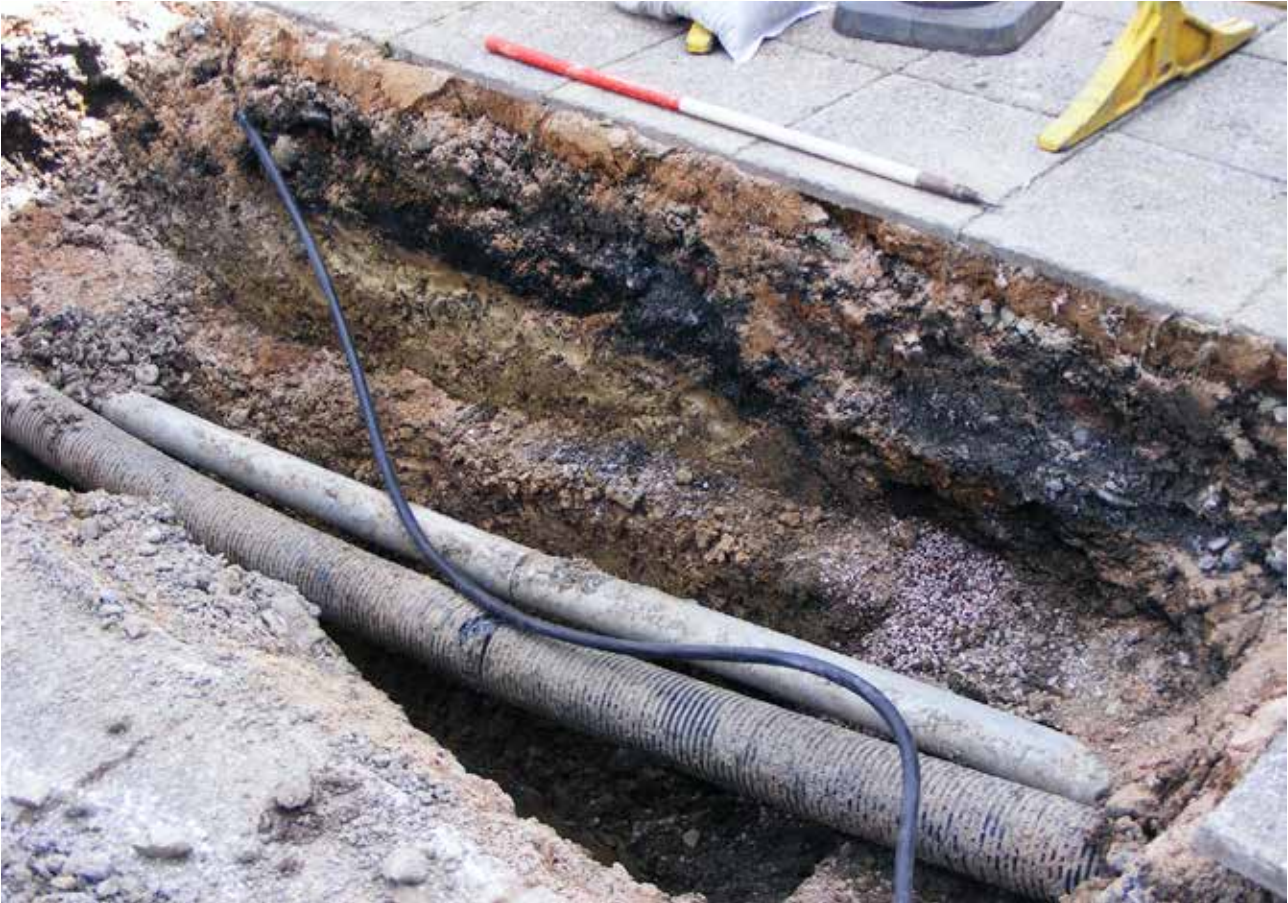
ILLUS 2

SE facing view of section showing extent of modern disturbance

A service trench measuring 21m in length and 1.30m in width was excavated to a depth of 1.20m. The deposits excavated to enable the electricity cable to be installed comprised modern made ground and geological deposits. A disturbed layer (c.0.40m in depth) consisted of the current slabbed surface (101), mixed stone hardcore

beneath it (102) and a number of modern service pipes (Illus 2). The geological horizon was observed at a depth of 0.40m below ground level and comprised a creamy white solid bedrock.

No archaeology was observed during this scheme of work despite the excavation reaching the geological horizon. The shallow depth of (modern) overburden suggests that truncation has taken place in this part of the site. It is possible that this truncation relates to groundworks associated with the construction of the housing estate adjacent to the gardens.
