# TANKERVILLE MINE, SHROPSHIRE

Watching Brief

SAM No. 1014865

July 2014

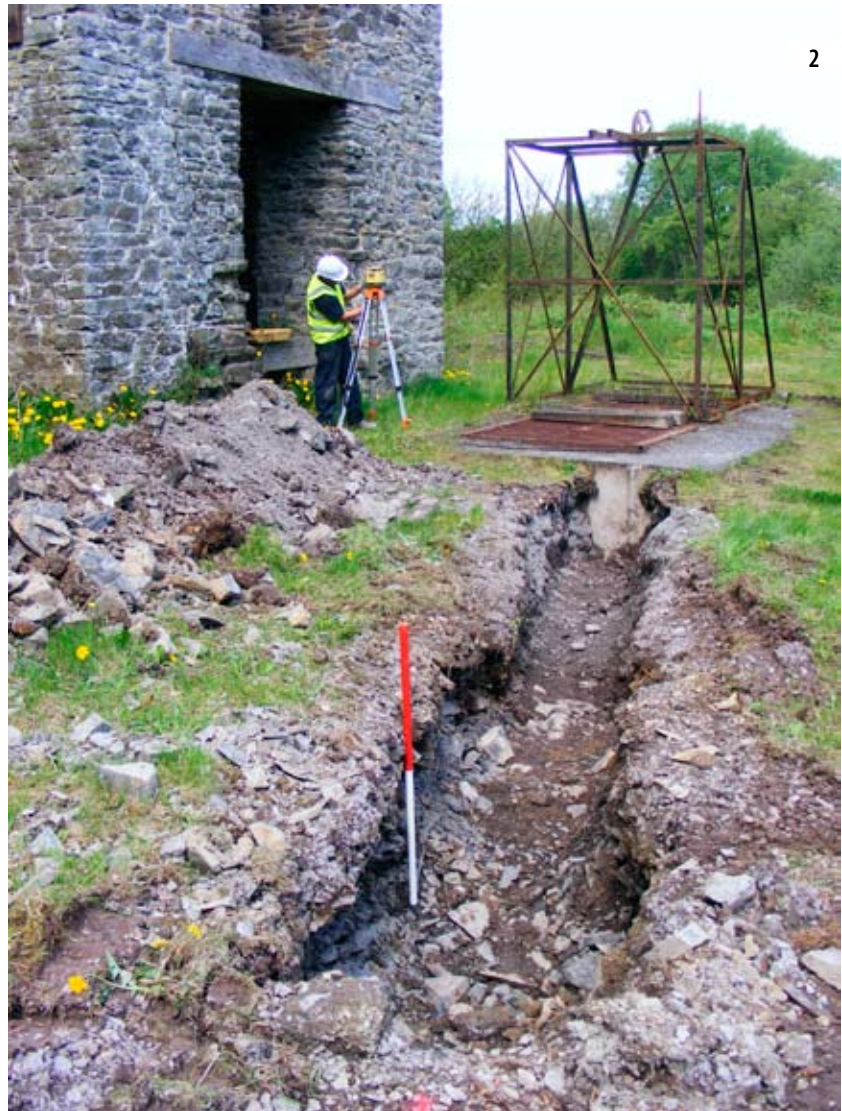
## ILLUS 2

Drainage trench heading north-west towards mine shaft

Trench 1 was excavated on the upper level to allow the insertion of a drainage pipe from the upper reservoir (not shown on plan) to the top of the redundant mine shaft (Illus 2). This area formerly functioned as the crushing floor of the mine where steam powered rollers crushed the ore as it came up from the mine shaft. A trench measuring 21.0m x 0.6m was excavated to a depth of 1.00m at the south-east end but shallowed out to 0.60m at the north-west end.

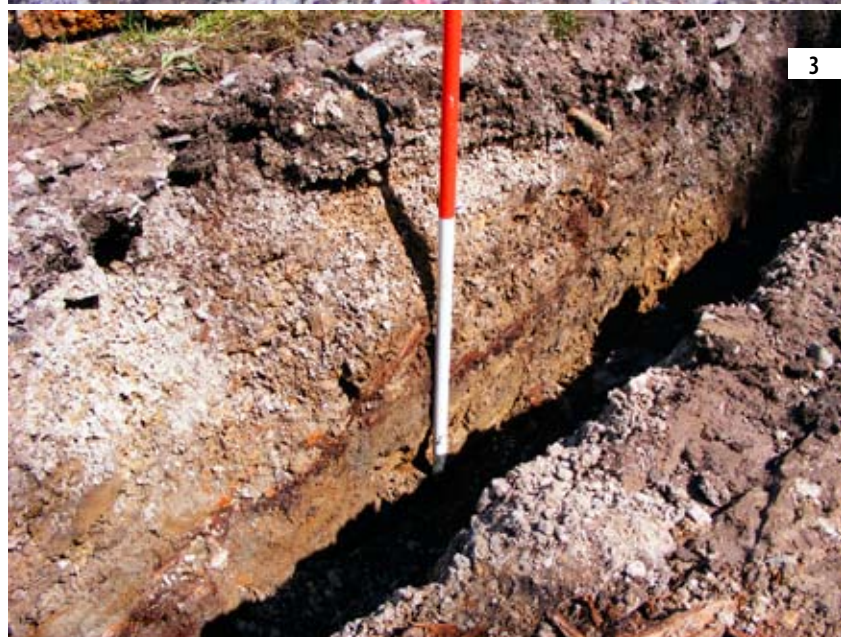
## ILLUS 3

Section facing north-east showing rubbish pit [104]

At the mid-point of the trench and cut into geological deposits was a shallow pit [104] containing what appeared to be the remains of a 20th century rubbish dump; deposits of gravel (106) overlay farm refuse (107) containing twine and plastic (Illus 3). A rectangular metal object (0.50m x 0.30m x 0.12m) perforated with regularly spaced circular holes (Illus 4) was recovered from deposit (107). The function of the object is unknown but there is the possibility that it related to mining or processing activities and has subsequently been redeposited in a later rubbish pit. Natural deposits were observed beneath deposit (107) at a depth of 0.70m below ground level.

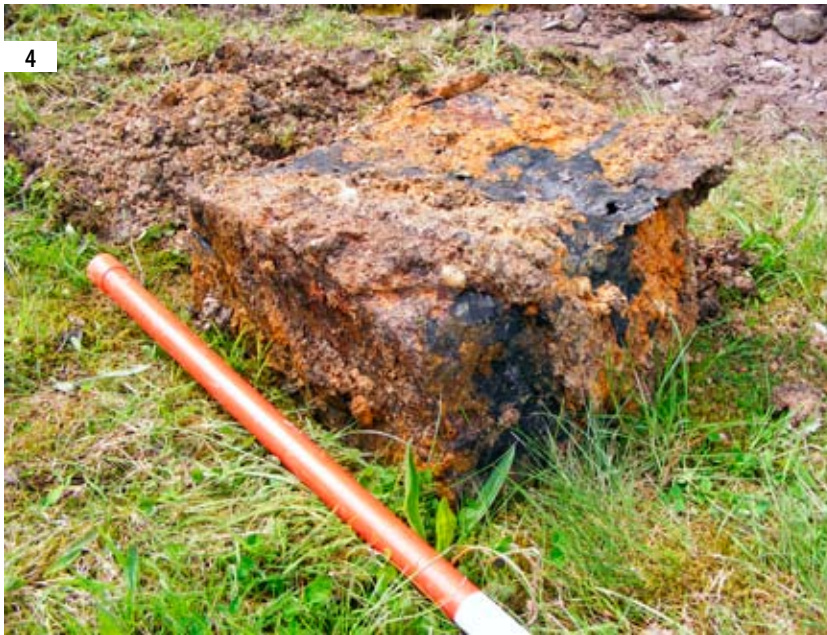
ILLUS 4

Metal box recovered from pit [104]

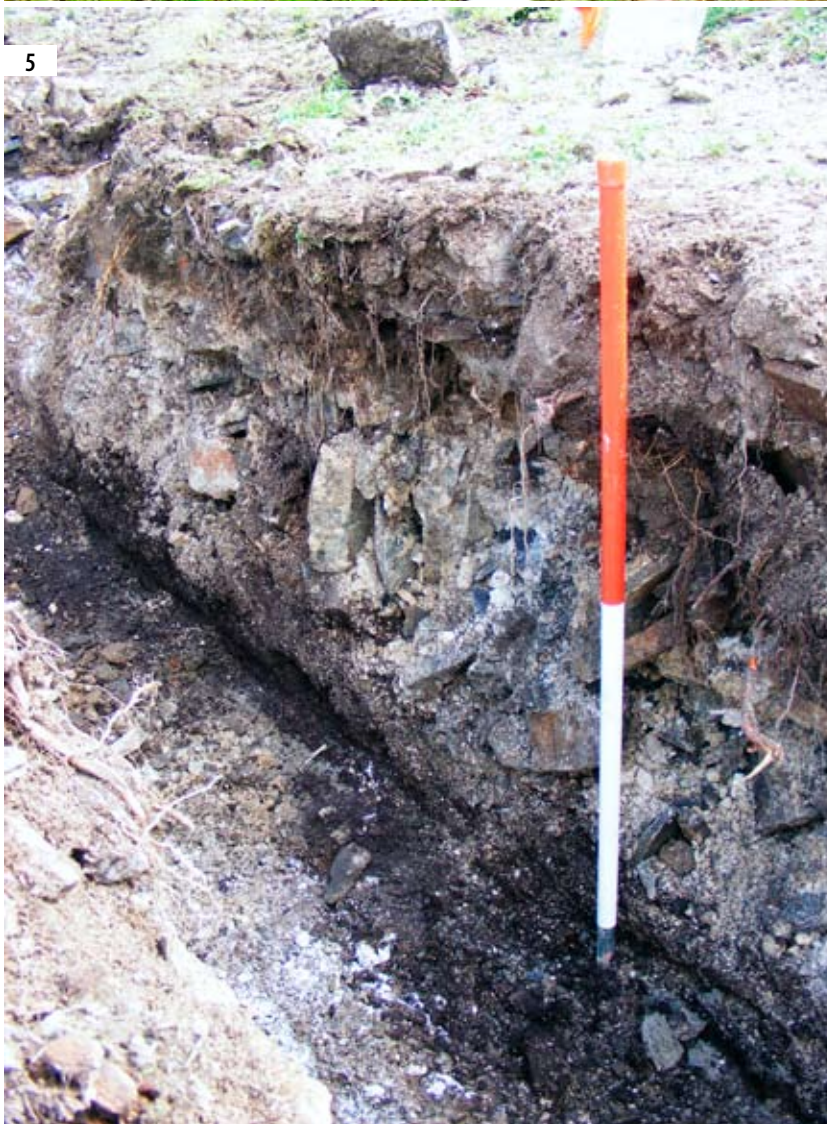
ILLUS 5

Section facing north-east in Trench 2 showing demolition and burning layers

A trench measuring 15m x 0.60m was excavated from the lower entrance to the mine workings in a south-easterly direction. An immature topsoil deposit (200) overlay a demolition layer (201) measuring 0.50m in depth. Worked stone, mortar and rubble were present in the deposit which appears to represent either the gradual collapse or the intentional demolition and leveling of structures on the site (**Illus 5**). The lack of stratigraphic change within the deposit would suggest the latter.

A deposit of charcoal and ash (202) beneath the demolition layer suggests the occurrence of a fire within the structures prior to demolition. The depth of the trench did not exceed 1.0m and no in situ deposits were observed.
