LAND TO THE REAR OF 86/94 WIDEMARSH STREET, HEREFORD

Archaeological Watching Brief

commissioned by Bluebell Properties

August 2014

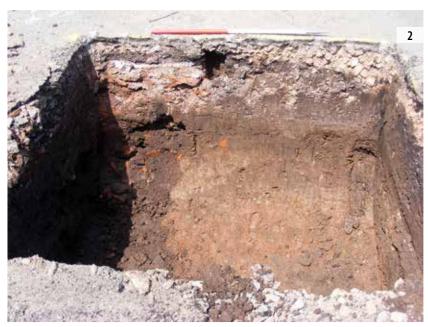
ILLUS 2

Section of Trench 1, facing SE, showing [102]

Section of Trench 1, facing SE

Trench 1 was 2m x 2m (**Illus 2, 3**) and excavated to a depth of 1.2m. The tarmac road and hardcore sealed the deposits and was 0.2m thick. Underneath was (101), a dark black brown silt clay with rare inclusions of post-medieval pottery, charcoal, coal, and brick. All were broken into small pieces. This layer was 0.2m deep. Beneath

(101) was (104), a dark yellow brown silt clay with occasional gravels 0.6m deep. Very few finds were recovered from this layer and were similar to (101) in that they were all quite broken and were post-medieval in date. The natural gravels (105) were encountered below this layer. Cutting through (101), (104) and (105) to the south of the trench was [102] a feature 0.8m wide which extended out of the boundaries of the trench. It had steep sides and was excavated to a depth of 1m but was still continuing down into (105). The fill (103) was a dark silt clay with abundant amounts of post-medieval tile, brick, glass, pottery, metal, and animal bone. This material was a mixture of broken up and intact finds.

Features [102] and [204] cut through all earlier leveling deposits and are only post-dated by the concrete foundations of the workshop seen in Trench 2. It is impossible to say if they are the same feature but are likely to be contemporary and represent a demolition episode. The finds and material contained within these fills suggests the demolition of a mixture of industrial and residential buildings. This demolition episode is probably the same event witnessed in the 2010 evaluation to the east of these trenches.

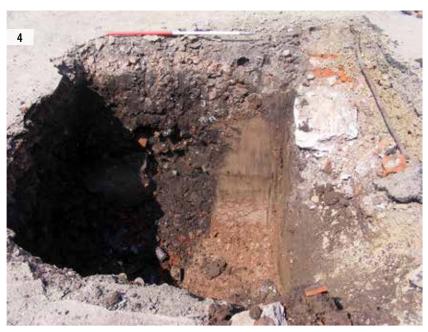
ILLUS 4

Trench 2 was 2m x 2m (**Illus 4, 5**) and was 1.4m deep. As with Trench 1 it was sealed by a layer of tarmac and hardcore (200) 0.2m in depth. To the north the brick and concrete foundations of the pre-existing workshop were observed, [208], (202) and (203), extending into the trench by 0.5m and continuing outside the limits of excavation. These foundations were 0.4m deep. [208] was cut into (206), a layer very similar to (104) with a depth of 0.7m. (206) overlay the natural gravels (207). To the south a large feature [204] 1.5m wide was encountered which was cut by the foundations [208] on its northern edge. This feature was very similar to [102] in that it cut through the previous deposit (206), had steep edges and, although excavated to 1.2m, continued down through the natural and outside the limits of the trench. The fill (205) was similar in composition to (103) in that it was predominantly made up of post-medieval demolition rubbish.

Section of Trench 2, facing SE, showing [204]

Section of Trench 2, facing SE
