# ROYAL OAK INDUSTRIAL ESTATE, DAVENTRY, NORTHAMPTONSHIRE

Archaeological Evaluation and Gradiometer Survey

for Ford Motor Company

September 2014

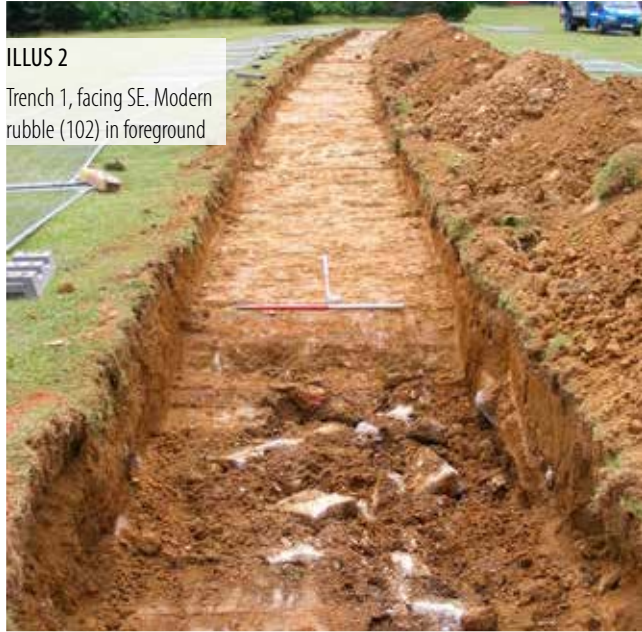
**ILLUS 2**  
Trench 1, facing SE. Modern rubble (102) in foreground

Trench 1 (Illus 2) measured 50m in length and was aligned northeast/southwest. The topsoil was a mid brown silt loam, probably imported. It overlay a mixed subsoil, containing modern rubble. At the north-eastern end of the trench, cutting the natural yellow stony natural

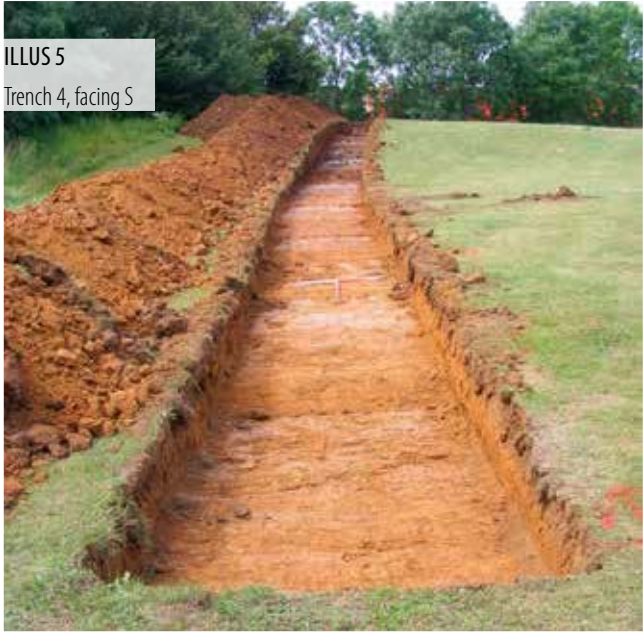
**ILLUS 5**  
Trench 4, facing S

Trench 4 (**Illus 5**) was 25m long and was aligned north/south. Excavation took place to natural deposits throughout (0.3m). Beneath the topsoil and subsoil the only deposits present were natural orange clays.

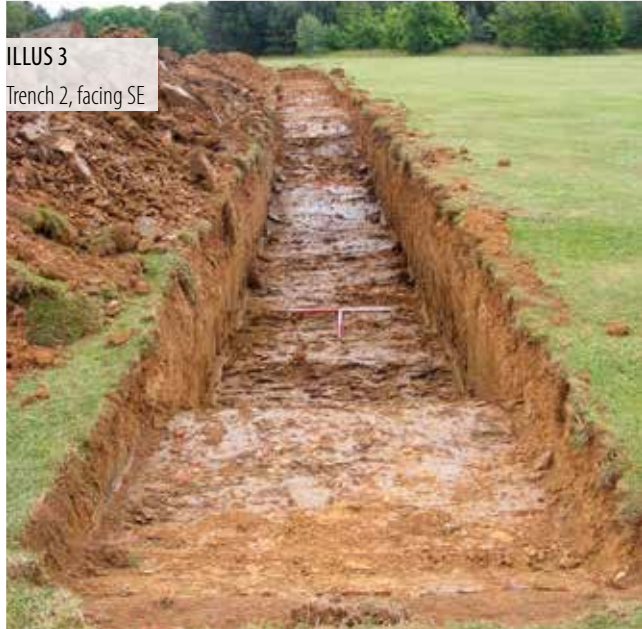
**ILLUS 3**  
Trench 2, facing SE

The second trench, Trench 2 (**Illus 3**) was aligned northwest/southeast and also measured 50m in length. It was excavated to 1.2m in depth at the northwestern end of the trench without natural deposits being encountered. The only deposit present was a brown clay which contained modern pottery, including blue and white transfer printed ware dating to the very end of the 18th century and later and scrap iron. The deposit smelled of oil or grease. It was investigated along the length of the trench using machine cut sondages and found to be present along the full length of the trench.

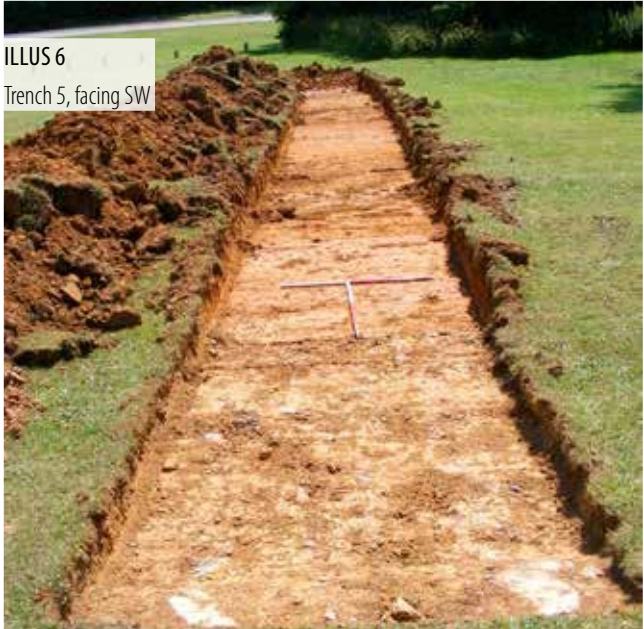
**ILLUS 6**  
Trench 5, facing SW

Trench 5 (**Illus 6**) was 50m in length and was aligned approximately east/west. It was excavated to a depth of 1.0m. The topsoil was approximately 0.5m deep above a mixed subsoil. The single feature identified in the trench was a linear feature (501) 1.8m wide filled with a dark reddish brown clay which contained occasional charcoal flecks. Pottery seen in the feature included transfer printed ware, the presence of which was noted, but it was not retained. The natural deposit in the trench was a bright orange brown clay.

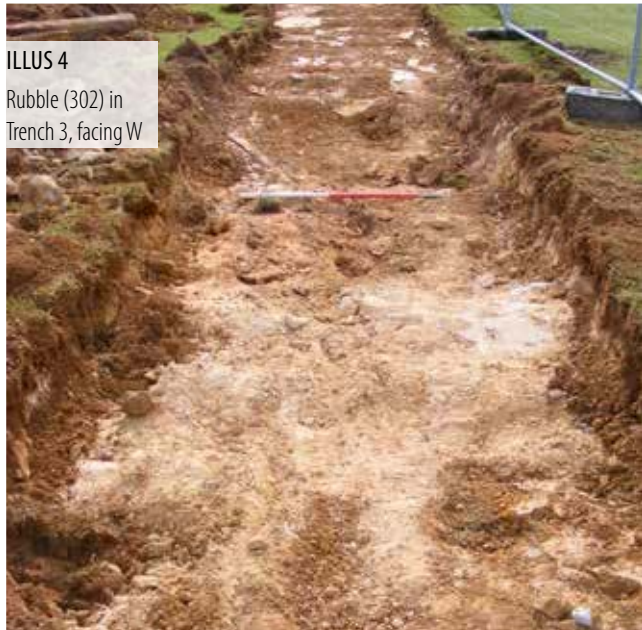
**ILLUS 4**  
Rubble (302) in Trench 3, facing W

Trench 3 (**Illus 4**) was aligned northwest/southeast and was 50m long. It was excavated to a depth of 0.25m at which point the natural limestone was apparent. The only feature in the trench was a 6.5m long hollow containing scrap iron and other modern rubble, including plastic, in a white sandy plaster or mortar.

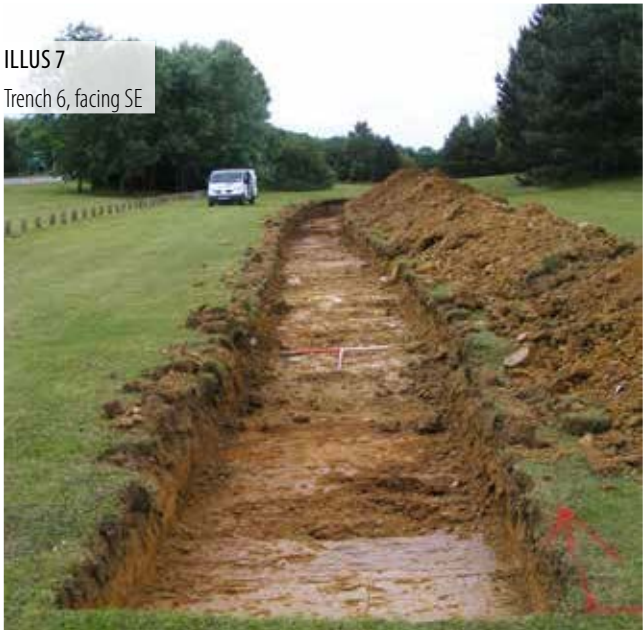
**ILLUS 7**  
Trench 6, facing SE

Trench 6 (**Illus 7**) measured 25m in length and was aligned north/south. It was excavated to a depth of 0.3m at which depth the natural clay was encountered. At the northern end of the trench

was a cut (601) extending outside the trench, filled by 602, a mixed rubble including brick and concrete. Natural deposits in the trench were bright orange brown clay.

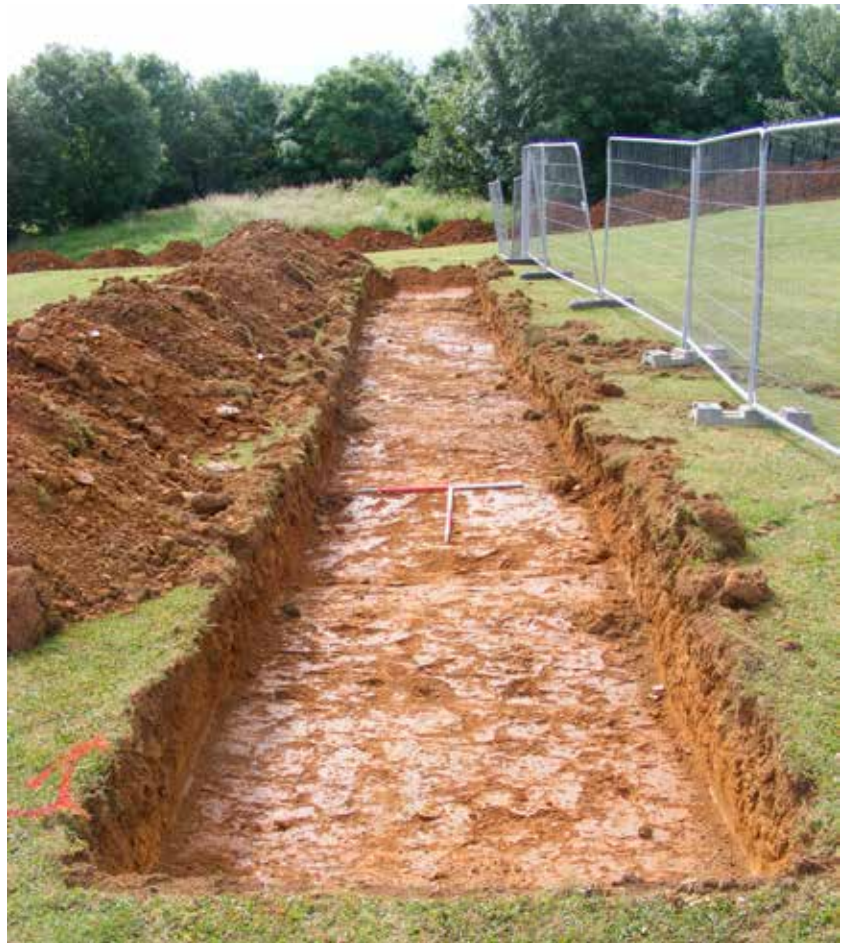
**ILLUS 8**

Trench 7, facing NW

Trench 7 (**Illus 8**) was 50m in length and was the easternmost trench to be excavated. It was aligned more or less east/west and was dug to a maximum depth of 0.6m. Beneath the topsoil was a layer of disturbed, redeposited natural clay, containing modern rubble. The natural orange brown clay was present beneath this deposit.

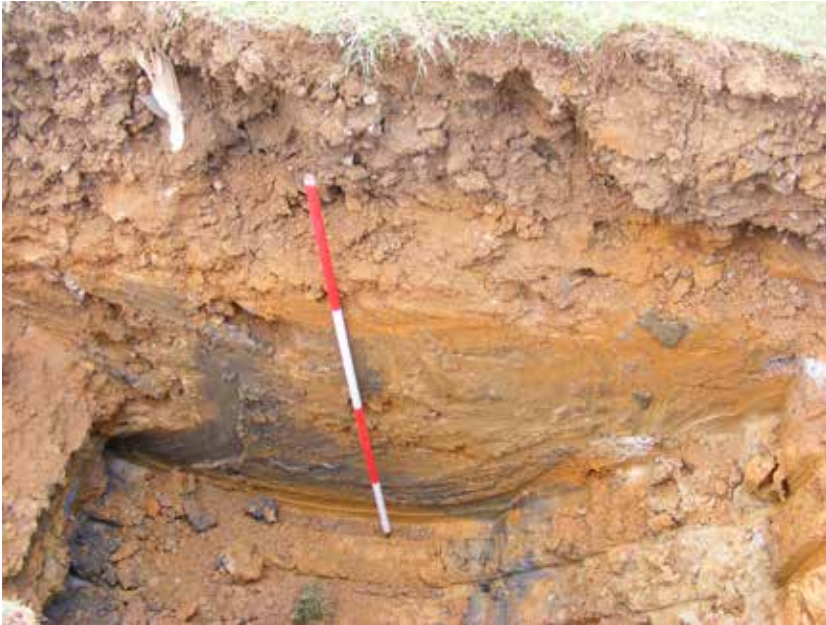
ILLUS 9

Eight small test pits were excavated in the north-eastern part of the site, an area previously identified as being made up ground. Although made up ground was identified in the ground investigation this was not found to be present in the test pits excavated as part of the archaeological work. A 0.2m deep layer of topsoil was present in the entire area of the test pits. The layer of modern rubble beneath this varied to a maximum of 1m deep. Beneath it the natural clay or limestone was identified in all the pits (**Illus 9**).

Test Pit 1, facing N

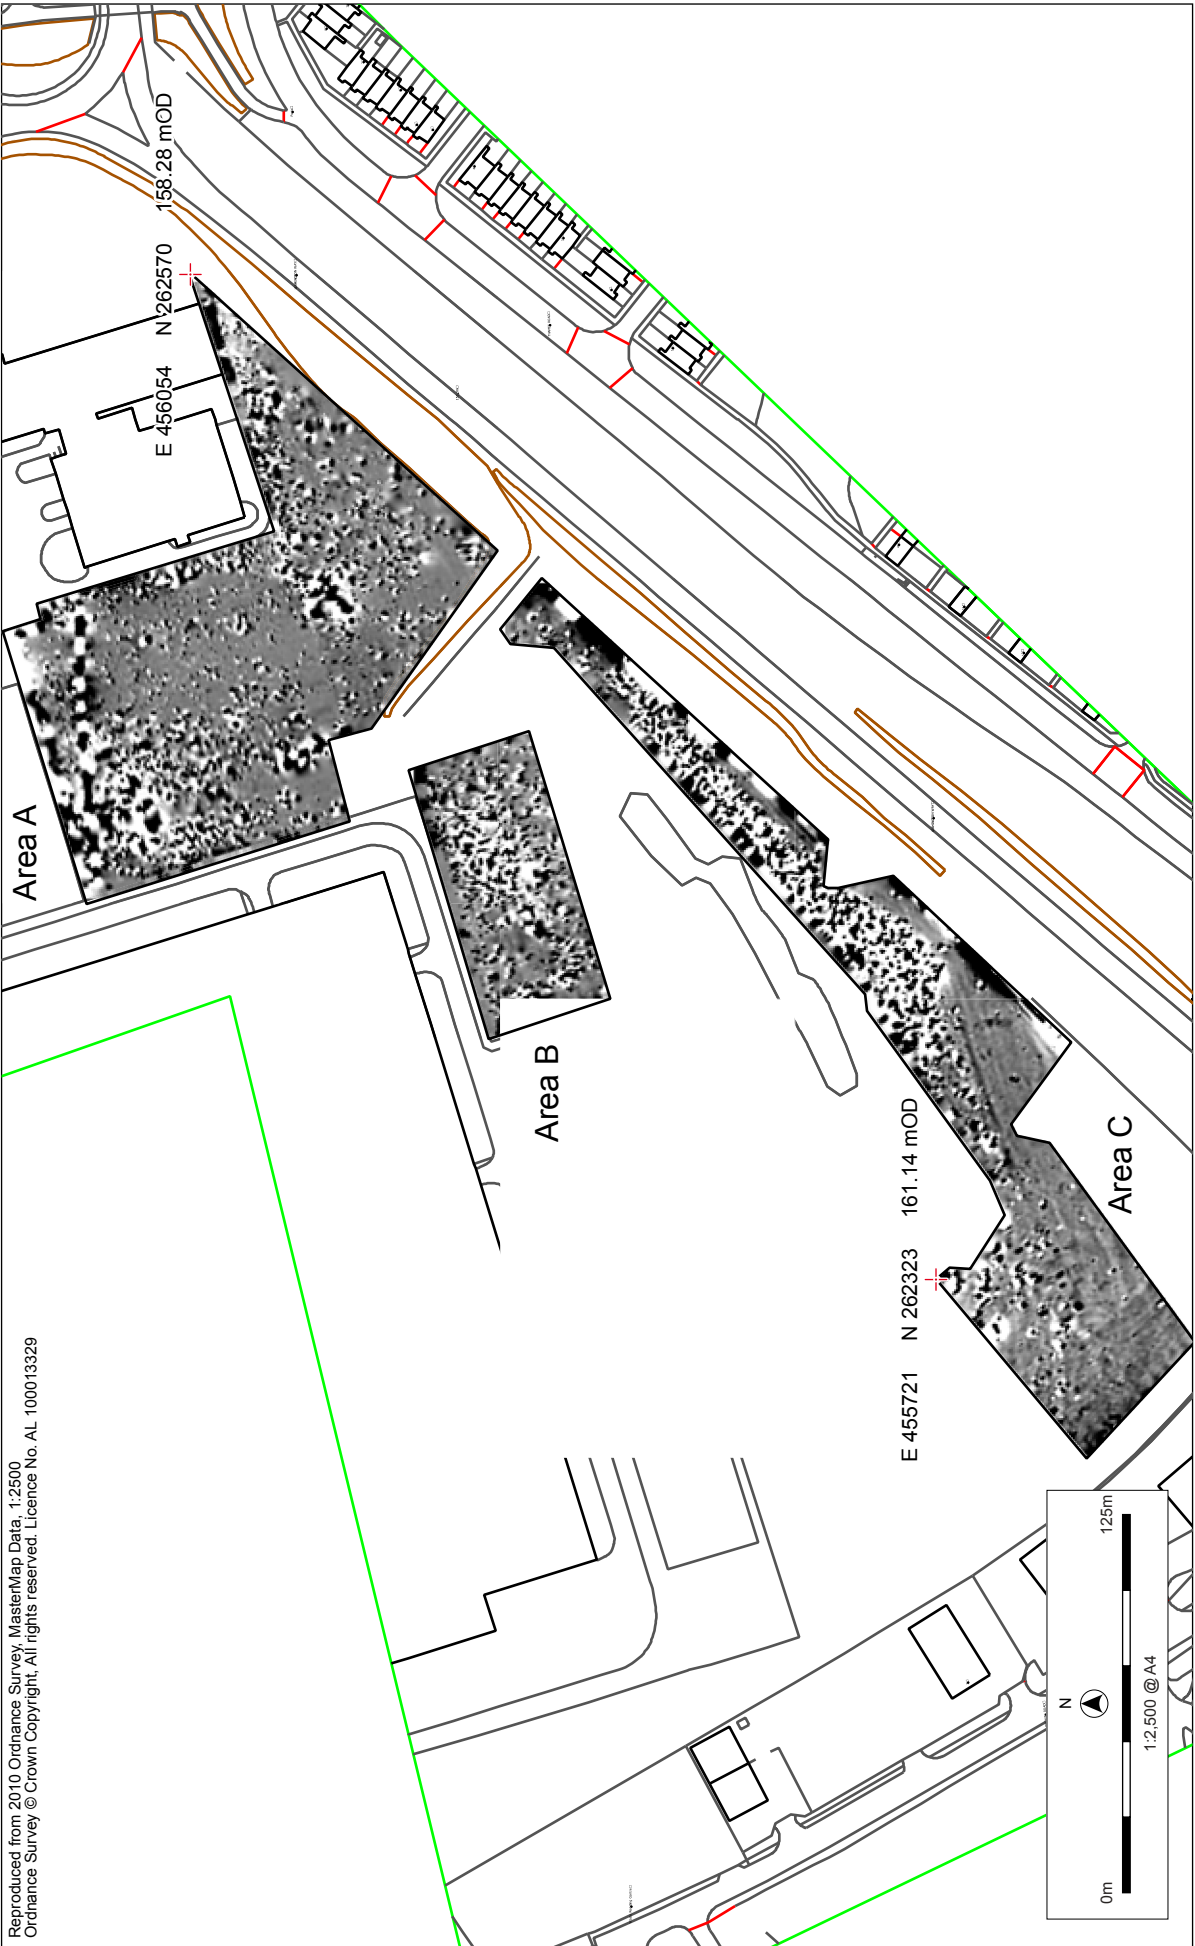
ILLUS A2.2  
Processed data (Areas A, B and C)

The results from Area A1 depict numerous ferrous anomalies. There are spreads of numerous ferrous items in some area of Area A1, but there is nothing visible on the ground in this area. It is unclear if these anomalies area caused by ferrous material or stones/boulders composed of the iron rich ferruginous limestone.

The results from Area B1 are variable throughout, depicting numerous ferrous anomalies. It is unclear whether these anomalies

are caused by ferrous material, or by stones/boulders that are derived from the ferruginous limestone bedrock. The results in the northwest of the survey area are particularly variable and show a concentration of the material described above. There is a ferrous pipeline running almost straight east/west, entering and exiting the survey area in the north-eastern corner.

The results from Area B2 are extremely variable throughout, depicting numerous ferrous anomalies. It is unclear whether these anomalies are caused by ferrous material or a spread of stones/boulders derived from the underlying ferruginous limestone. The concentration is sufficient to render no 'quiet' areas, thereby completely obscuring any archaeological remains that may be present. This survey area is located on the flat plateau and is located on the same elevation as the factory itself. It is therefore likely that this area is entirely made ground, devoid of any archaeological features; intrusive investigation would be required to ascertain the depth of this material and whether it masks deposits of archaeological potential.
