# IMPERIAL GATE, GLOUCESTER

## Archaeological Evaluation

commissioned by CgMS Consulting  
on behalf of Robert Hitchens Ltd

October 2014

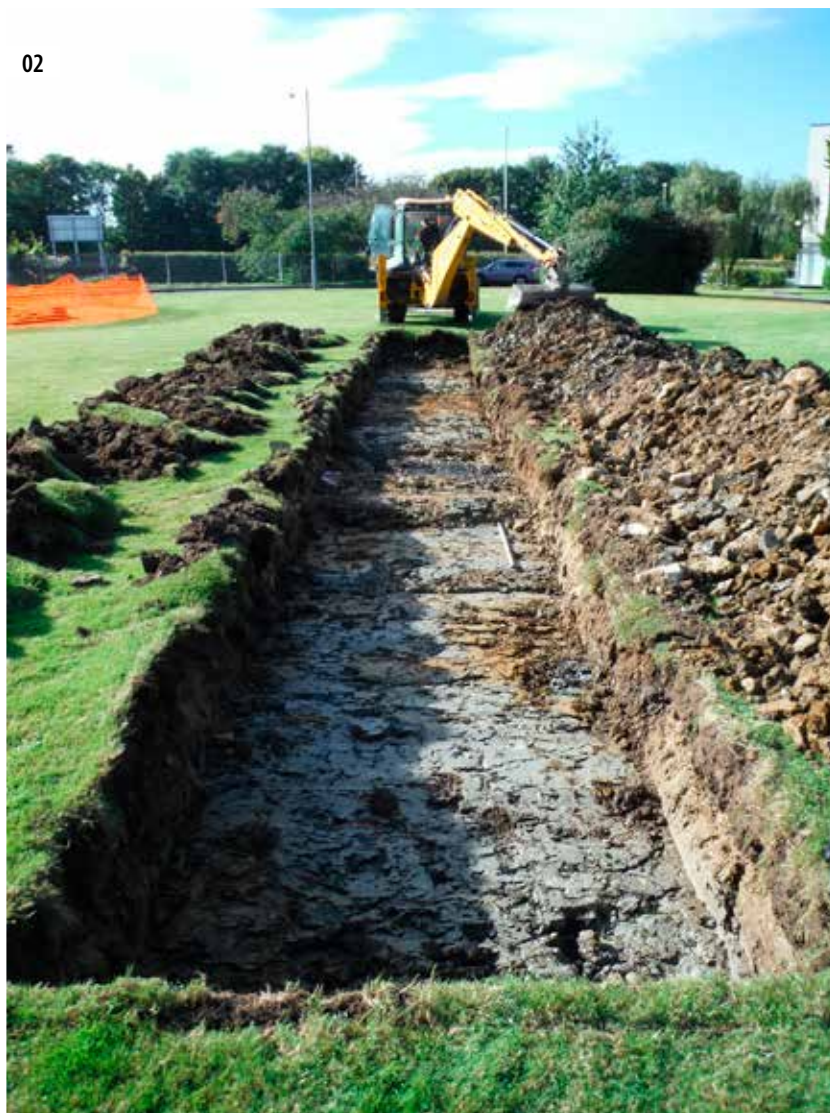
ILLUS 2

General view of Trench 1

Trench 1 was excavated to a depth of approximately 0.5m before a geological and archaeological sterile horizon was encountered, investigation of the geological deposits was conducted to a further depth of 0.25m, the geological natural remaining consistent. Within the trench a line of a modern service run was identified, aligned approximately north-south, the service run was comparable to one identified within Trench 2 ([2005]), both sharing a similar fill and coal dust capping. The service run [1004] was cut from a modern deposit of building debris (1002), located directly beneath the topsoil which consisted of a mixture of stone, brick fragments and concrete. Slight traces of charcoal smearing visible at the surface of the substrate were investigated, but were not associated with any archaeological feature and are likely to have derived from the modern levelling activity.

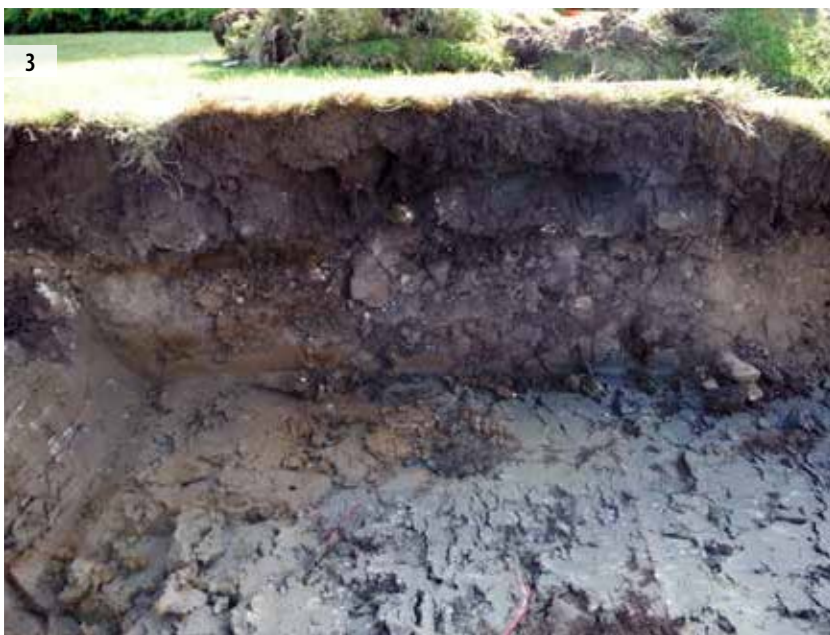
**ILLUS 3**

S facing section of Trench 1

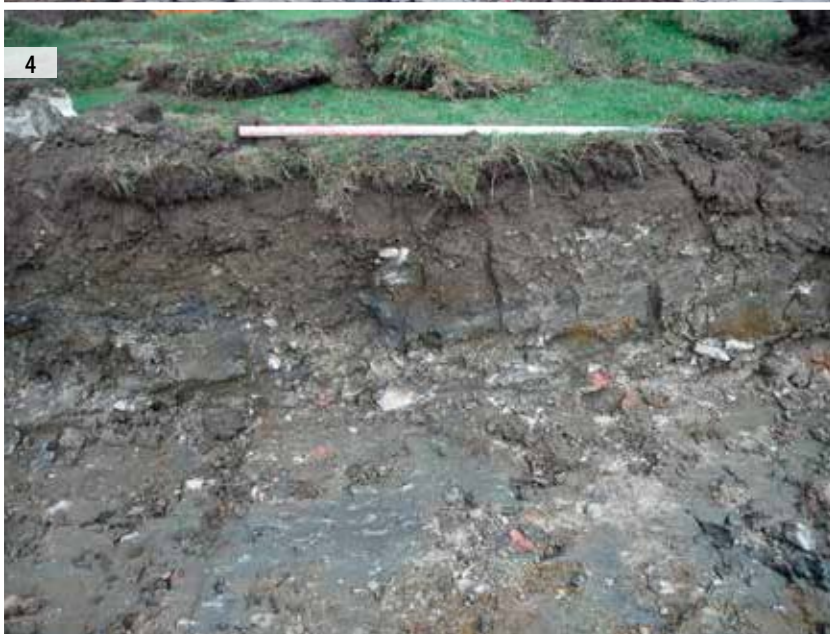
**ILLUS 4**

S facing section of Trench 2

The stratigraphic sequence of Trench 2 was identical to that of Trench 1, however the depth of the deposits was slight greater, suggesting that the present landscape has been levelled.

Within the evaluation trench three features were identified, two relating to modern service runs ([2005], [2007]) while [2004], a red clay pipe may indicate evidence of past agricultural land use in the form of a land drain.

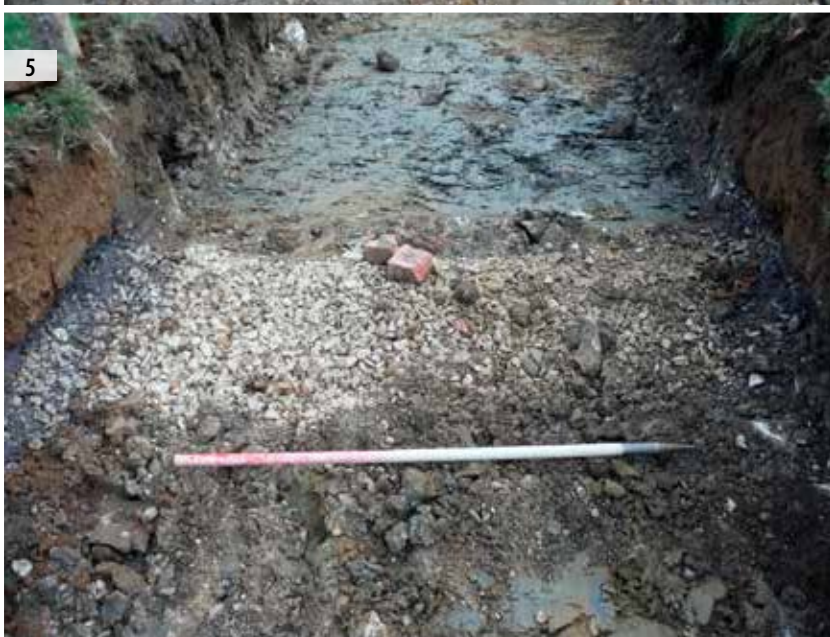
**ILLUS 5**

Detail of service run seen in both Trench 1 and Trench 2
