LAND OFF SCHOOL LANE, WHITMINSTER, GLOUCESTERSHIRE

Archaeological Evaluation

commissioned by CgMs Ltd on behalf of Robert Hitchins Ltd and its successors in title to the land

November 2014

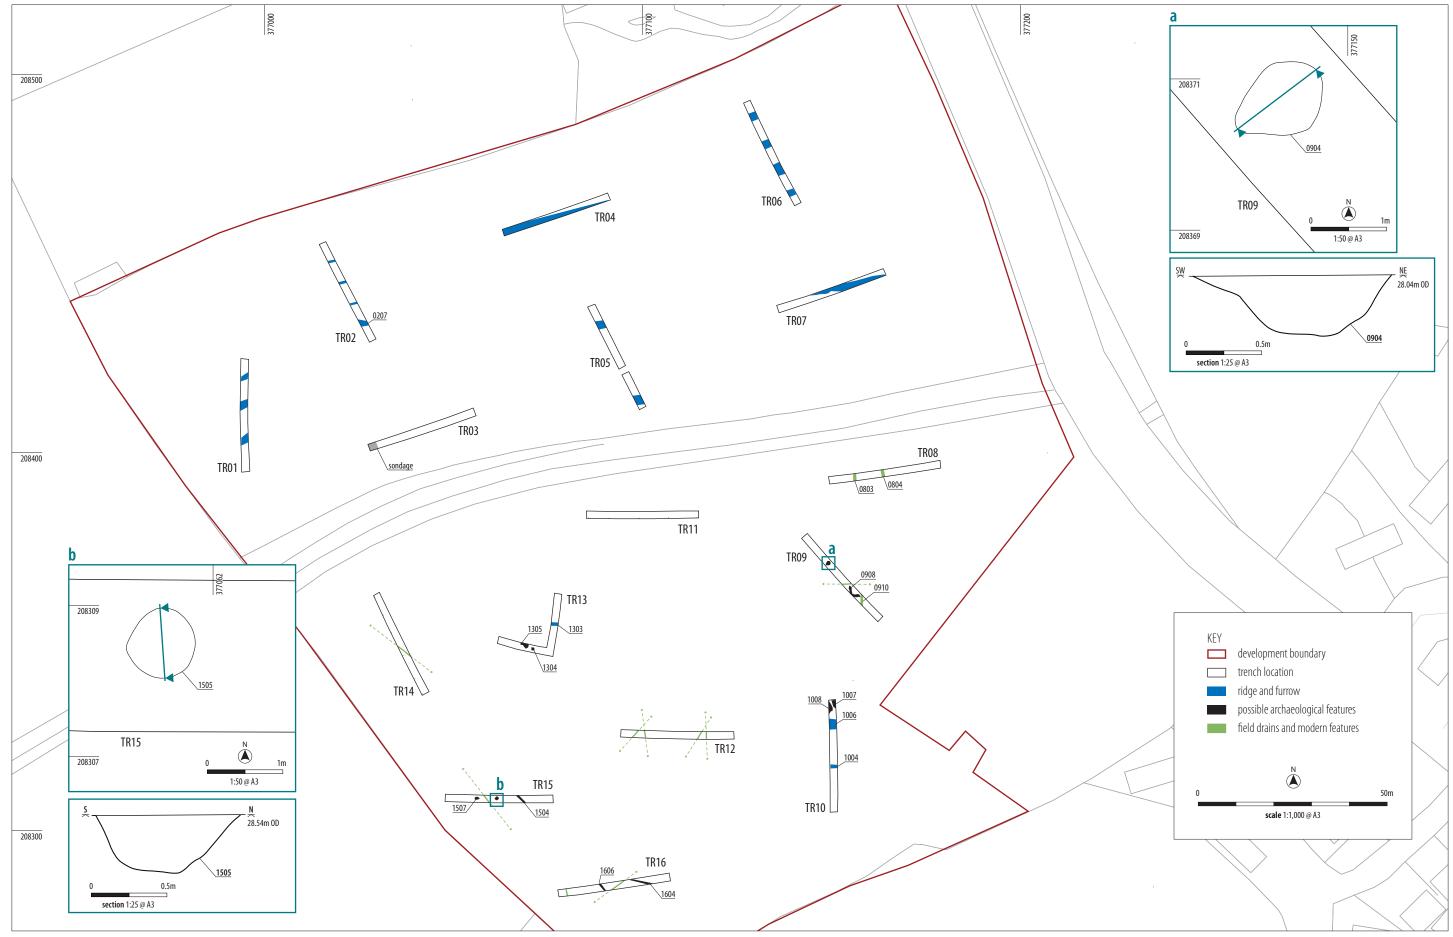
ILLUS 2 Site plan

The location of features discussed below can be found on **Illus 2**. A full trench and context register is included in Appendix 1.

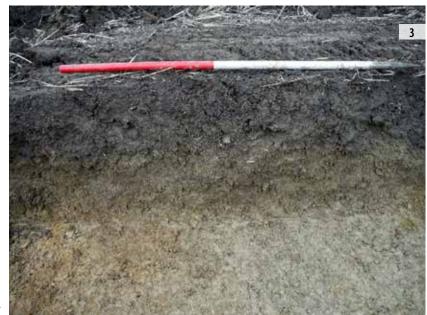
ILLUS 4

Pit feature [0904], SE facing section

An oval pit [0904] (Illus 4) measuring 1.2m in width was identified beneath subsoil deposits at a depth of 0.3m below ground level (BGL). The feature, which contained three fills, exhibited a steep sided profile terminating in a concave base at a depth of 0.4m. The lower fill [0907] was formed from a yellow silty clay similar in composition to the surrounding natural and is likely to represent the erosion of the sides of the feature following its original excavation. A thin (0.02m deep) charcoal lens [0906] was formed over deposit [0907] and was sealed by the upper fill of the feature [0905] which consisted of a mid brown silty clay with an orange hue. No artefacts were recovered from the feature and its date is unknown.

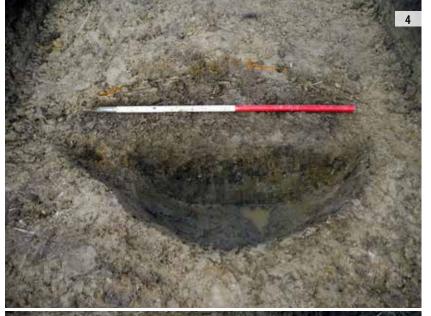
ILLUS 5

Linear feature [0908], northern terminus

Approximately 8m to the south-east of pit [0904], an L-shaped linear feature [0908] was identified (**Illus 5**). The feature was irregular in form, varying in width between 0.36m and 0.62m along its length. The feature displayed a rounded terminus to the north and was truncated by a modern feature [0910] to the east. The single fill of the feature [0909] extended to a depth of 0.12m and comprised a light brown silty clay with a yellow hue. No artefacts were recovered from the feature. The irregular nature of the feature is suggestive of tree rooting or animal burrowing activity.

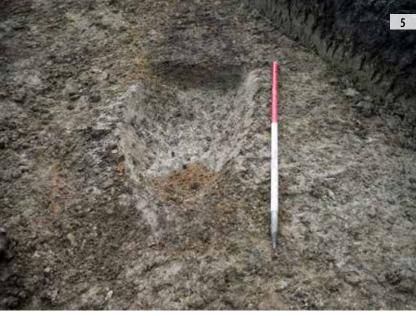
ILLUS 6Trench 10, camera facing N

Two potential features [1007] and [1008] were observed at the northern end of Trench 10 at a depth of 0.3m BGL. Due to the infiltration of groundwater into the northern end of the trench (**Illus 6**) it was not possible to excavate the features and no dateable material was recovered. The features were amorphous in shape and were filled with deposits identical in nature to the overlying subsoil. Evidence for ridge and furrow was identified immediately to the south [1006] and it is possible that the features relate to disturbance caused by ploughing in this area.

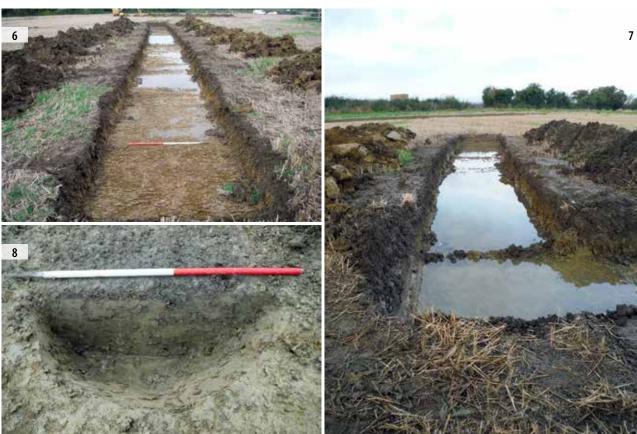
ILLUS 7

Groundwater in Trench 13, camera facing W

Trench 13 was targeted upon weak anomalies identified by the geophysical survey. During machining two potential features were identified in the southern part of the trench at a depth of 0.43m BGL. A small rectangular feature [1304] measuring 0.66m x 0.59m in plan was filled with a mid brown silty clay. Immediately to the west of [1304] was a roughly circular feature measuring approximately 1.3m in diameter. The feature was filled with a clean orange gravel, which may be natural in origin, however the regularity of the feature in plan suggests that an archaeological origin is also possible. Excavation of the features was not possible due to the infiltration of groundwater (**Illus 7**).

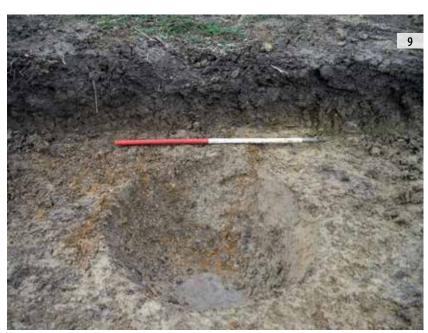
ILLUS 8

Pit feature [1505], E facing section

A circular pit [1505] (**Illus 8** and **Illus 9**) measuring 0.9m in diameter and 0.4m in depth was identified beneath subsoil deposits at a depth of 0.35m BGL. The feature, which was fully excavated, contained a single fill [1506] composed of a mid brown sandy clay with a grey hue. A small quantity of animal bone was recovered from the upper surface of the feature, however, no dateable material was identified. Approximately 4m to the west of [1505] a further pit was identified at a depth of 0.4m BGL. Pit [1507] was oval in shape and measured 1.15m x 0.73m in plan. Due to the infiltration of groundwater at the western end of the trench, the feature was not excavated. The fill was observed to be similar in nature to deposit [1506].

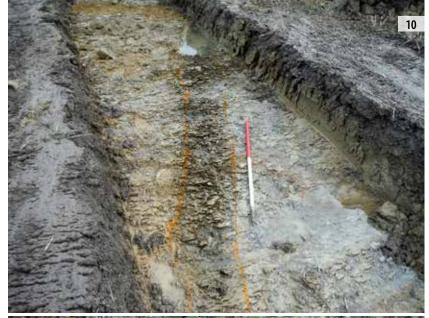
ILLUS 9
Pit feature [1505], fully excavated

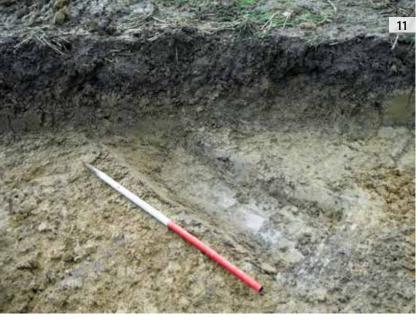
ILLUS 10

Linear feature [1604], camera facing SE

Two linear features on differing orientations were identified within Trench 16. Linear [1604] (**Illus 10**) was identified beneath subsoil deposits at a depth of 0.35m BGL. The feature was orientated approximately E-W and measured 0.5m in width and 0.1m in depth. No artefacts were recovered from the fill [1605] and the feature remains undated.

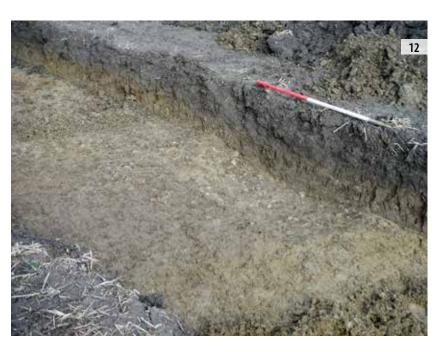
ILLUS 12

Evidence for ridge and furrow field systems was identified in eight Trenches (01, 02, 04, 05, 06, 07, 10 & 13) predominantly in the northern part of the site. Undulations were noted in the topsoil and subsoil deposits, but the impact of furrows into the underlying geological deposits varied from trench to trench. Furrows were excavated in Trenches 02 (Illus 12) 10 and 13 where the impact of the furrows into the underlying geological deposits measured between 0.1m (Trench 10) and 0.12m (Trenches 02 and 13).

Furrow [0207], W facing section
