RYEFORD, STROUD, GLOUCESTERSHIRE

Historic Building Recording

commissioned by The Environment Agency

August 2015

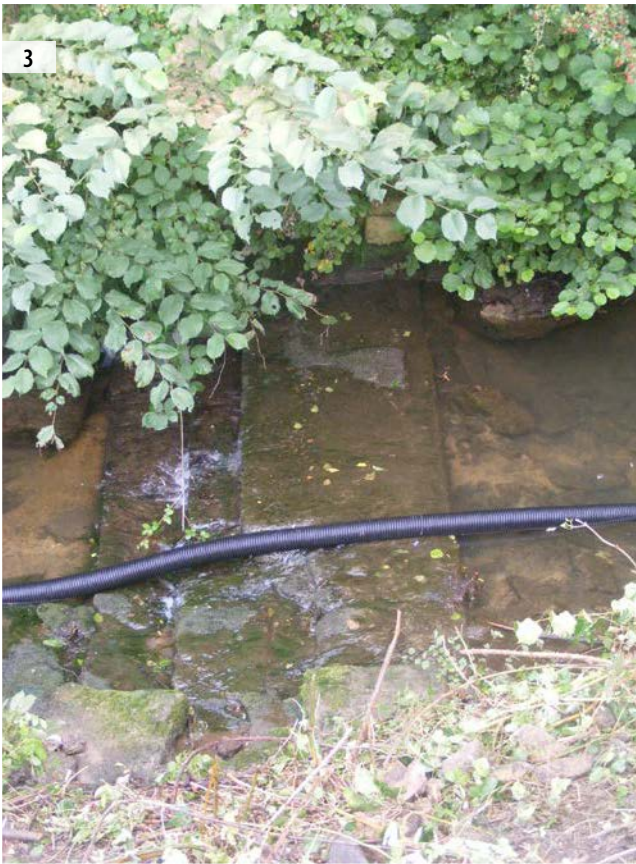
ILLUS 3

The weir (**Illus 2**) is positioned at an angle of 90° to the direction of water flow within the southern river channel. The north-western wing wall constructed of limestone ashlar blocks flanks the stepped base of the weir which falls in a south-westerly direction (**Illus 3**). A recess cut into the wing wall (**Illus 4**) is likely to relate to a water management system which formerly controlled the head of water upstream of the weir. The south-eastern wing wall has been lost due to erosion and land slippage of the south-eastern bank. The upper courses of the weir only survive in one location with the remaining stones washed downstream; but at the time of the survey were visible within the stream bed.

Photo showing the weir prior to the works

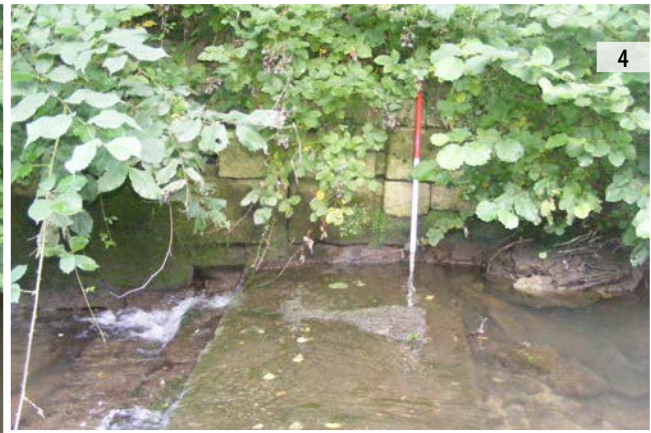
ILLUS 4

A stone cut recess was observed within remains of the wing wall of the side weir which indicated that the structure once contained a system of sluice gates which would have allowed the control of the water height within the River Frome. Removal of masonry on the side weir for the installation of the fish pass revealed that the weir was constructed in limestone with a solid stone core in contrast to the weirs downstream, which were stone faced with a brick core.

Photo showing the slot in the weir wall for a sluice gate

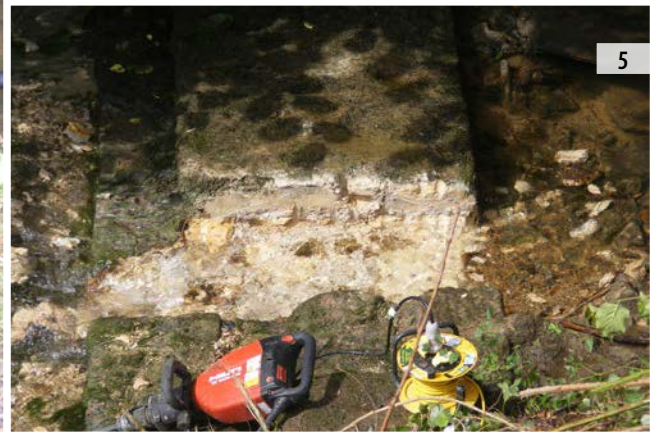
ILLUS 5

The subsequent alterations to the structure for the insertion of the fish pass involved the cutting and removal of some of the ashlar slabs forming the base of the structure. This allowed the identification of the stone type used in the construction and revealed that, unlike the weirs located downstream, the Ryeford weir was constructed in limestone with a solid stone core (**Illus 5**).

The construction of the fish pass in the side weir has allowed the core work and the construction methods involved in the original construction of the side weir to be examined. The core of the weir is formed of solid stone making it different to the weirs located downstream; which generally had a brick core with stone facing. The location of the weir is also unusual as it is set away from the main course of the river, the different location and change in construction may indicate that the weir belongs to a different phase of construction in relation to the water management schemes in place on the River Frome.

Photo showing the weir after the works

Changes to the fabric of the existing structure were required to enable the installation of a stainless steel fish pass. An 840mm section of the weir crest was cut through using hand tools to allow the fish pass to be positioned within the water flow.
