CRAVEN ARMS TO LUDLOW ELECTRICITY CABLE INSTALLATION

Archaeological Watching Brief

commissioned by Western Power Distribution

February 2015

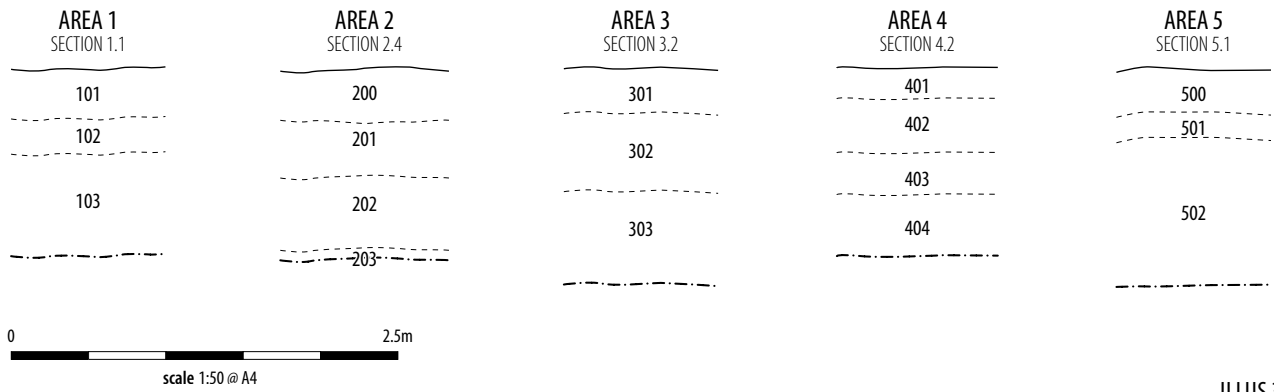
ILLUS 3

Sample sections from each area

The location of monitored areas and sample sections through deposits are provided in **Illus 2** and **3**. Full context descriptions are provided in Appendix 1.

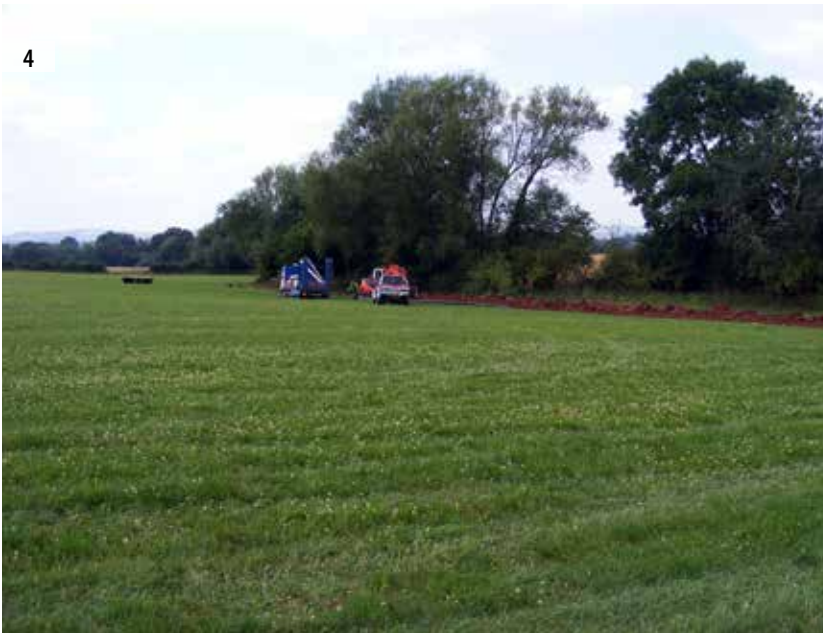
ILLUS 4

General shot, facing E, Area 1

Archaeological monitoring was undertaken to the east of the postulated Roman Road (**Illus 4**). A dark brown silty clay topsoil (101) overlay a light brown silty clay subsoil (102). A light brown silty clay deposit (103) believed to be geological in origin was identified at a depth of between 0.50 and 0.65m below ground level. The deposit continued to a depth of 1.20m below ground level at which point excavation terminated. No archaeological finds or features were identified.

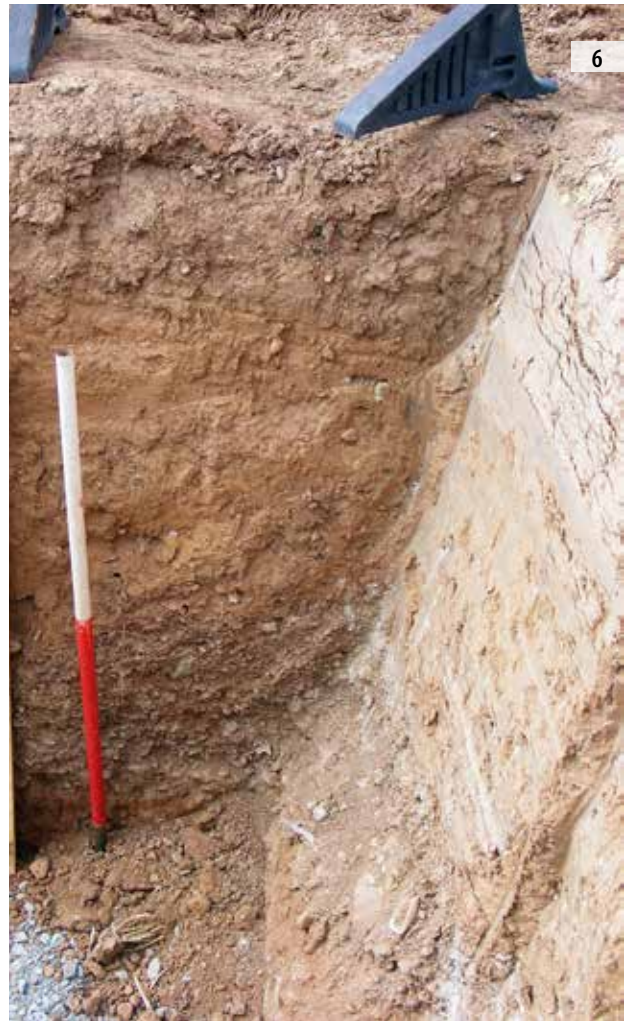
ILLUS 6

E facing view of section, Area 3

Junction box 3.2 measured approximately 3.00m x 2.00m in plan and was excavated to a depth of 1.40m below ground level. A dark brown clayey silt topsoil (301) measuring 0.20m in depth overlay a reddish brown silty clay (302). Coarse river gravel deposits (303) were identified at a depth of 0.80m and continued to the completed excavation depth of 1.20m below ground level (Illus 6).

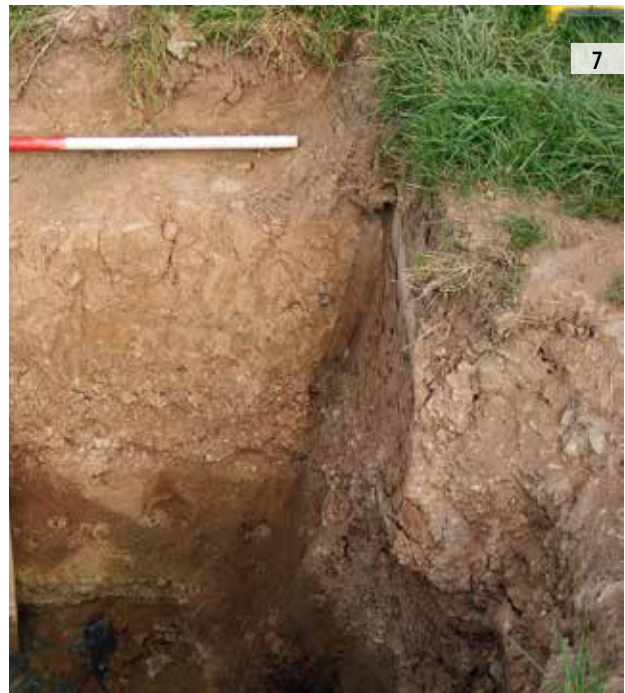
ILLUS 7

W facing view of section, Area 4

Deposits were generally consistent across the observation points, with only the underlying geological deposits varying. Topsoil comprised a dark brown clayey silt (401) and overlay a reddish brown alluvium (402) extending to a depth of between 0.50m and 1.20m below ground level. Deposits of geological sands and gravels (403/404) were identified beneath the alluvial deposits (Illus 7). No archaeological finds or features were identified within the excavated area.

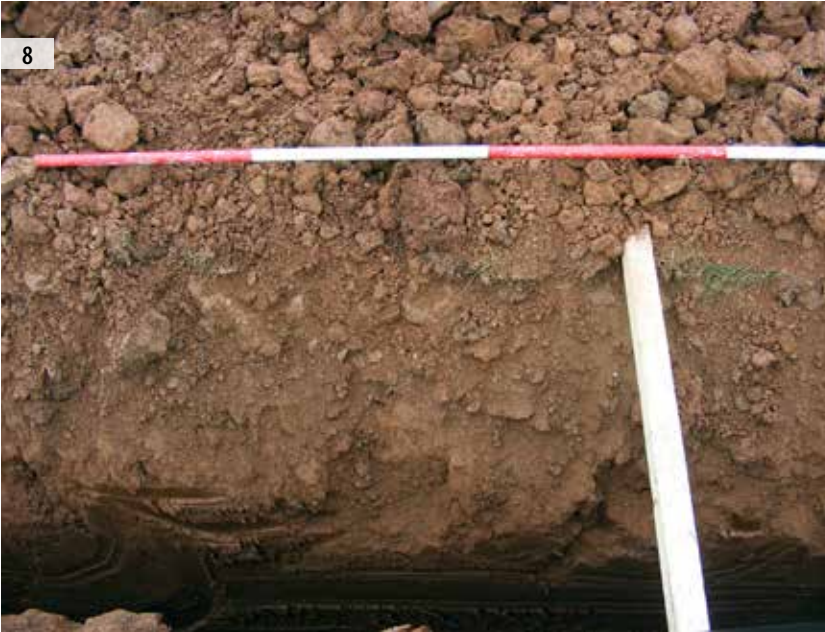
ILLUS 8

E facing view of section, Area 5

Continuous archaeological monitoring was undertaken across the full extent of Area 5. Deposits were consistent throughout (Illus 8) and comprised a topsoil (500), overlying a mid-brown orange, firm, silty clay (501), below which was a geological deposit of reddish brown clay marl (502) extending beyond the finished excavation depth (1.40m below ground level). No archaeological finds or features were identified over the course of the cable trench though this area.
