A49 NEWMARKET STREET ROUNDABOUT

Archaeological Watching Brief

commissioned by Amey Plc

June 2014

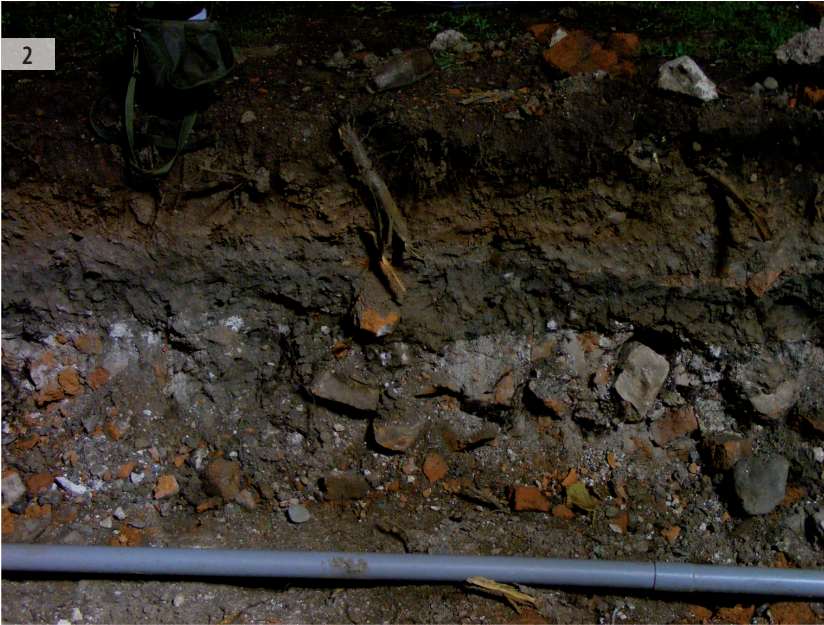
ILLUS 2

General view of section within Area 1, showing modern make-up levels

Within Area 1 the work consisted of the strip, excavation and construction of a new south-bound carriageway. The site was excavated to an average depth of 500mm below the present surface. The general make up of the area was topsoil, rubble, drainage service runs and a previous kerb and road edge. At the base of the excavations dumps of modern white china and brick building footings were uncovered. The modern intrusions and build up of the ground levels meant that no archaeological remains were observed. A large drainage run was also noted, indicating further heavy disturbance of the area.

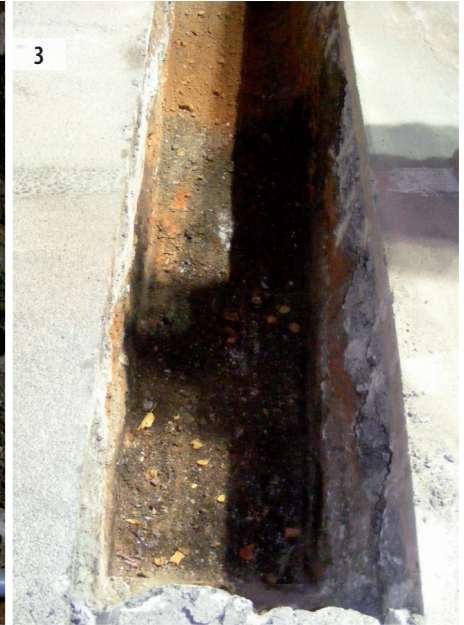
ILLUS 3

General view within Area 6, showing possible soil horizon at base level of excavated cable trench

A cable trench was excavated towards the south of the roundabout to a depth of 500mm. Beneath the associated modern makeup of the carriageway and subsequent resurfacing events a compacted soil horizon was observed. The excavation of the cable trench stopped at this level as the required trench depth had been achieved. No datable finds were observed within the soil horizon. Despite the subsequent levels of hard core associated with the road having been compressed into the surface of the deposit, it is possible that it represents an intact archaeological horizon pre-dating the modern road.

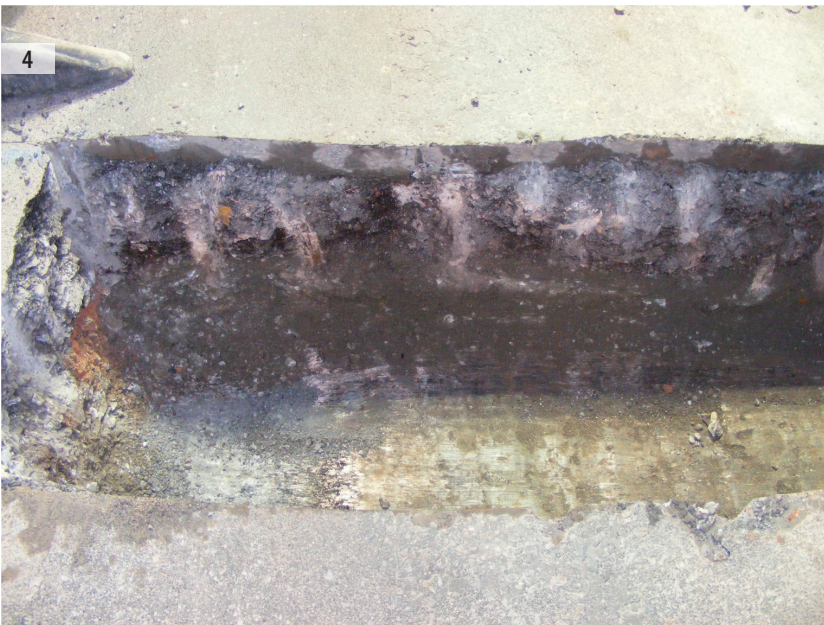
ILLUS 4

General view of section within Area 7, showing tarmac at base level of excavated cable trench

A series of cable trenches approximately 50mm wide and with a maximum depth of 600mm were excavated across the main carriageway through layers of made ground, consisting of hardcore and tarmac from previous road surfaces. No archaeological remains were observed.
