# CASTLE GATE (FORMERLY CORNER HOUSE) BROAD STREET, WEOBLEY, HEREFORDSHIRE

Archaeological Watching Brief

commissioned by Andrew R Thomas (Architect)  
on behalf of Mr Michael Ware

August 2015

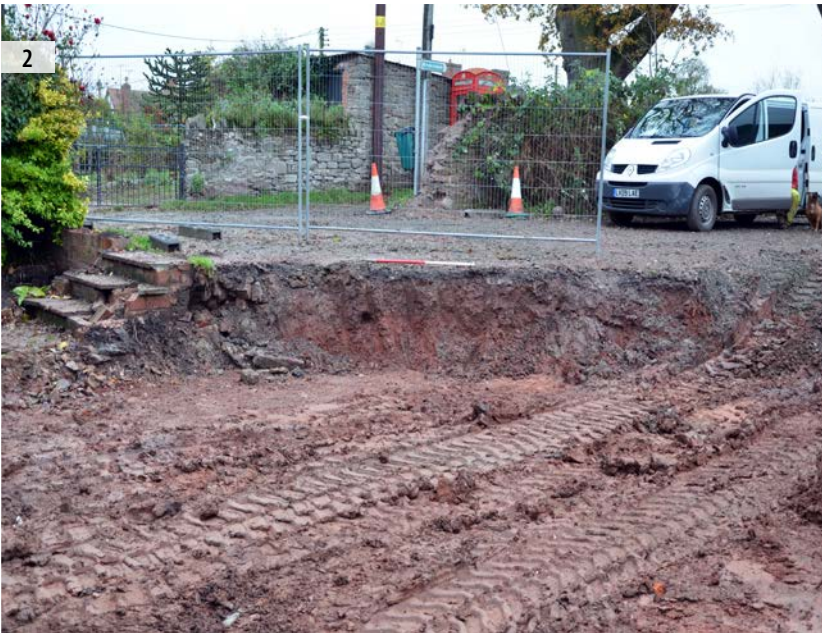
ILLUS 2

S facing detail view showing cut for staircase into sunken garden and original ground level in section

Archaeological monitoring was undertaken after the mechanical removal of the existing buildings and sunken patio area (Illus 2).

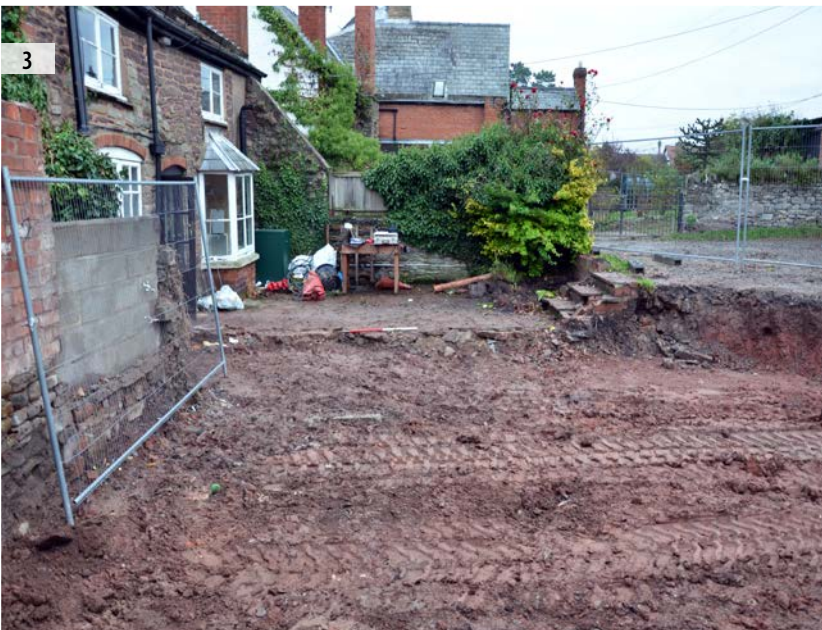
ILLUS 3

E facing view showing sunken garden area

The stratigraphic matrix of the area to the south of the existing sunken patio, when excavated, was represented by three distinct deposits. The earliest deposit encountered, at a depth of 0.45m from the ground surface, was the natural basement of red, slightly sandy clay (1003). This was excavated to a depth of 0.90m in order to form a level surface for the construction of the new extension. Immediately overlying this was a layer, 0.28m deep, of mid-dark red/grey friable silt (1002) which appeared to represent former garden soil. A number of fragments of modern white china were observed within its matrix. The uppermost horizon comprised a hard packed layer of hardcore and scalping's (1001), forming an area of hardstanding, approximately 0.10m deep (**Illus 3**).
