HOO BROOK, KIDDERMINSTER ELECTRICITY CABLE INSTALLATION

Archaeological Watching Brief

commissioned by Amec Foster Wheeler Environment & Infrastructure UK on behalf of Western Power Distribution

May 2015

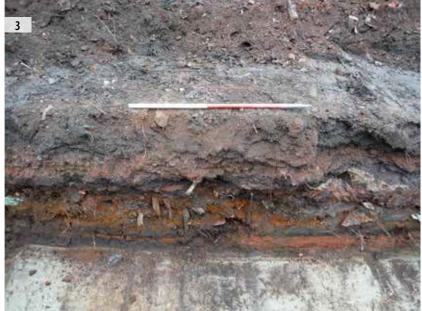
IIIUS 3

W facing section of modern deposit (1003)

At sporadic intervals along the course of the cable trench and for the final 50m to the south end a dump of mixed dark brown/yellow material (1003) consisting of sand, clay and silty topsoil was present between (1001) and (1002). Visible tip lines were present in the sections along with large quantities of plastic, brick, steel and glass (Illus 3). These were possibly rubbish dumps associated with the adjacent industrial estate.

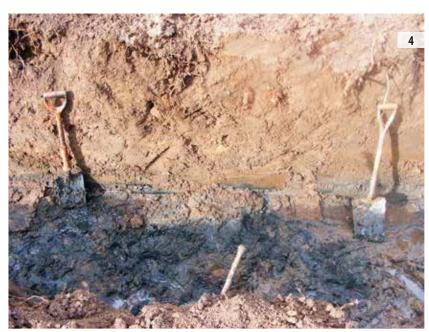
ILLUS 4
E facing section of organic deposit (1004)

Towards the northern extent of the site a dark grey-black silty organic deposit (1004) was noted at 1.20m below the ground surface. This extended for 24m along the cable trench beyond the areas of excavation to the east and west. The remains of brick, steel wire and an iron pipe were found in the deposit suggesting a modern date, the organic nature of the deposit could suggest a dump of material over a previous drainage channel (**Illus 4**).

No archaeological finds, deposits or features were identified during the course of the watching brief. It is possible that below the modern organic deposit (1004) there is a backfilled drainage channel. However, this was outside the limits of excavation. No evidence for the post-medieval rolling mill identified near the site prior to work commencing was found within the monitored area. No new heritage assets were identified during the course of the works.

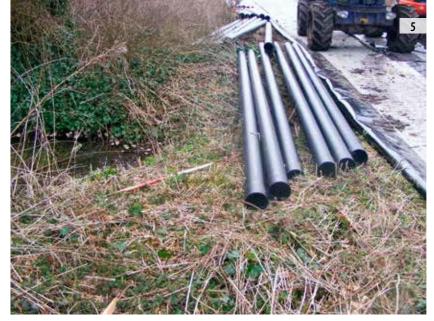
ILLUS 5

Former relief channel ending before excavated area

A former relief channel had been identified as crossing the path of the cable trench prior to commencement of the site work. However, upon excavation the channel was found to not extend that far on the surface or within the limits of excavation, a possible reason for this is the presence of modern waste material that could have filled the relief channel down to the extent of excavation. (Illus 5). This meant that a full profile of the channel was not recorded and a sample for environmental assessment/processing was not undertaken.
