ELECTRICITY SUB-STATION, BATH STREET, HEREFORD

Archaeological Watching Brief

commissioned by Western Power Distribution Ltd

June 2015

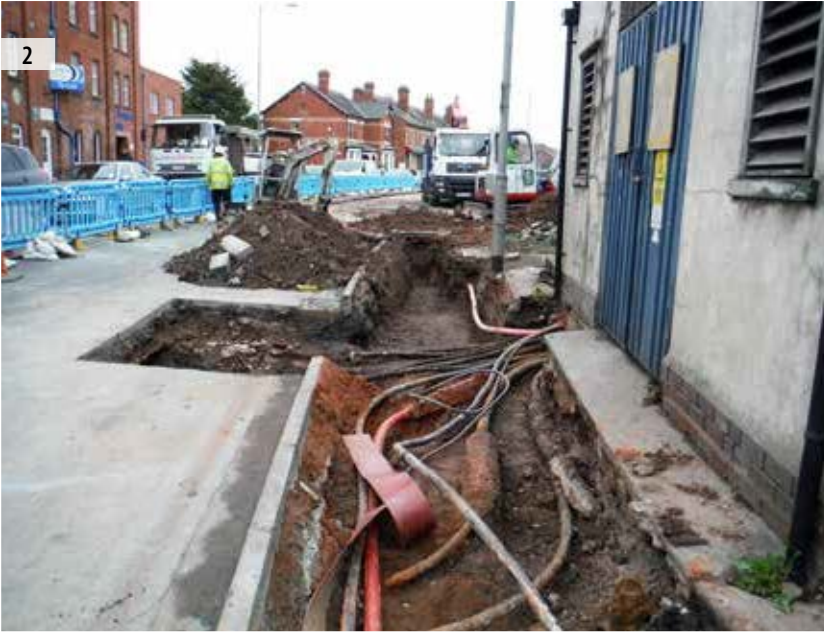
ILLUS 2

S facing view of cable trench in front of substation

A trench excavated to the east of the sub-station measured the full width of the existing pavement (1.75m) and was excavated to a depth of 0.86m (Illus 2). The trench was subsequently extended to the north-east beneath the road surface. The extension measured 1.5m x 2m in plan and was originally excavated to a depth of 0.86m. A 0.6m wide sondage was subsequently excavated into the base of the trench to a depth of 1.46m. To the south-east of the extension, the cable trench continued along the north-bound carriageway of Bath Street for approximately 45m until it terminated opposite the junction with Kyrle Street. Over this distance, the trench measured 0.6m in width and was excavated to a depth of between 0.75m and 1.27m depending on the existing cables and pipes present.

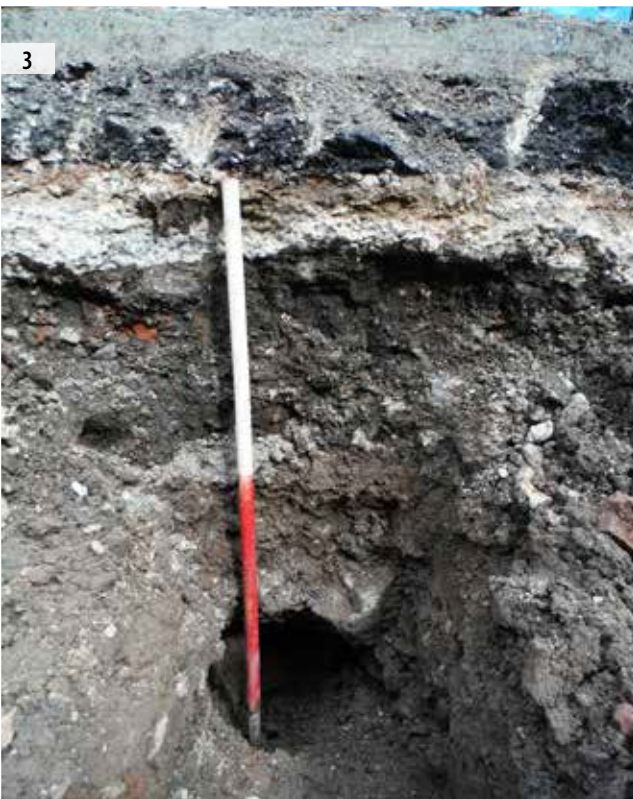
ILLUS 3

NE facing section through road into post-medieval deposit (1003) with void

The excavations beneath the pavement were confined to existing cable trenches backfilled with a dark black-brown clay (1002) approximately 0.3m in depth, the cables themselves having red sand around them for identification. Within the 1.5m x 2m trench extension which extended into the carriageway a deposit of dark red-brown clay (1003) with frequent small angular stones and rare charcoal flecking was identified at a depth of 0.76m below ground level. Occasional post-medieval and modern pottery as well as modern glass was present within the deposit. It was difficult to ascertain the true nature of the fill (1003) as no edges were visible due to the limits of excavation but it may relate to the backfilling of the city ditch in the nineteenth century. A machine dug sondage measuring 0.6m x 0.6m in plan was excavated through deposit (1003) to investigate any possible deeper cables though none were found. It was in this sondage that a small void was identified at a depth of 1.14m below the road surface (**Illus 3**), suggesting loose consolidation of deposits within this area.

The void identified at a depth of 1.14m within deposit (1003) may relate to a lack of consolidation of materials during the backfilling of the city ditch in the 19th century.

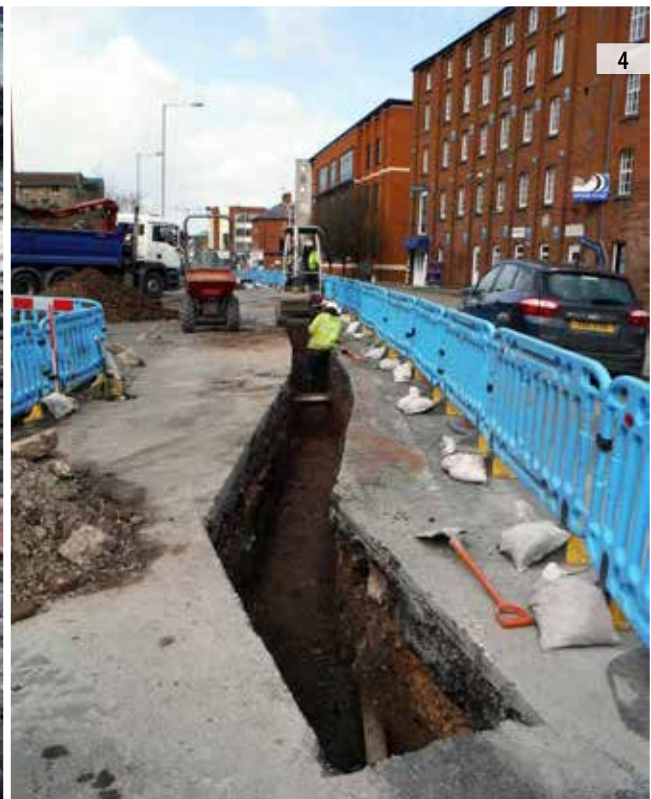
ILLUS 4

N facing plan of cable trench in roadway

The excavation of the trench continued in a south-easterly direction, terminating at the junction of Bath Street and Kyrle Street (**Illus 4**). Deposit (1003) was identified along the full length of the trench at a depth of between 0.76m and 1.28m, no earlier deposits were identified (**Illus 5**).

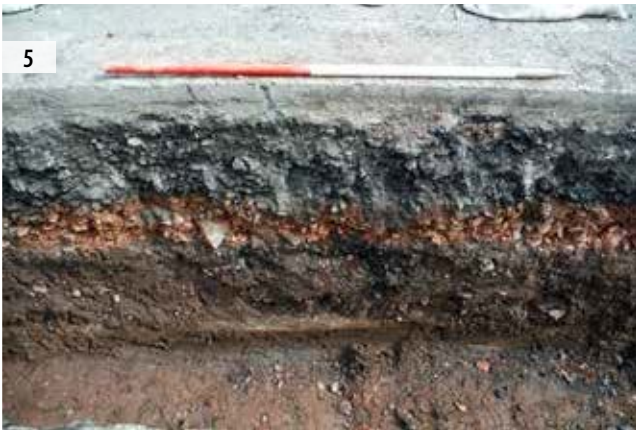
ILLUS 5

SW facing section of cable trench with modern pipe at base

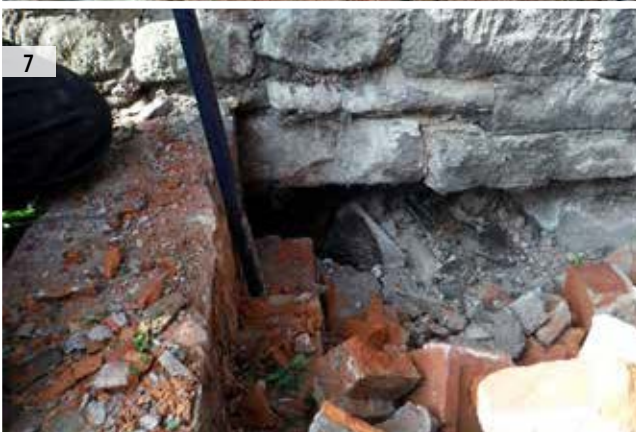
ILLUS 6

NW facing view of metal supporting pins for substation wall

Where the sub-station structure abutted the city wall, demolition was undertaken with a sledge hammer and by hand to reduce any damage to the stone wall (**Illus 6**). The southern sub-station wall was loosely mortared to the existing stone wall and was easily removed. The northern wall had two metal pins cut into the stone wall between three modern red bricks, likely for extra stability. These pins were removed with care to prevent damage to the stone wall (**Illus 7**).

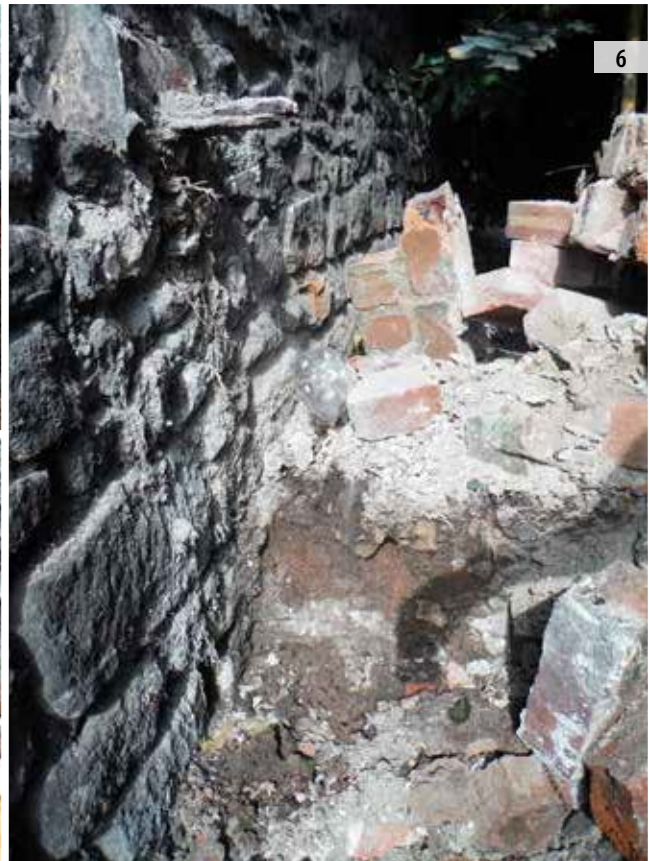
ILLUS 7

W facing view of void at base of stone wall

Beneath the city wall and adjacent to the southern wall of the sub-station a small void containing modern rubbish was identified. The void is likely to relate to a former power supply to the Police Station.
