HEREFORDSHIRE COUNTY HOSPITAL TEMPORARY EMERGENCY WARD AND SEPARATE CAR PARK

Archaeological Watching Brief

commissioned by Wye Valley NHS Trust

EHE 80135

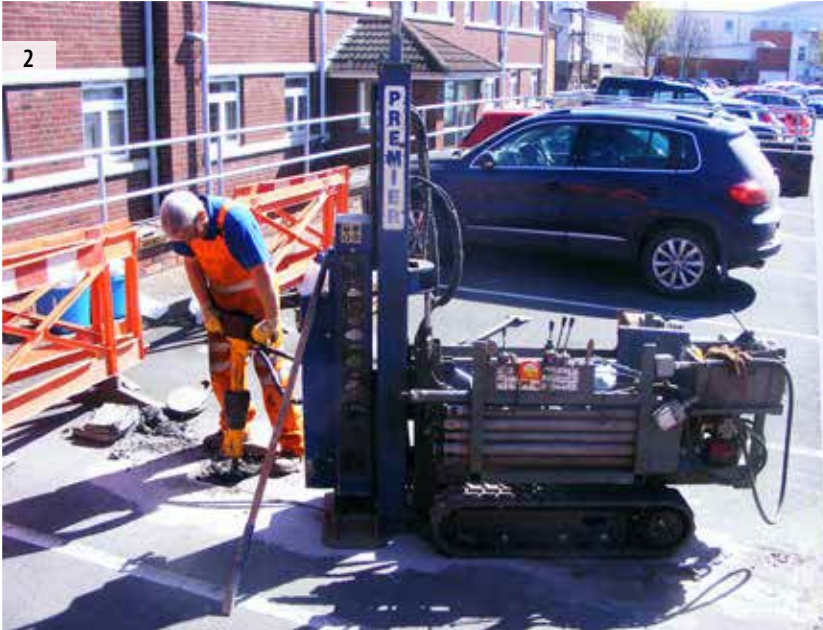
ILLUS 2

Excavation of test pit in Gwyndra car park prior to window sampling

At a depth of 1.2m hand excavation ceased and a window sampling percussion rig was positioned over the test pit (Illus 2). A 0.1m borehole was excavated into the base of the test pit to a maximum depth of 3m.

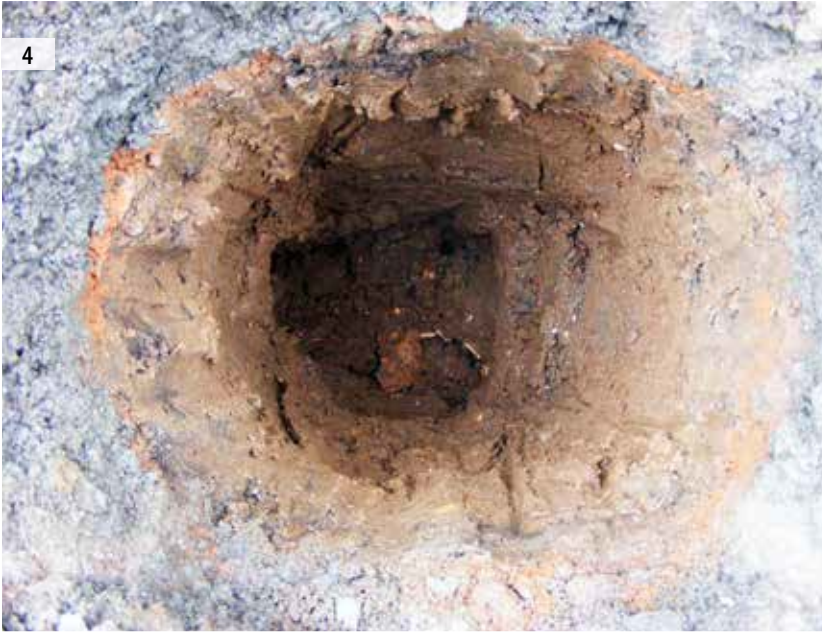
ILLUS 4

Human skull fragments found in hand dug TP04

Four attempts were made to excavate test pits to the required depth at the northern end of the car park (TP01, 03, 04, 05). In all cases human remains were encountered at a depth of between 0.8m and 1.07m and excavation was abandoned (**Illus 4**). Due to the limited dimensions of the test pits it was not possible to ascertain

Summary: Possible grave fill (0404) with human skull fragments at 1.07m beneath a large sandstone block – possible cist or coffin material.

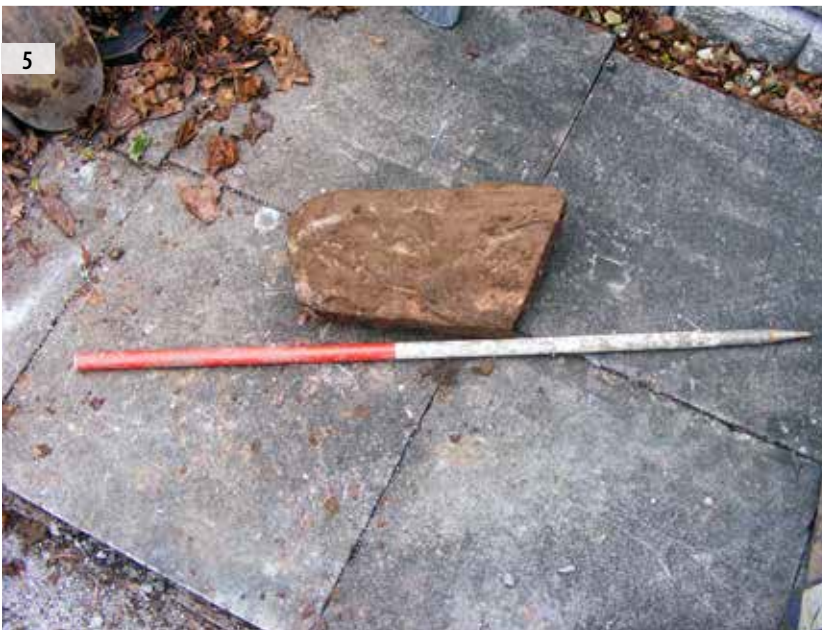
ILLUS 5

Possible sandstone cist fragment found above skull fragments in TP04

Within Test Pit 04 a sandstone slab (**Illus 5**), possibly representing part of a cist was located over human remains at a depth of 1.07m (51.43mOSL) below ground level.
