ABBNEY FIELDS COMMUNITY CENTRE, WINCHCOMBE

Archaeological Watching Brief

commissioned by Winchcombe Town Council

September 2015

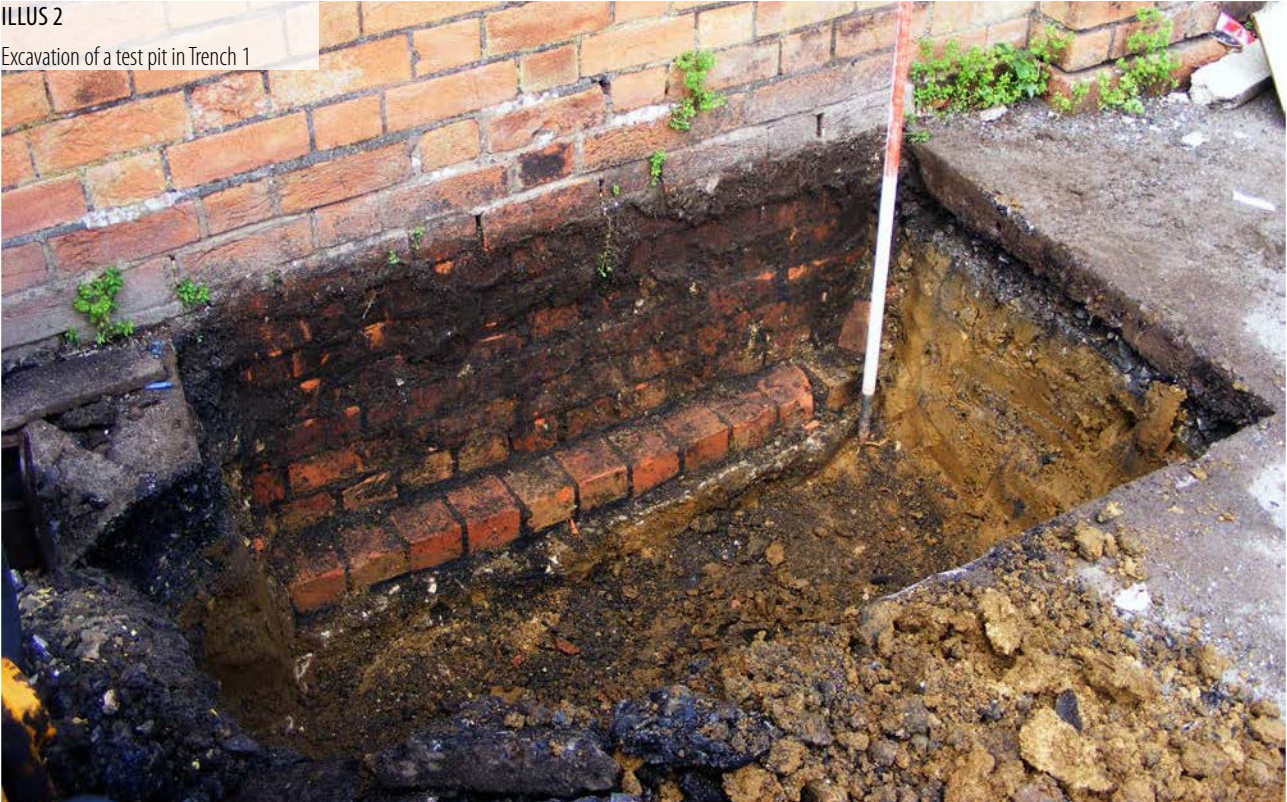
ILLUS 2

Excavation of a test pit in Trench 1

The excavation of a single test pit (Trench 1) adjacent to a length of subsiding wall at the western end of the site revealed modern, made ground to a depth of 0.65m+ at which point the foundation base was encountered. Upon removal of the tarmac and sub base (at a depth of 0.1–0.2m) along the length of the wall it was decided that no more excavation would be necessary due to the presence of concrete foundations (Illus 2) which were supporting the wall. No archaeological deposits were identified.

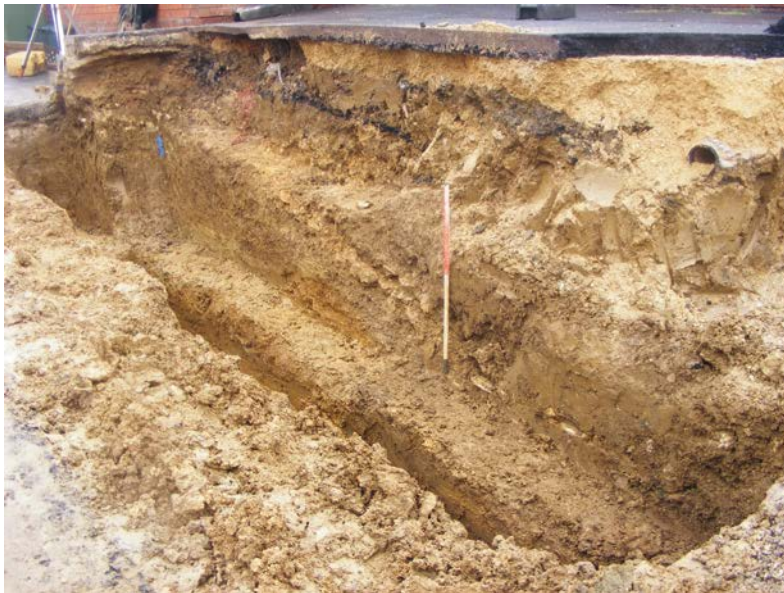
ILLUS 3
Location of NW facing section of section in the area of reduction (Trench 2) showing remnants of the probable Saxon-period 'clay bank'

Beneath made ground, at a depth of 1.0m below ground level, a mounded deposit of large compacted sandstone fragments [202] overlying a firm layer of light brown sandy clay [203] was identified (Illus 3). This in turn overlay a greyish blue clay [205] and an orange/brown sandy gravel deposit [206] considered to be geological in origin.

To the north-west of deposit [203] and apparently cutting [205] was a darker, less compact silt [204] which potentially represented a ditch fill, however, excavation ceased at the top of this deposit making interpretation speculative.

The deposits identified during the current works appear to relate to the Saxon rampart; deposit [203] identifiable with the flat-topped bank previously excavated and deposit [202] representing a collapse of the stone revetment.

Although the rampart has previously been shown to have a flat top, the abrupt interface between modern overburden and the top of the feature is suggestive of truncation. The main body of the bank however, and potentially ditch material to the northwest of the feature appear to have been afforded a degree of protection in the form of made ground extending to a depth of c.1m below ground level. The made ground was present throughout the excavated areas, and as excavation did not continue below 1m in depth across the main part of the site, no further archaeological or geological deposits were observed.

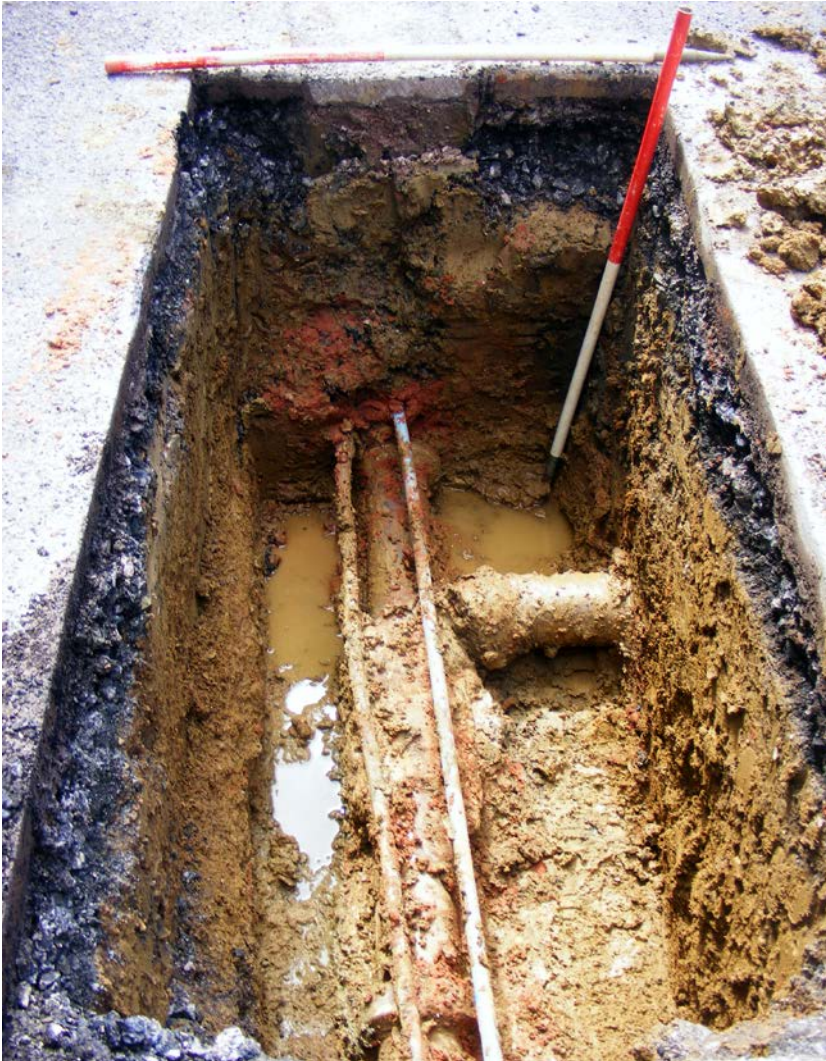
ILLUS 4

Example of the excavation of drainage and the modern, made ground beneath the carpark

Deposits observed within the trench sections were consistent across the site; A layer of tarmac (or concrete in Trench 3) and sub-base to a depth of 0.2m covered the entire site, with a deposit of disturbed made ground (eg [302]) extending to a depth of 1m+ (Illus 4). Material including bricks, metal and plastics was present within the deposit suggesting the deposition of material within the modern period. No deposits of archaeological significance were identified.
