# CABLE OVERLAY – CASTLE SQUARE AND DINHAM, LUDLOW

## ARCHAEOLOGICAL WATCHING BRIEF

commissioned by Western Power Distribution Ltd

November 2015

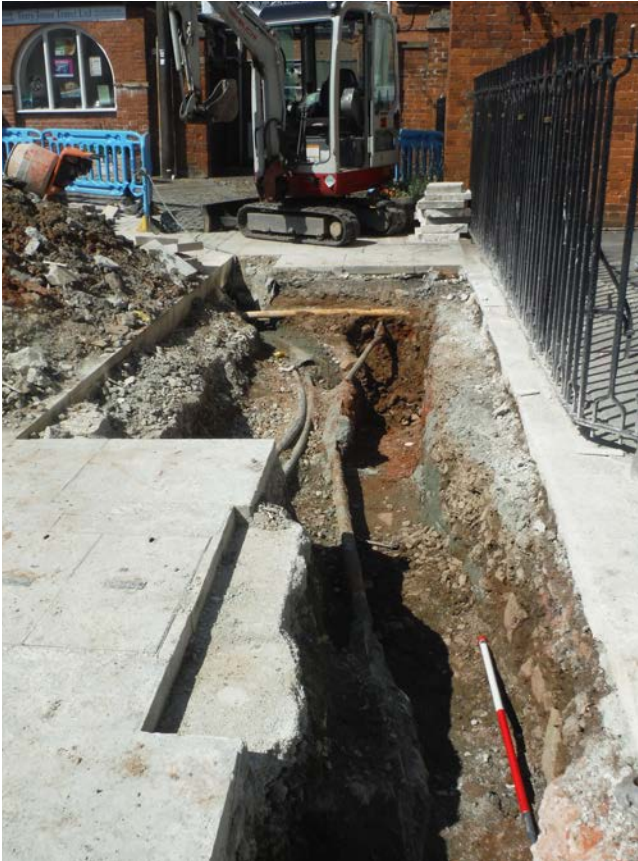
ILLUS 2

West facing view of services in widened part of Castle Square trench

The excavated trench measured, on average, between 0.5 and 0.75m wide. The exception was at Castle Square, on the east-west segment of the trench, where the trench was widened to 1.7m (ILLUS 2), in order to fully expose the services. The trench did not exceed 0.65m deep.

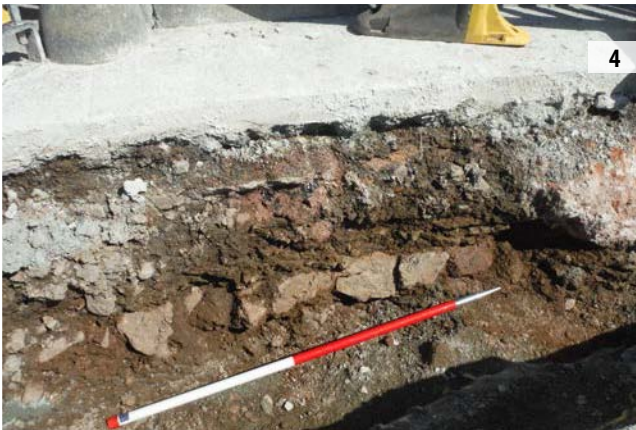
ILLUS 4

In Castle Square, the trench contained multiple extant services, including gas, water and electricity. In the southern facing section of the trench, at a depth of 0.5m, the remains of a possible former surface; comprising irregular stone blocks (009) was observed (ILLUS 3 and ILLUS 4). This feature survived to a length of approximately 1.2m and appeared to be truncated, to the east, by a deposit of mixed brick rubble and cement (008). Both (008) and (009) were truncated by the existing trench and thus, only visible in section. The remainder of the trench revealed layers of backfill and modern surface layers including paving and tarmac (ILLUS 5). Excavation ceased within the backfill layers when the surface of the existing cable was reached. The stratigraphic sequence was recorded at 10m intervals along the complete length of the trench.

South facing view of possible masonry in Castle Square trench

With the exception of the remains of the possible, truncated, stone surface at the end of the Castle Square trench, no archaeological features or deposits were identified during the watching brief. As all excavations were carried out within the footprint of existing service trenches, this was not unexpected.

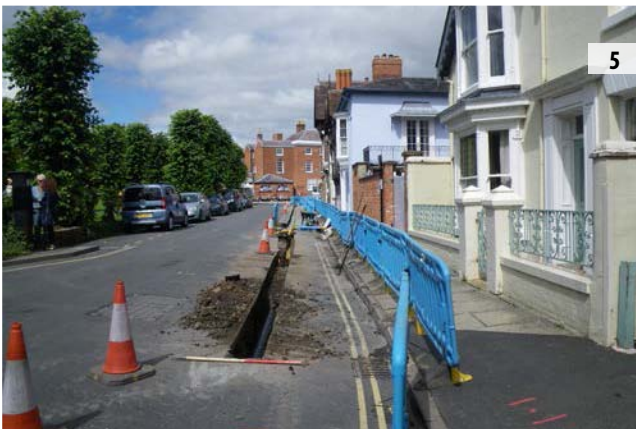
ILLUS 5

Looking north along trench from Dinham to Castle Square
