PROJECT ECLIPSE, DOWN HATHERLEY, GLOUCESTERSHIRE

ARCHAEOLOGICAL EVALUATION

January 2016

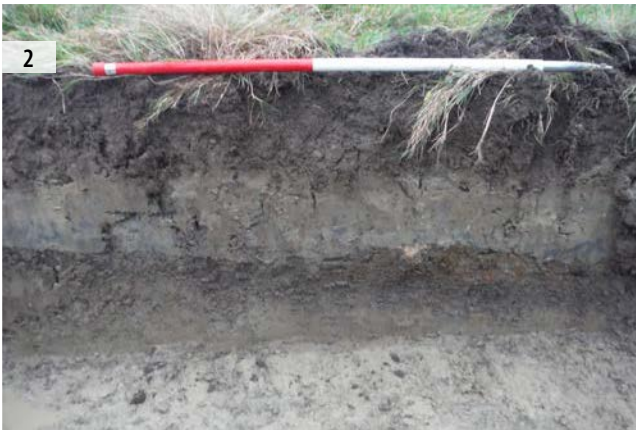
ILLUS 2 NW facing section of Trench 9 **ILLUS 3** NW facing section of Trench 5 **ILLUS 4** W facing shot of Trench 3 showing modern material **ILLUS 5** NE facing shot of Trench 7

Trenches 1–6 contained modern overburden in two distinct layers (**ILLUS 2**). Topsoil comprised a brown silty clay with grey hue and measured between 0.23m and 0.30m in depth (e.g. 1000). Below this was a grey silty clay with yellow hue and occasional blue mottling (e.g. 6001), this was present between 0.46m and 0.75m below ground level (BGL) and overlay a brown sandy clay deposit with a yellow hue (e.g. 3002) that was present across the site between 0.36m and 0.75m BGL. This deposit contained frequent rubble and brick throughout. Below this was a black silty clay with a blue hue (e.g. 4003) that had substantial quantities of tarmac within it. The natural clay geology (e.g. 5004) was only reached through excavating sondages and had been stained a blue black by the above tarmac. Geological deposits were encountered at a depth of between 0.97m and 1.19m BGL.

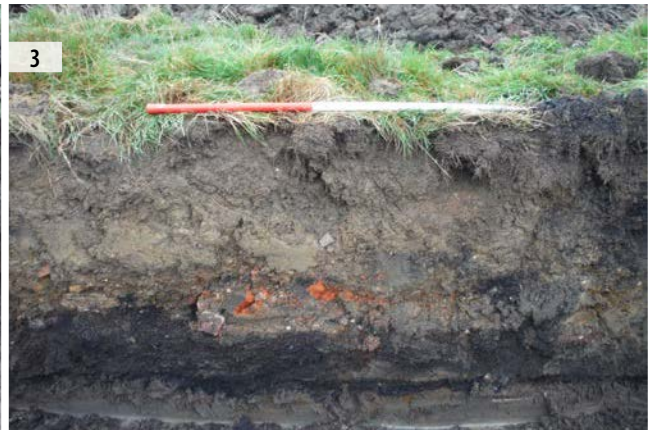
Trench 9 (**ILLUS 3**) contained a thin layer (0.11m) of modern overburden (9002) equivalent to the made ground identified in Trenches 1–6. Below this was a geological deposit of brown slightly silty clay with a yellow hue present at 0.64m BGL.

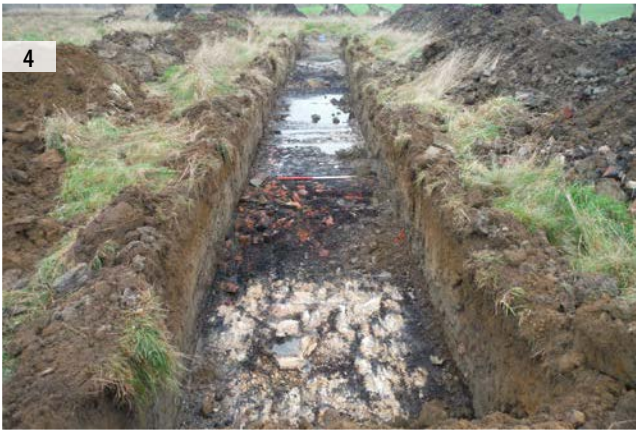
Trenches 7 (**ILLUS 4**) and 8 had a brown silty clay topsoil with grey hue (e.g. 7001) measuring between 0.26m and 0.30m in depth. Below this was a grey silty clay with a blue hue (e.g. 8002) measuring between 0.26m and 0.72m BGL. The natural geology was reached between 0.64m and 0.72m BGL and consisted of a brown slightly silty clay with a yellow hue.

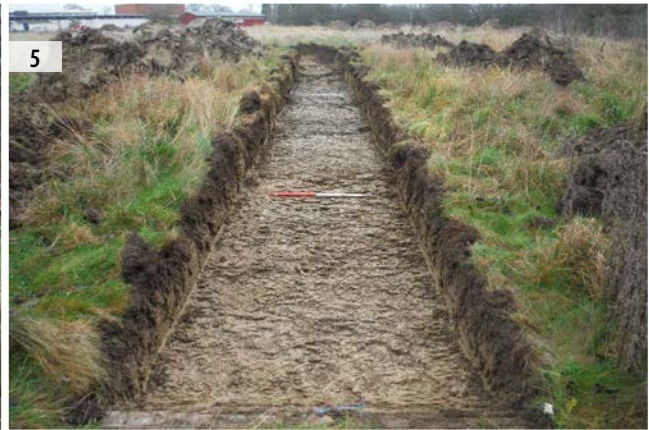
Significant deposits of made ground were identified across the majority of the site. The presence of brick and rubble within the made ground deposit suggests that it relates to the demolition of buildings (**ILLUS 5**). The Desk-Based Assessment notes that the site was part of the Staverton Airfield complex and Dowty Aircraft Components Factory, and it seems likely that the made ground relates to demolition of buildings relating to these former land uses.
