TEMPORARY EMERGENCY WARD, COUNTY HOSPITAL, HEREFORD

ARCHAEOLOGICAL WATCHING BRIEF AND EXCAVATION

commissioned by Wye Valley NHS Trust

P151135/F

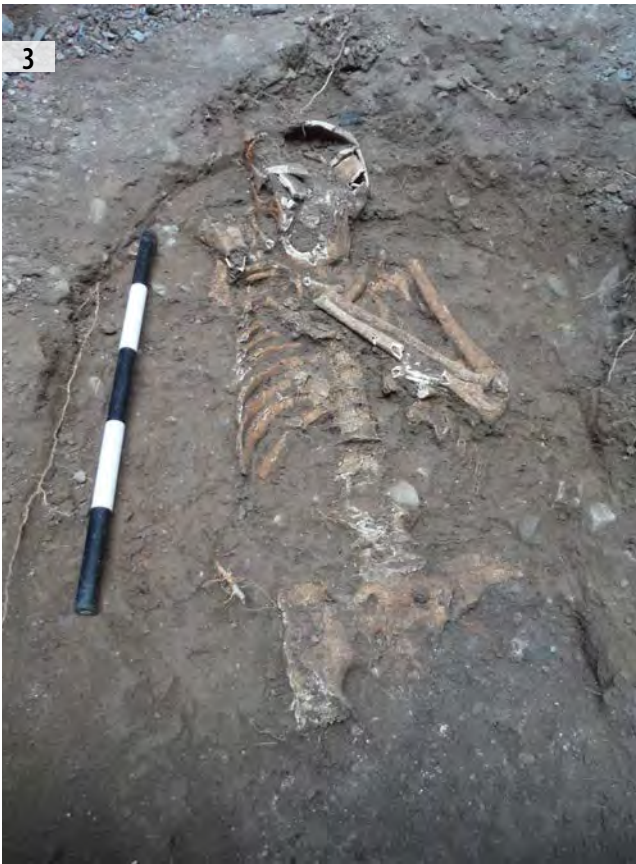
ILLUS 3 Trench 1, skeleton (1012), looking northwest **ILLUS 4A** Trench 1, cist [1018] with collapsed lid, looking northwest **ILLUS 4B** Skeleton (SK1021) within cist, looking northeast

Separated from these remains, by a thin lens of grave soil (1010) and at the approximate centre of the 1.2m diameter wide excavation area, a third partial set of human skeletal remains (SK1012), were uncovered. The remains represented the upper body and partial pelvis of an adult male, aged 40–45 years, the lower portion of which had been removed by the insertion of wall footing [1014]. The skeleton was in a prone position and appeared to have its hands folded across the chest. The frontal bones of the skull were fragmentary as were the upper surfaces of the ribs. Laboratory analysis revealed that (SK1012) had extensive osteoarthritis of the spine (both in the neck and lumbar regions), as well as in the shoulders, left elbow and hands.

No obvious cut was identified in association with the burial and no accompanying items or structures were recorded. The burial was aligned roughly northeast-southwest. The grave soil (1010) was indistinguishable from below and above the burial. Above the point at which this was encountered (2.0m BGS) were the remains of multiple modern intrusions.

A few pathological and traumatic lesions and developmental anomalies were noted: Middle Adult male, SK1012 had extensive osteoarthritis of the spine (both in the neck and lumbar regions), as well as in the shoulders, left elbow and hands.

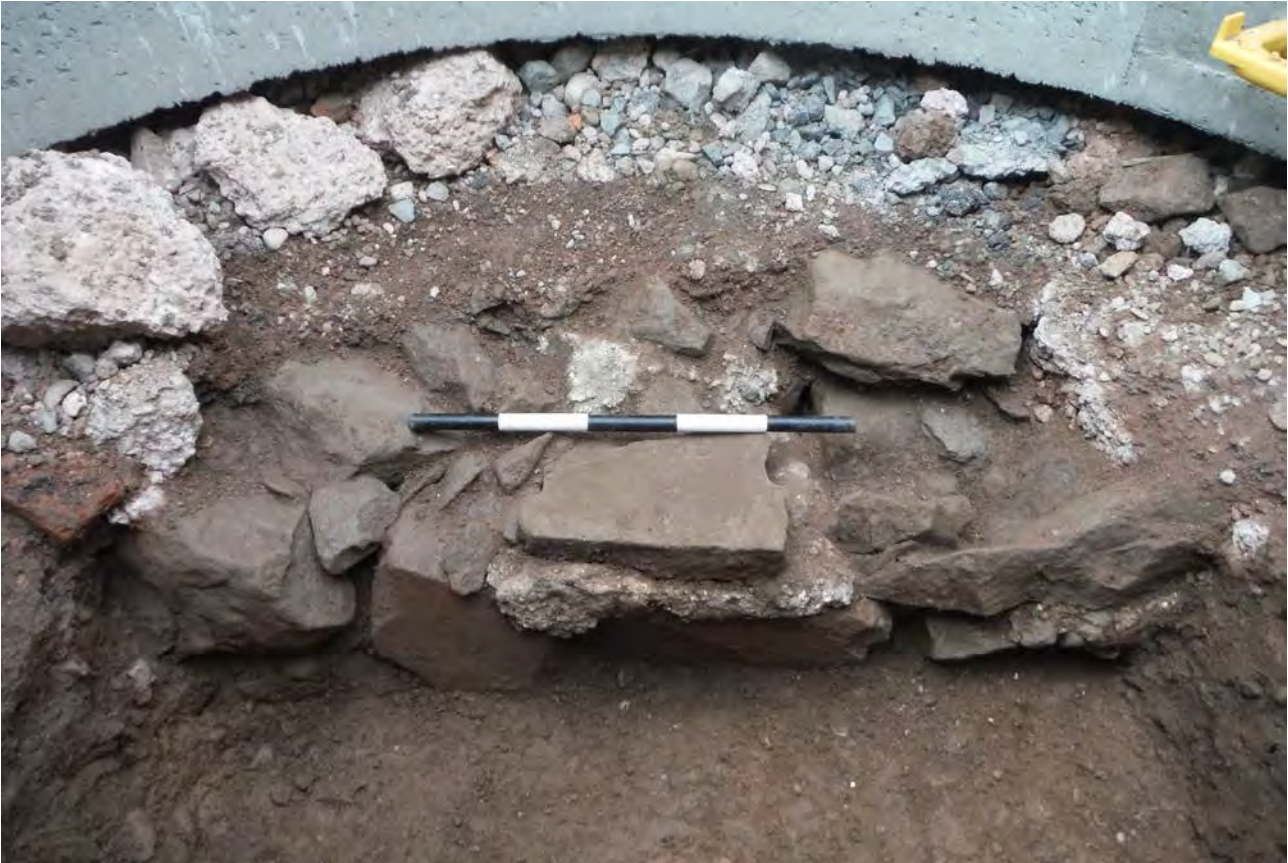
ILLUS 5 Trench 4, masonry and mortar wall [4008], looking southwest

This trench was situated to the south-east of Trench 2, slightly inset to the south. It measured approximately 2.1 × 2m at the surface and was excavated to a maximum depth of 2.70m.

The natural gravels (4102) were encountered at a depth of 2.1m from the current ground surface. Overlying this was a 0.30m deep, compact layer composed of pebbles or cobbles in a grey-brown silty matrix (4010). This was truncated by the remains of a northwest-southeast aligned wall [4008], encountered 1.5m below the modern carpark surface. The wall comprised of roughly hewn, vacuous limestone blocks [4008] partially and coarsely bonded with cement-like mortar on their uppermost surface (4011). The wall survived to a height of 0.40m and was sealed by a 0.50m deep layer of mid-brown silty sand, sealed, in turn by layers of post-medieval construction debris and modern surface levels. No further archaeological features or deposits were encountered within this trench.

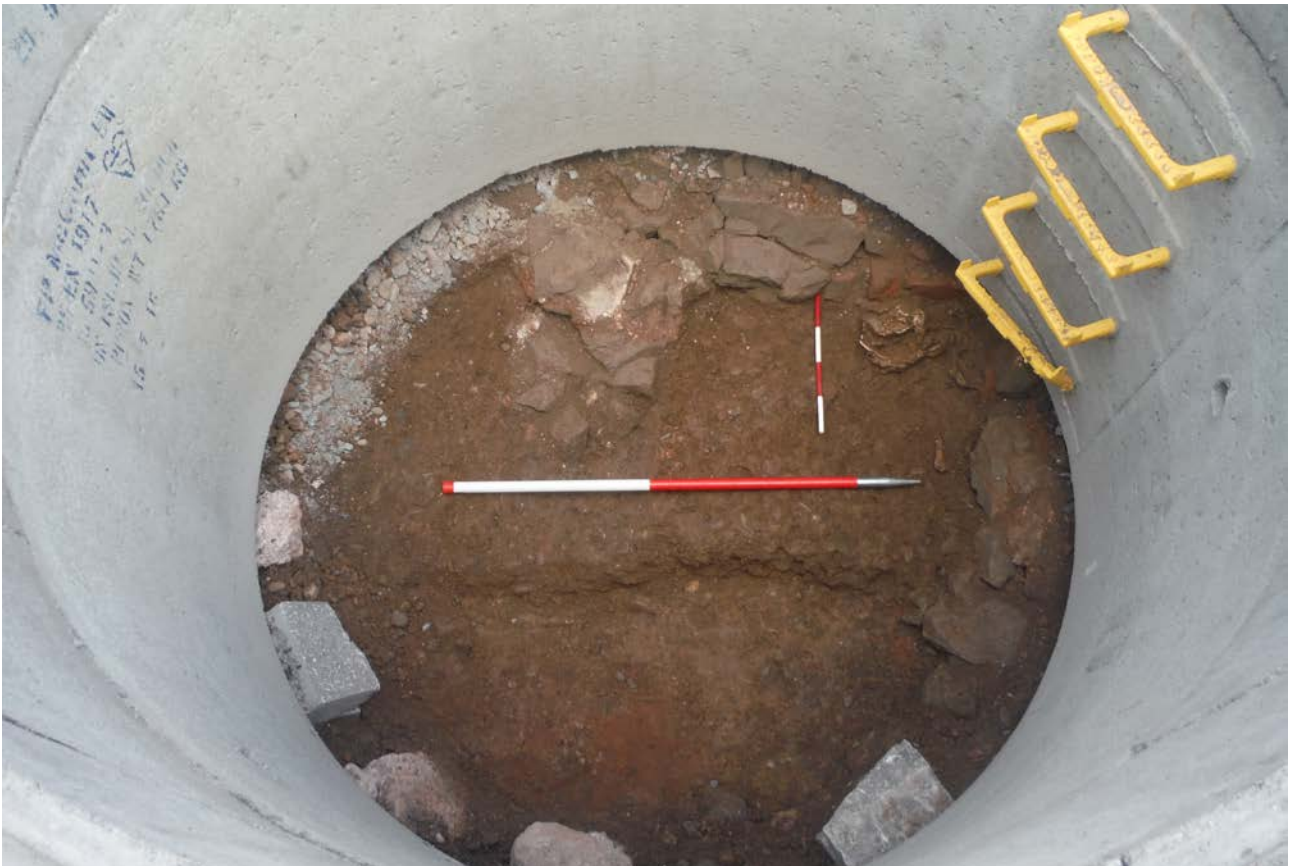
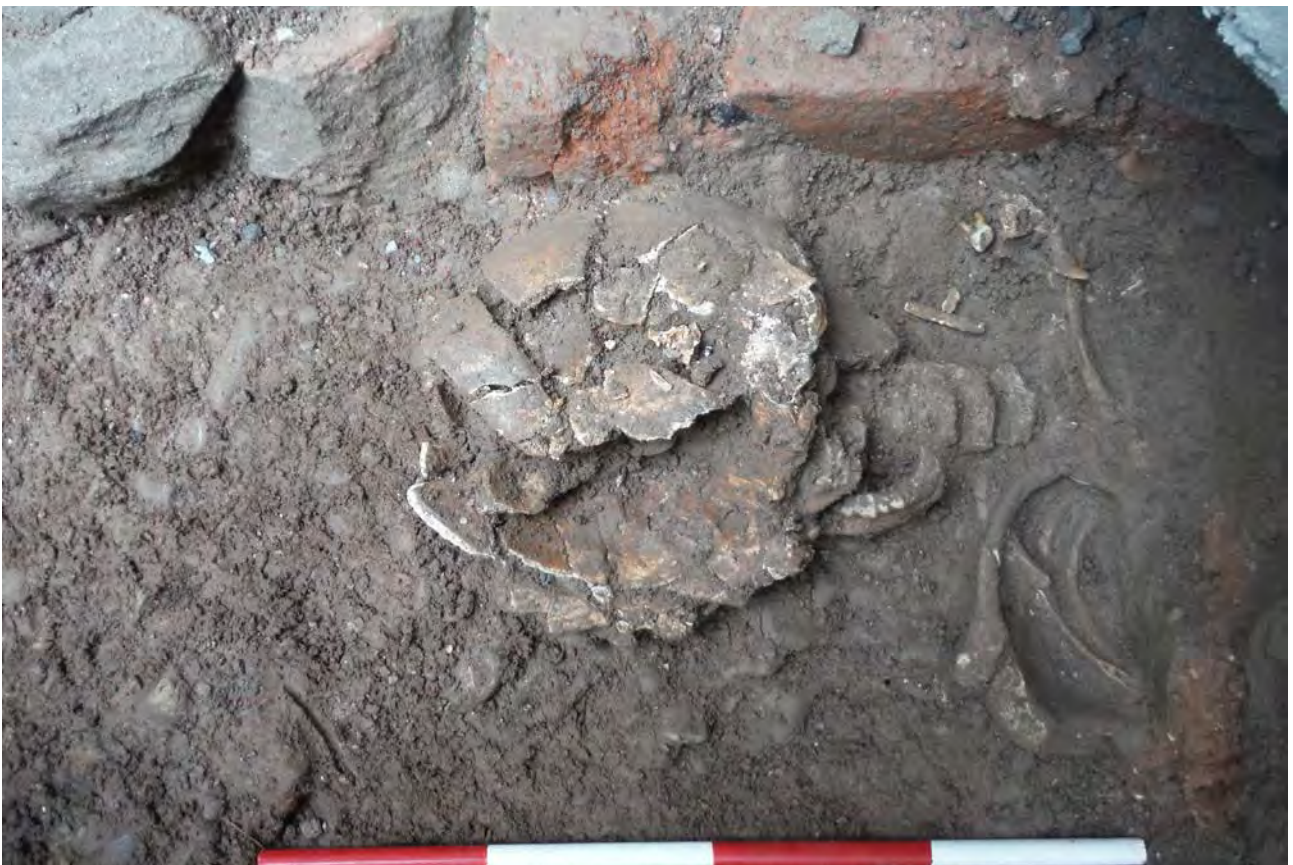
ILLUS 6A Trench 5, location of skeleton (SK5008), looking northeast

ILLUS 6B Close-up of skeleton (SK5008), looking northeast

Located 1.4m to the south-east of Trench 4, this trench revealed a similar sequence of deposition. The natural gravels (5018) were encountered at approximately 2.0m BGL and sealed by, what was presumed to be the same pebble surface (5009); isolated to the north-western portion of the trench. Overlying the pebble surface, toward the eastern limit of excavation, the remains of the head and shoulders (SK5008) of an individual, with an age at death estimated as c15 years, were identified. The cranial vault was entirely collapsed

and only a few vertebrae and upper limb fragments were present within the limit of excavation. Osteological analysis revealed that the teenager had impacted third molars, which had led to severe crowding of other teeth and rotation of the upper premolars. At the opposite side of the trench, on its north-western edge, the lower legs and feet of an adult (SK5016) were also recovered. The skeletal remains were discovered within a mid-brown silty clay matrix, the top of which was encountered at a depth of 1.8m (BGS).

Both burials were truncated by a post-medieval stone and cement wall [5011 and 5013] and possible culvert [5006]. The northeast-southwest part of wall [5011], located toward the north-eastern limit of excavation, was deemed almost certainly to be the continuation of wall [4008], in Trench 4. A second wall, a northwest-southeast spur of [5011], was observed at 90 degrees, running toward the centre of the trench. This was truncated, at its south-eastern end by modern intrusion. The upper horizons, sealing the walls and the skeletal remains comprised mixed brick rubble and layers of modern surface levelling deposits.

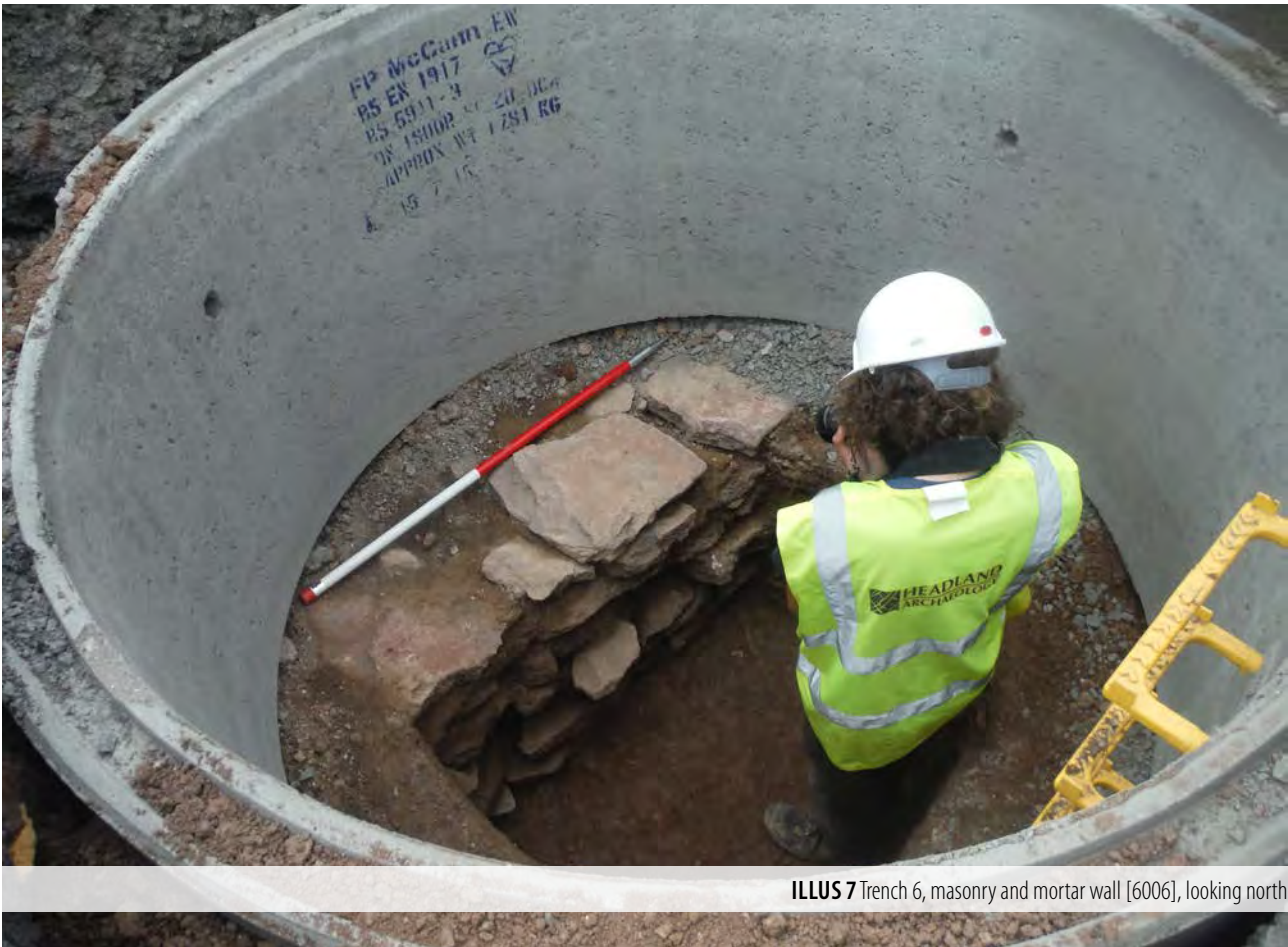
ILLUS 7 Trench 6, masonry and mortar wall [6006], looking north

thick sterile layer of dark grey-brown clay silt (6009), into which the foundation for a wall [6006] was cut. The wall itself was constructed of coarsely hewn limestone slabs of various sizes and was oriented roughly northeast-southwest. Six courses survived, to a height of 0.40m and it was located against the north-west limit of excavation. The overlying deposit, (6005) infilled the area to the south-east of the wall and was encountered at a depth of 1.2m from the modern car park surface. It comprised dark brown silt sand containing pottery, glass and animal bone of probable late 19th century date. This was sealed by approximately 1.2m of brick rubble and other modern make up layers.

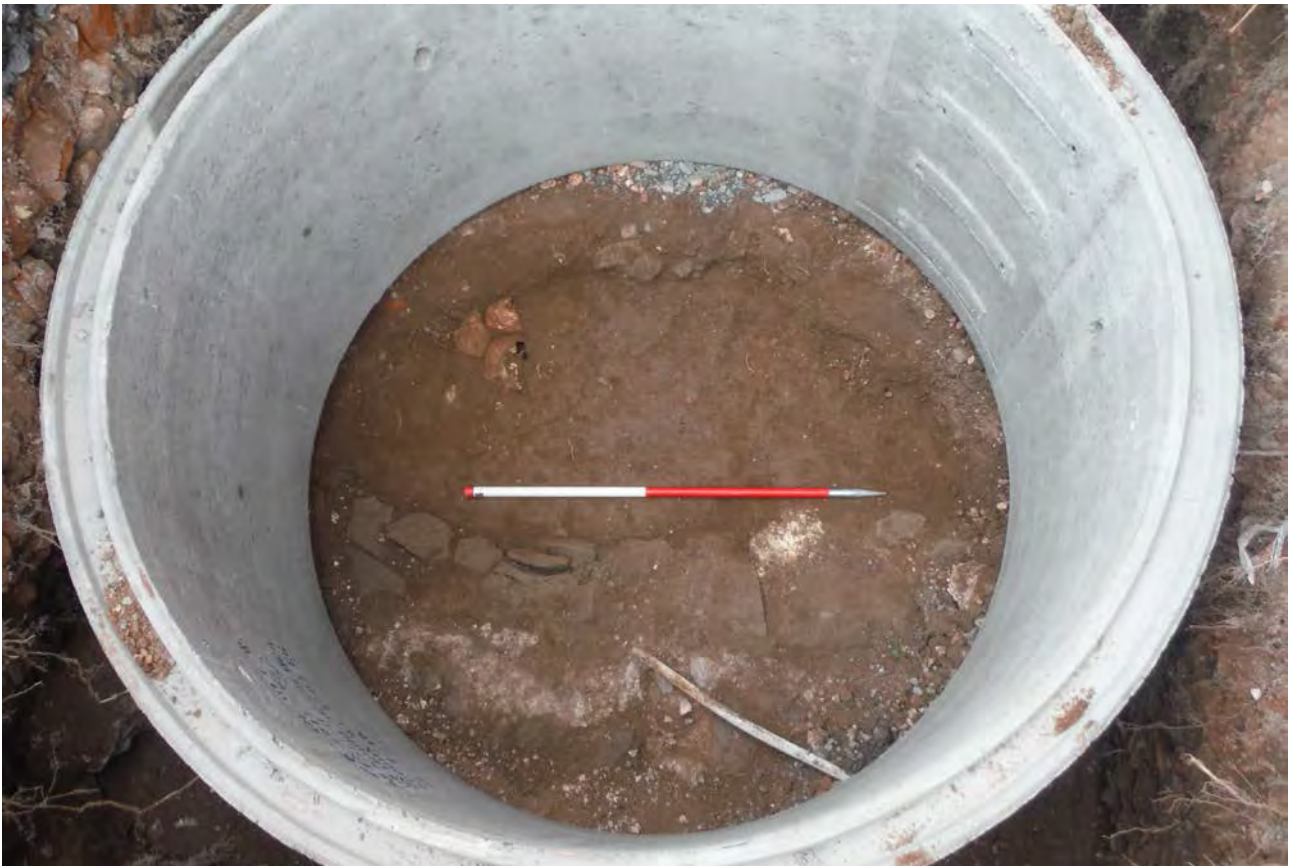
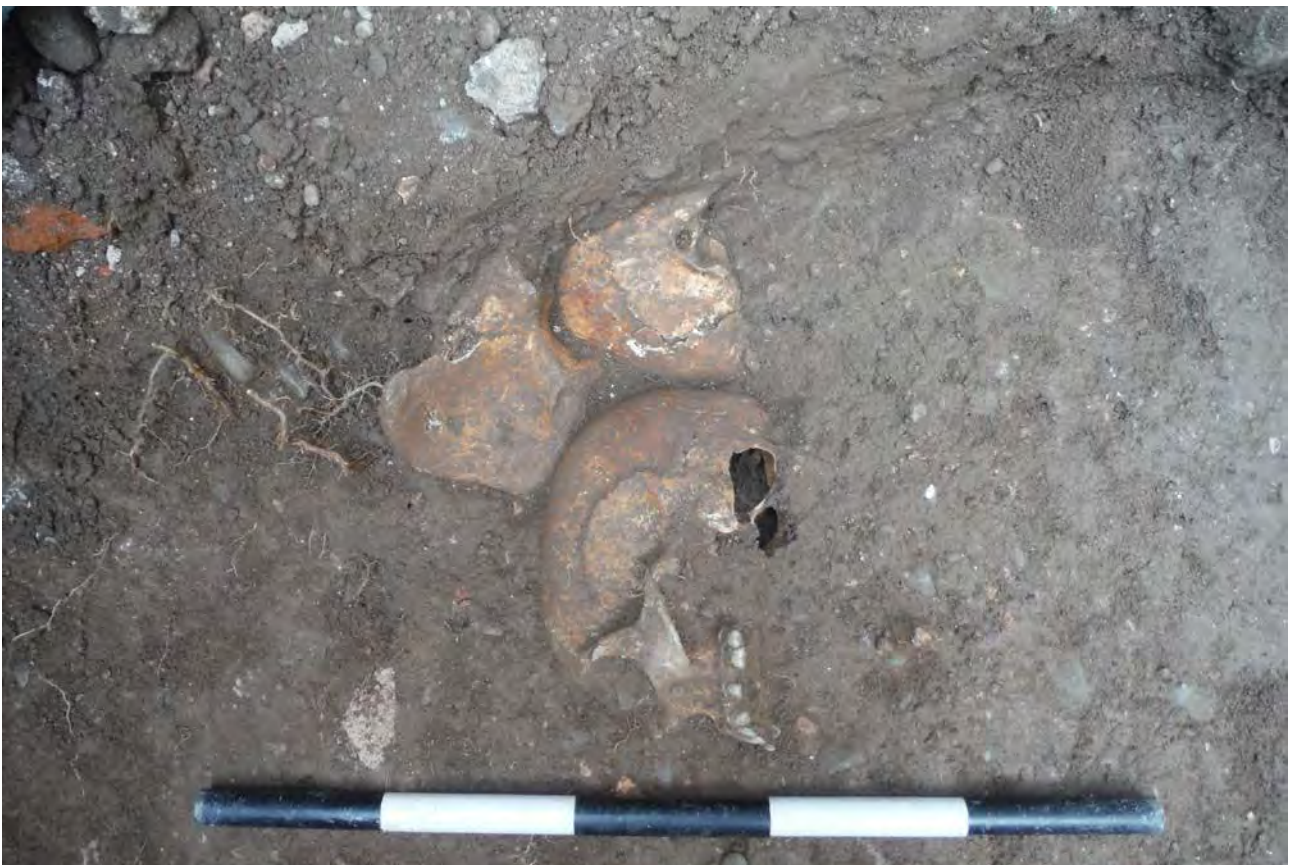
ILLUS 9A Trench 13, location of wall and charnel deposit, looking northwest

ILLUS 9B Close-up of part excavated skulls (SK 1306) in charnel deposit, looking northwest

Trench 13 was located just over 1.0m to the east of Trench 12 and measured 2.30m by 2.30m at its surface. The natural (1312) was identified at a depth of approximately 3.0m from the ground surface. Cut into the natural gravels, in the south-western part of the trench, the edge of an irregular, shallow pit (1309) was identified. Within the pit, within a dark grey-brown silt matrix (1308), the remains of a minimum of five individuals (1306), including parts of a pair of feet from a single individual were revealed. The remains appeared to contain elements of at least four males and one (possibly two) female(s). All of the bones were adult and tooth-wear patterns suggested ages of between 25–45 years, while pelvic age-indicators also suggested a female of over 50 years was represented. Several of the male skeletal elements (probably deriving from a single individual) were of notably large size and robust build. A number of bones throughout the charnel deposit also displayed pathology, including osteoarthritis on several vertebrae and at a shoulder joint,

along with a well-healed fracture of a rib. Owing to the number of individuals represented and the co-mingling of the remains, this was interpreted as a charnel pit. Sealing the charnel deposit was the same, dark brown silt clay (1305) seen across the north eastern part of the site. This was truncated by a northeast-southwest aligned wall [1307] which also partially truncated the charnel deposit. The wall was constructed of roughly hewn stone blocks of irregular size. It was bonded with a thick, hard cement-like mortar, similar to that seen in walls identified in Trenches 4, 5 and 6. It spanned the width of the excavated area survived to a height of approximately 1.0m. The wall was sealed by a deposit of building rubble (1304), which was in turn overlain by further modern levelling layers.

Several bones in the charnel deposit (1306) displayed pathology including osteoarthritis on several vertebrae, osteoarthritis at the shoulder joint and a well-healed fracture of a left rib body.
