SEWAGE PUMPING STATION, BARTON-UNDER-NEEDWOOD, STAFFORDSHIRE

WATCHING BRIEF

commissioned by Amey plc
on behalf of Severn Trent Water plc

February 2016

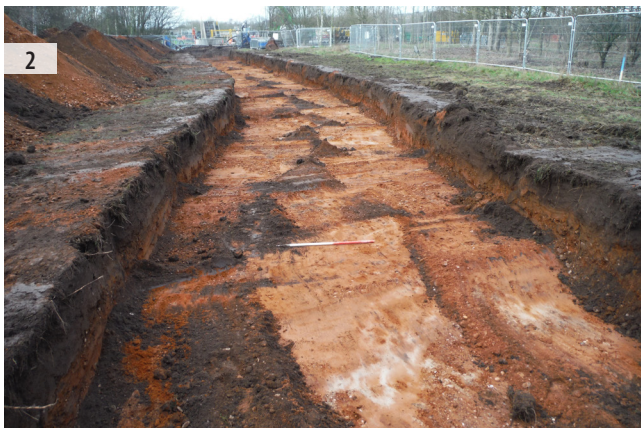
ILLUS 2 General shot of the larger western trench end, facing NW facing SW **ILLUS 3** General shot of the east end of trench, facing SE **ILLUS 4** Section of east end of trench, facing SW **ILLUS 5** NE facing section at west end of trench

A total of 90m of a rough 4.7m wide trench was observed. Its length was approximately 70m on the main north-west to south-east aligned section (**ILLUS 2**), and then a further 20m at the south-eastern end where it turned to connect to the existing sewer (**ILLUS 3**). Due to a bend in the main section, the trench was widened along the south edge to compensate and create a straighter line. This widened the central 30m of the trench to a maximum of 5.7m in this area.

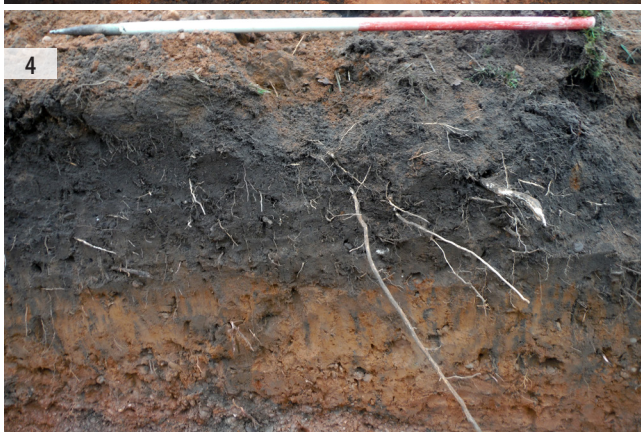
Due to the length of the trench and the uniformity of the deposits within it, sections were recorded at regular intervals. Significant levels of rooting can be seen in all sections, whilst the more substantial layers of subsoil can be seen in the southern leg of the trench (ILLUS 4 and 5).

Natural geological deposits generally comprised sands and gravels of varying hues from mid-brownish orange to red, with lighter striations in some areas. In particular the redder sand deposits were concentrated around the bands of gravel. Concealing this was a disturbed subsoil layer. This was a mid-orange brown, clay sand with frequent root intrusion and rounded stone inclusions. This horizon had diffuse interfaces with both the topsoil and the underlying substrate with a large variance in thickness (between 0.10–0.30m thick).

The overlying topsoil was observed across the entire site. This thick dark brown, clay sand with humic material showed frequent large root intrusion and occasional small-medium rounded stone inclusions. This layer was relatively regular in depth of between 0.35 and 0.45m thick.
