LAND 16–18 HIGH TOWN, HEREFORD

ARCHAEOLOGICAL EVALUATION

May 2016

HA JOB NO. BBHH/02
HAS NO. 1173
NGR SO 51058 39993
PARISH Hereford
LOCAL AUTHORITY Herefordshire

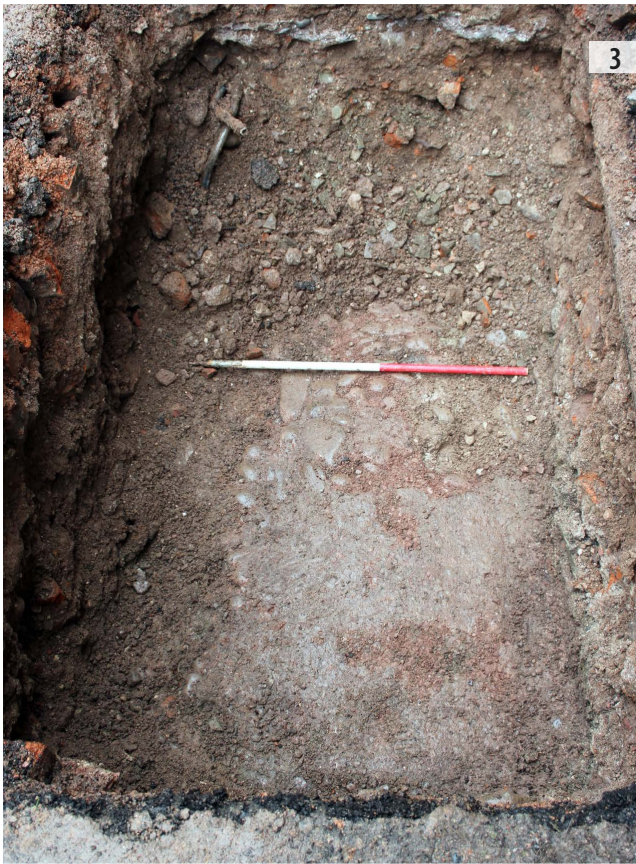
ILLUS 3 General view Trench 1, looking north, showing surface [110]

This surface was sealed by a reddish brown gravel and sandy clay levelling deposit (114) from which pottery of 19th Century date was recovered. This in turn was sealed by a reddish grey sandy clay gravel (113) which was interpreted as a setting deposit for a further metaled surface (110) which consisted of rounded cobbles of variable sizes, compacted within a sandy gravel matrix (ILLUS 3).

The earliest deposit encountered was recorded in the sondage at 53.31m AOD, and comprised a metaled surface [115] incorporating stone, tile and gravel (**ILLUS 3** and **4**) from which a sherd of pottery and fragments of tile of post-medieval to modern date were recovered.

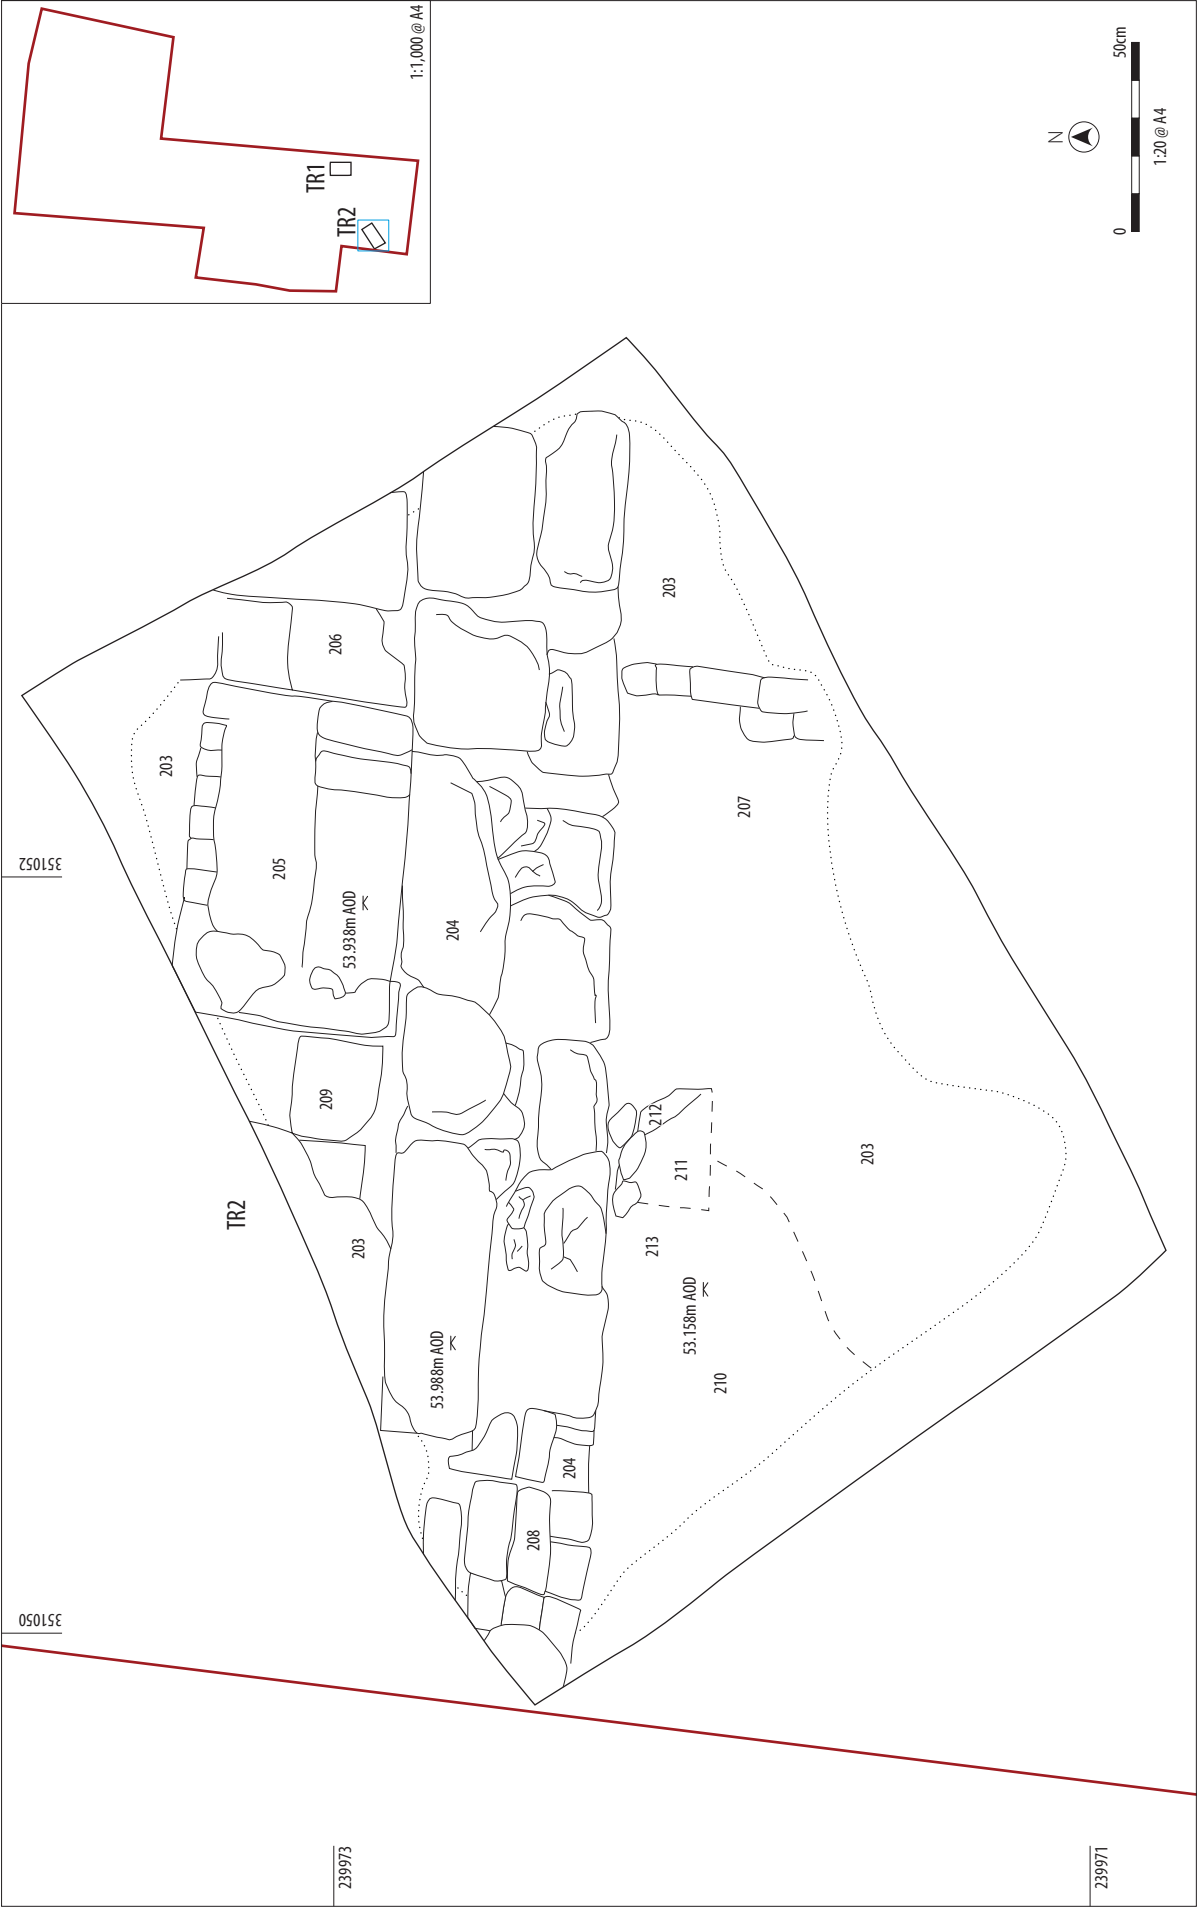
ILLUS 5 Plan of Trench 2 features

The earliest deposit encountered at 52.96m AOD, was a pinkish brown sandy clay (211) containing occasional charcoal and ceramic building material fragments and rounded and angular gravel. The deposit was identified as a former ground surface. Cutting (211) was a heavily truncated linear feature (213) exposed in a sondage, oriented south-east – north-west and lined with rounded stone cobbles. It was filled with a green, sticky sandy clay cess deposit (212) and the feature was identified as a cobble lined drain or culvert.

Abutting the northern face of [204] was a solid rectangular brick structure [205] bonded with a gritty mortar and measuring 0.84m long by 0.60m wide. To the east of this an associated stone slab surface [206] was partially exposed and to its west a ceramic tile surface [209] also abutted the rectangle of bricks and wall [204], indicating [204] had been incorporated or re-used in the structure defined by the rectangular brick structure and surfaces.

Abutting the eastern face of [204] was a brick wall [207] which survived nine courses high and was laid in a stretcher bond, two bricks wide. The wall was interpreted as being a partition wall.

Lying against the eastern face of [204] was a dark grey gritty clayey sand dumped deposit (210) containing large amounts of broken bottle glass, ceramics, brick and tile fragments, occasional animal bone and iron nails and objects. Ceramics and a coin recovered from the deposit dated it to no earlier than 1860. The deposit was not excavated to its base and interpreted as a probable cellar backfill.

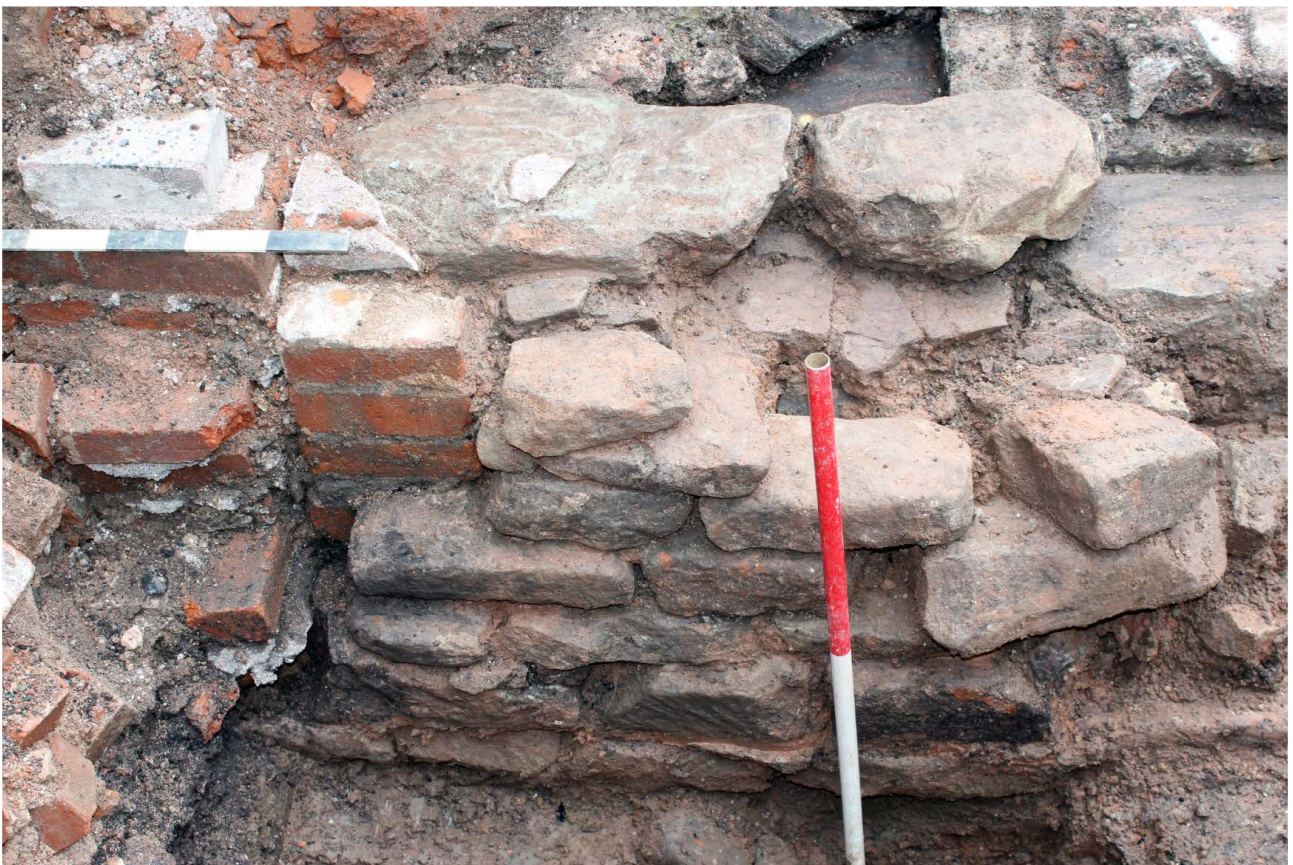
ILLUS 7 East facing elevation Wall foundation [204] and brick foundation [208]

Overlying the culvert [204], was a stone wall foundation (ILLUS 7) oriented east-west and bonded with a red clay. The foundation extended beyond the limits of the excavation area and measured greater than 3m east-west and 0.60m wide, surviving to seven courses, 0.73m deep. The top of the wall was encountered at 53.98m AOD.

On its western side [204] had been cut away and truncated by a north-south oriented brick wall foundation [205] (ILLUS 7). The base of [204] was observed to continue west below [205].

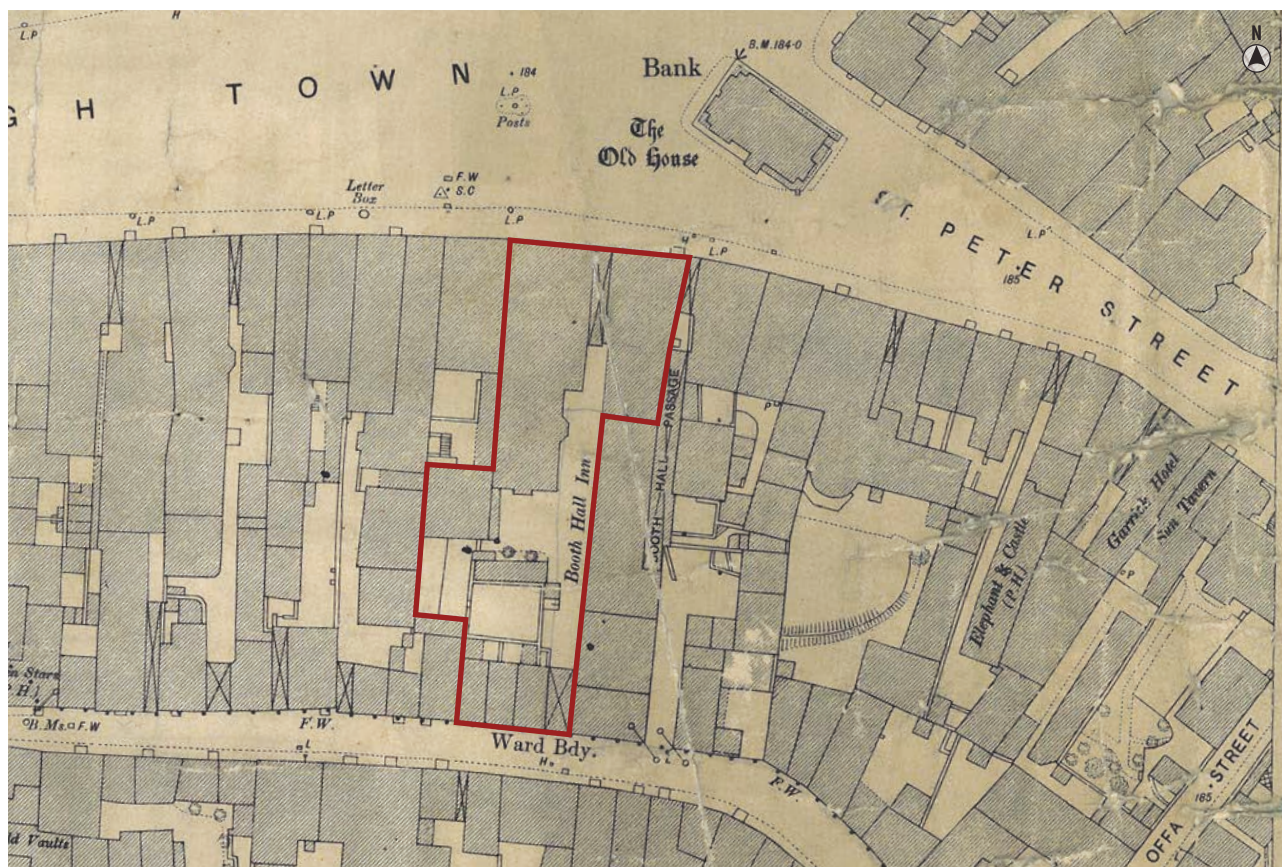
ILLUS 8 1886 Ordnance Survey map

Trench one revealed a sequence of compacted, trampled and metaled surfaces sloping downward from the south to the north, none of which extended wider than 1m from the eastern edge of the trench. A passageway accessing the market area of Hereford from East Street is recorded as recently as 1886 (**ILLUS 8**) and dating from the surfaces identified shows a sequence of repair or resurfacing of a path during the post-medieval period.

Trench two recorded a sequence of wall foundations and surfaces of brick construction which appear to be associated and are likely to relate to structures defined on the 1886 map (**ILLUS 8**). The dumped material sealed below made ground would also suggest the presence of a cellar in this area. A coin recovered from the cellar dump would suggest a date for its infilling of no earlier than 1860. A cess-filled culvert could be a later insertion beneath the early stone wall following abandonment of the cellar.

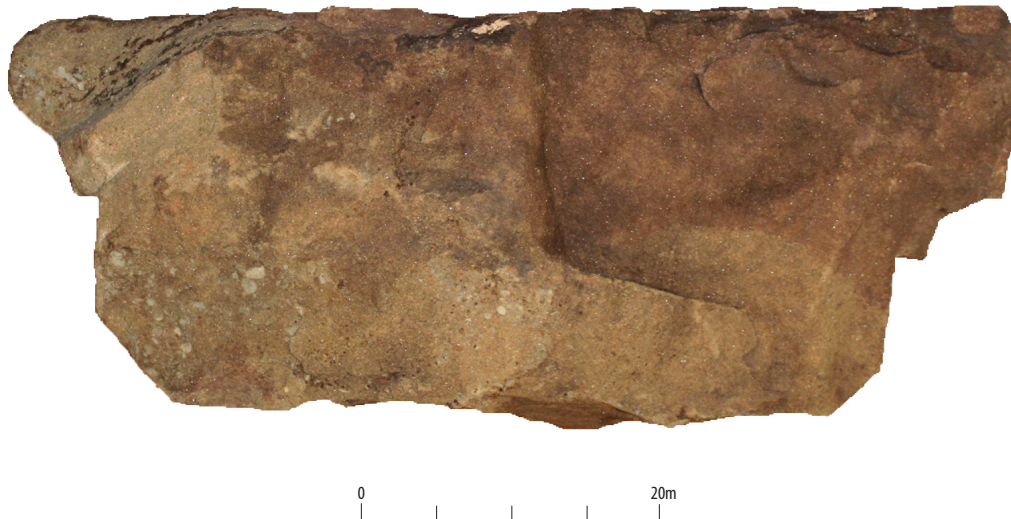
ILLUS 9 View of moulded stonework from Trench 2 (2903)

The remains of a clay-bonded stone wall was incorporated into a Victorian cellar construction. Although no directly associated dateable material was recovered, the nature of the construction would suggest an earlier date for the construction of the wall. Moulded masonry recovered from the made ground deposit (**ILLUS 9**) is of a style which suggests an earlier date, and the presence of

a building of medieval date in the vicinity. Mortar adhering to the stone implies its later re-use. It may derive from the demolition of structural remains associated with the stone wall foundation, though this cannot be unequivocally stated.
